**Bridge #A3941 (Routine)**  
**I-30 WB log 89.65 over PRAIRIE BAYOU**  
**Location: 8.35 MI SW OF SH 270**  
**Team Lead: Shane Byrd Inspection Date: July 14, 2020**

IDENTIFICATION	
(1) State Names	Arkansas
(8) Structure Number	A3941
(5) Inventory Route	30
(2) Highway Agency District	06
(3) County Code	59-Hot Spring County, Arkansas

**Bridge #A3941 (Routine)**  
**I-30 WB log 89.65 over PRAIRIE BAYOU**  
**Location: 8.35 MI SW OF SH 270**  
**Team Lead: Shane Byrd, Inspection Date: July 14, 2020**

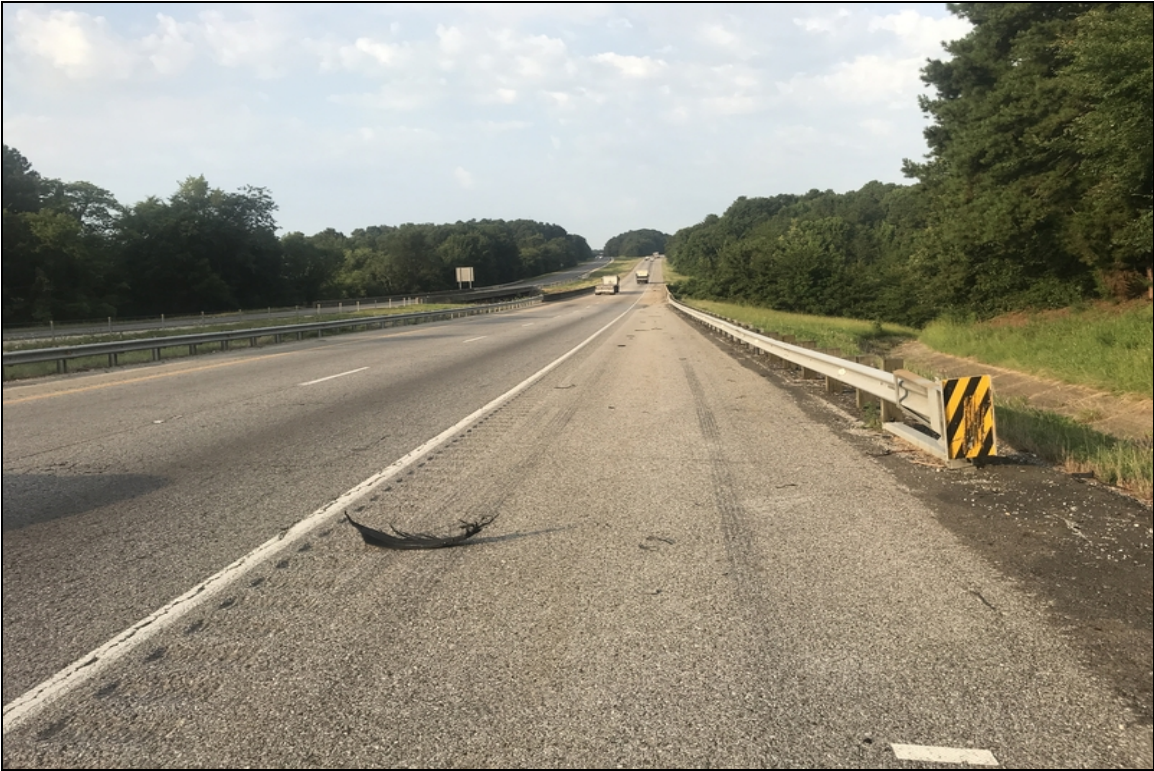
Approach looking Westbound.

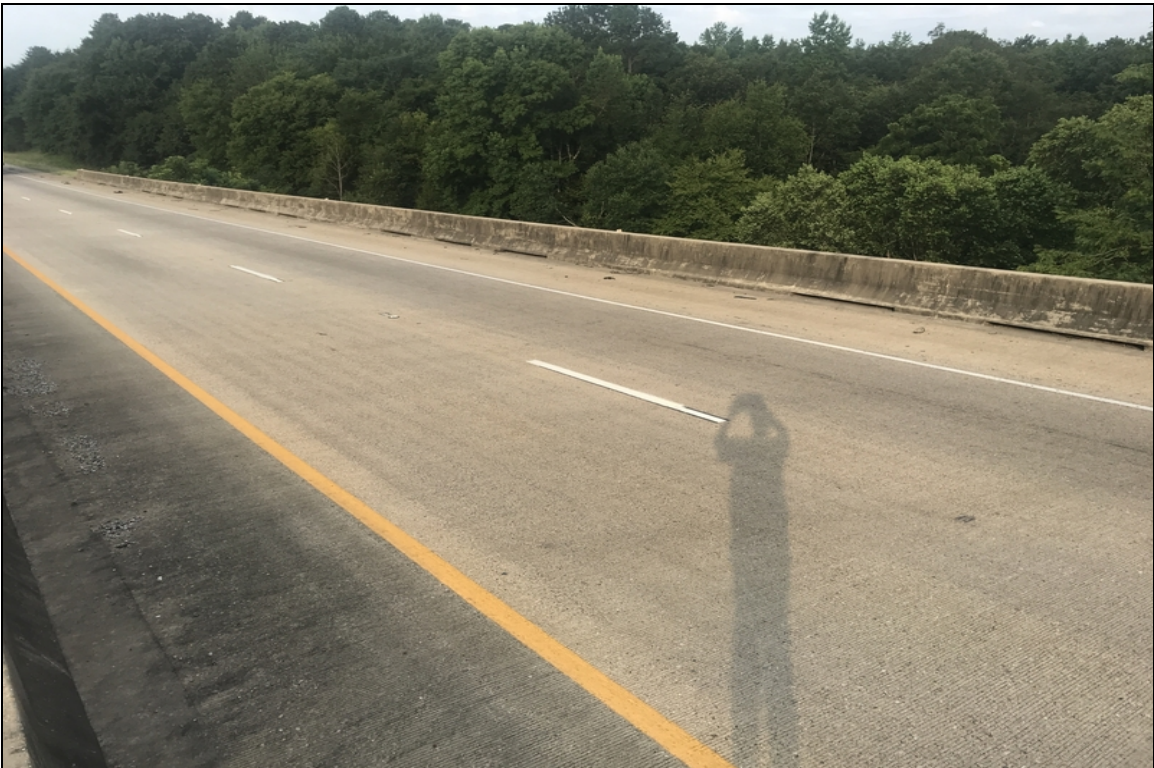
(12)	All spans have transverse cracks and longitudinal cracks that parallel the top flanges of the girders. Soffits have cracks with efflorescence.						
107	Steel Open Girder/Beam	LF	1680	1644	36	0	0
1000	Corrosion	LF	36	0	36	0	0
515	Steel Protective Coating	SF	13692	13399	293	0	0
3430	Oxide Film Degradation Color/Texture Adherence(Steel Protective Coatings)	SF	293	0	293	0	0

Deck overview.
