Bridge #03197(Routine)
SH 391 GALLOWAY over I 40 LOG 160.81

Location: I-40 & SH 391

Team Lead: Shane Byrd Inspection Date: July 23, 2019

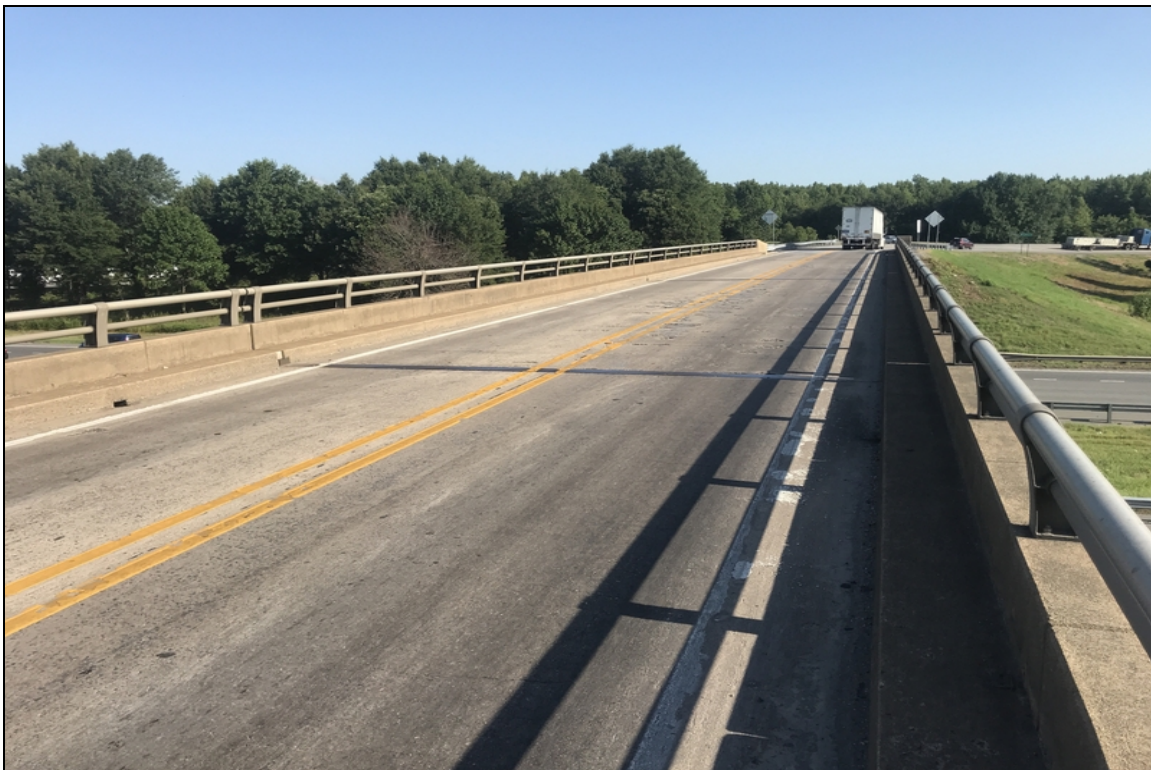
| ELEM | DESCRIPTION | UNITS | TOTAL | CS1 | CS2 | CS3 | CS4 |
|---|--|---|---|---|---|---|---|
| (12) | The deck surface has some abrasion due to the high truck volume. All spans have spalls and spalls filled with asphalt material and all spans have cracks on one foot centers. 0.075 inch max | | | | | | |

Deck overview

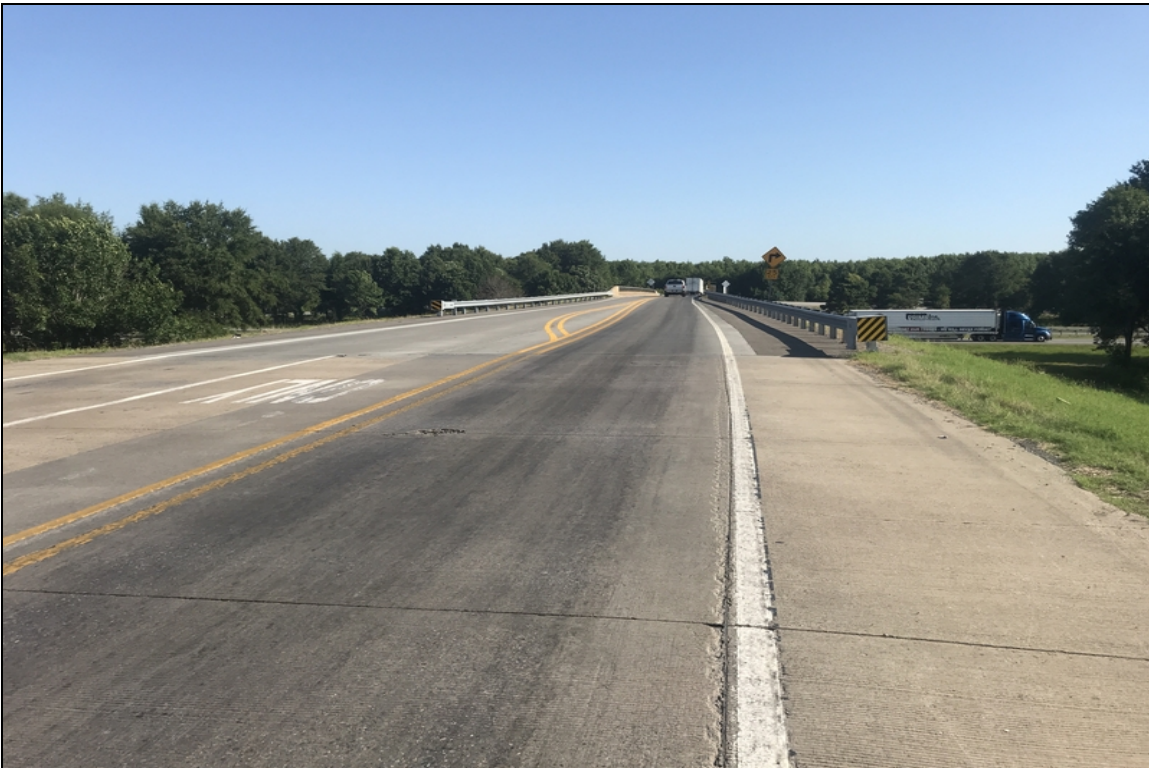
Approach looking Northbound
