Bridge #03653(Routine)

CR308-K Northcutt over I-40 LOG 179.34

Location: 1.4 M N US 70

Team Lead: Keith Harris Inspection Date: April 21, 2022

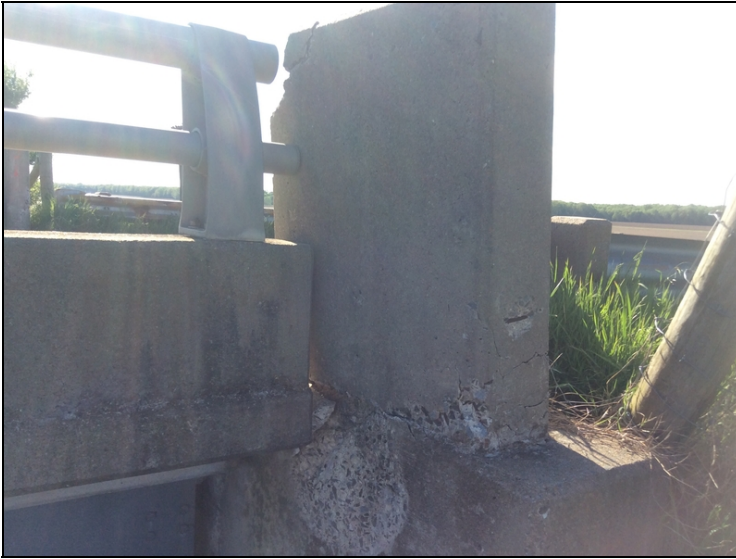
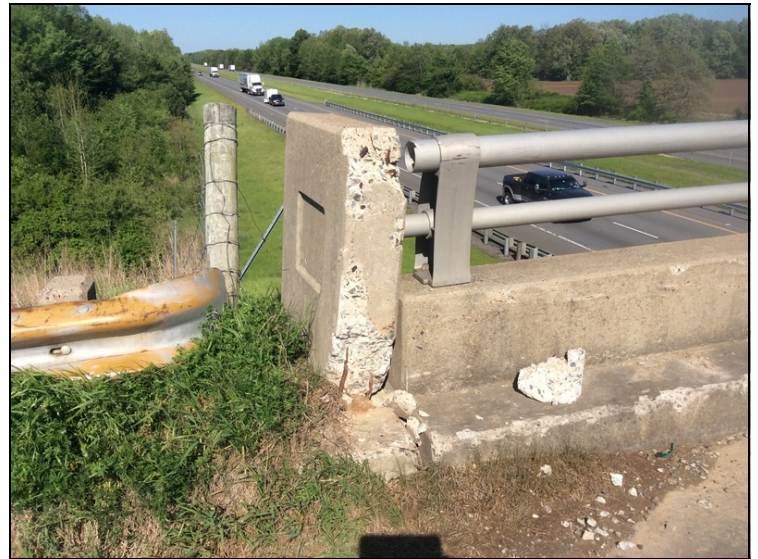
Left concrete end post at both abutment and both Bridge rails on spans 1 and 2 have traffic damage.  
Span 2 at bent 2 left rail is spalled from traffic impact

Left concrete end post at South abutment and both Bridge rails on spans 1 and 2 have traffic damage.
