Bridge #03672(Routine)

SH 249 Log 3.52 over I-40 LOG 191.13

Location: INTER SH 249 & I 40

Team Lead: Keith Harris Inspection Date: April 18, 2022

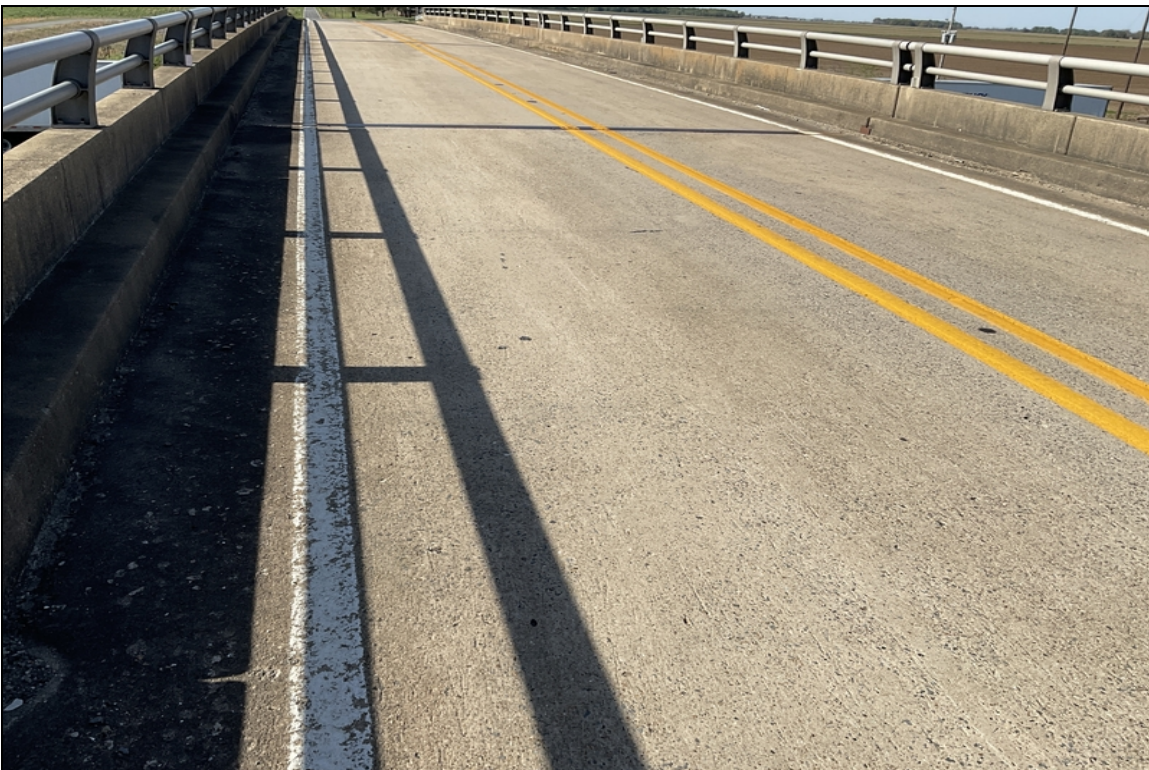
Deck overview

(12)							
Unsealed transverse cracks on 6 to 8 foot centers. 0.035 inch avg. There are some larger shrinkage cracks scattered on the deck surface. Three small spalls in span 1,2 & 4.							
Small spalls in soffit along the edge of beam 1 in span 1							
107	Steel Open Girder/Beam	LF	1070	907	163	0	0
1000	Corrosion	LF	155	0	155	0	0
7000	Damage	LF	8	0	8	0	0
515	Steel Protective Coating	SF	7297	0	7210	47	40
3440	Effectiveness (Steel Protective Coatings)	SF	7297	0	7210	47	40
