Bridge #A3709(Routine, Underwater type 2)

I-40 WB Log194.39 over HURRICANE CREEK

Location: 1.2 MI EAST JCT SH 11

Team Lead: Keith Harris Inspection Date: August 25, 2021

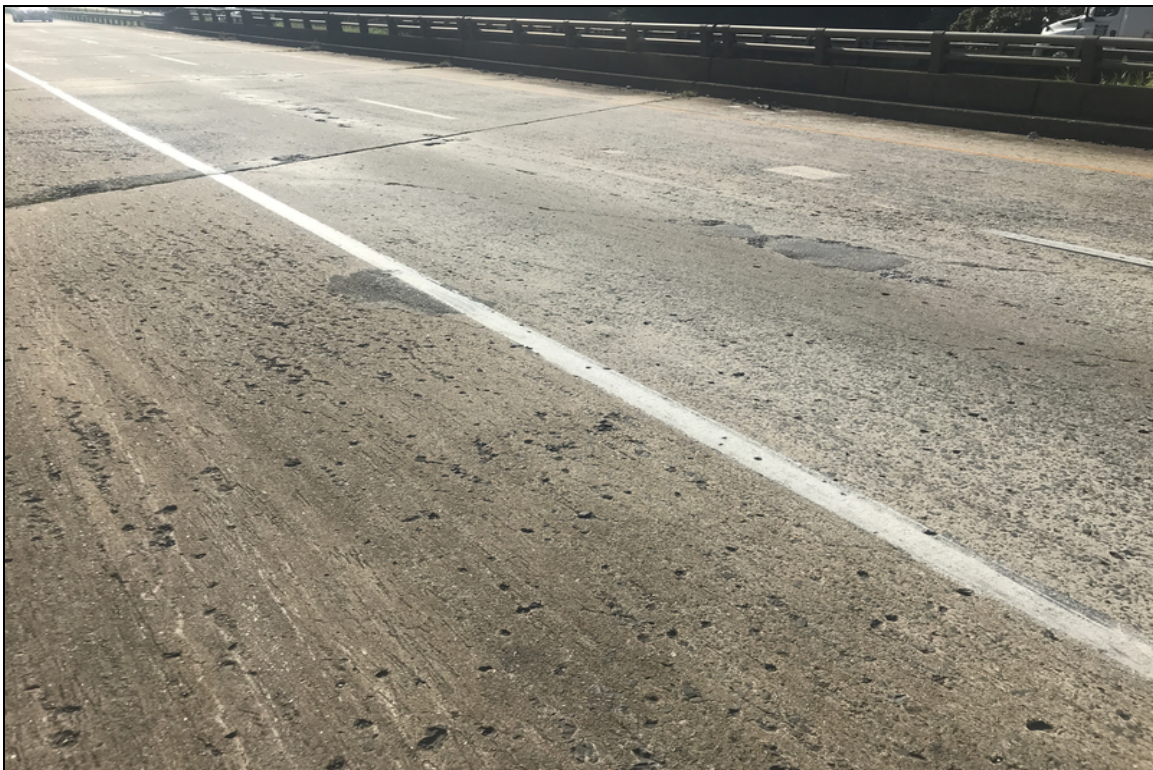
Deck overview

(38)							
All spans have patches filled with asphalt. Span 1 has on open spall in the outside lane, Span 3 has a large spall that was patched with asphalt but is deteriorating and is exposing steel. Span 2 has multiple spalls and spalls filled with asphalt that is deteriorating. Span 5 at bent 5 has a spall with exposed rebar in travel lane. All spans have large cracks, sealed and unsealed on the deck surface and all spans have longitudinal cracks with rust stains and efflorescence build up on the soffit. Scattered delams are present on the bottom of spans 2,3,4&5.							
215	Reinforced Concrete Abutment	LF	115	109	4	2	0
1090	Exposed Rebar	LF	2	0	0	2	0
1130	Cracking (RC and Other)	LF	4	0	4	0	0
