## Bridge 13213 Inspection Report

**Sentinel Rd over Creek**

**Location: .11 MI E SH 227**

**Team Lead: Keith Harris Inspection Date: 03/03/2026**

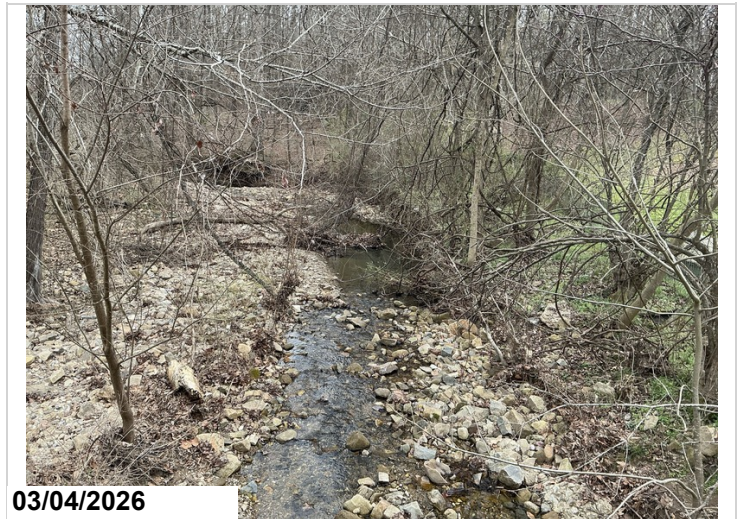
Downstream channel

The channel is in satisfactory condition. Sediment and vegetation slightly restrict channel. Bank is slumping on upstream and downstream.
