Bridge 19840 Inspection Report

SH 600 -21 Log 0.5 over Mill Creek 3 Sisters

Location: 1 MI E JCT SH 227

Team Lead: Chris Doggett Inspection Date: 11/20/2025

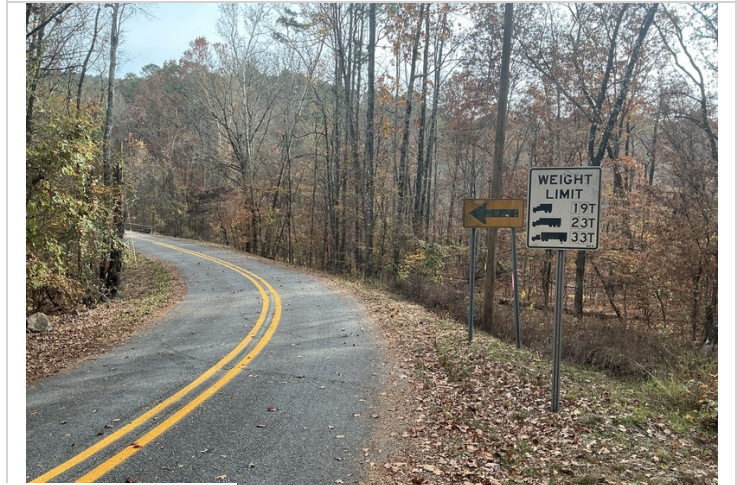
Load posting looking south

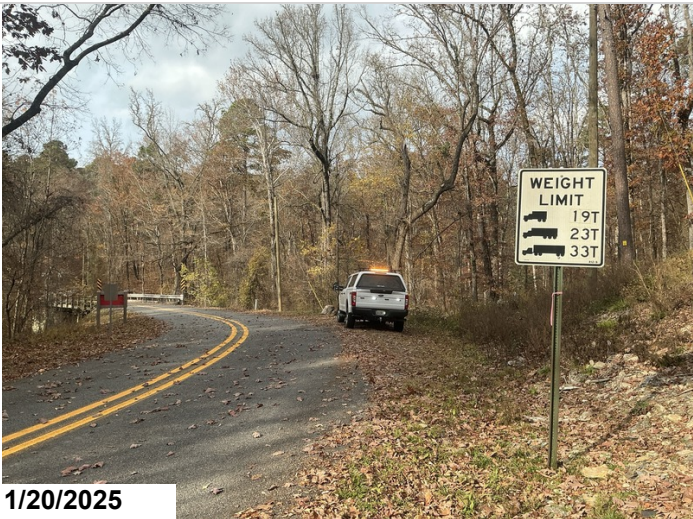
Load posting sign looking north

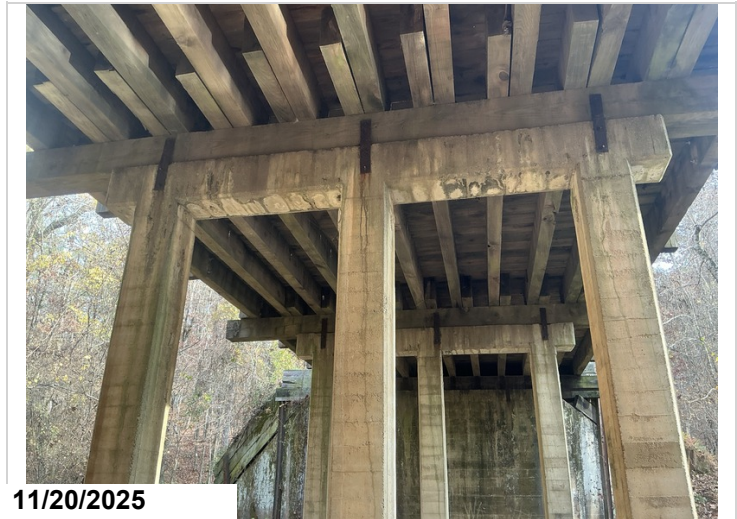
Under surface view

Overall the timber superstructure is in good condition with minor cracks/checks in scattered locations.

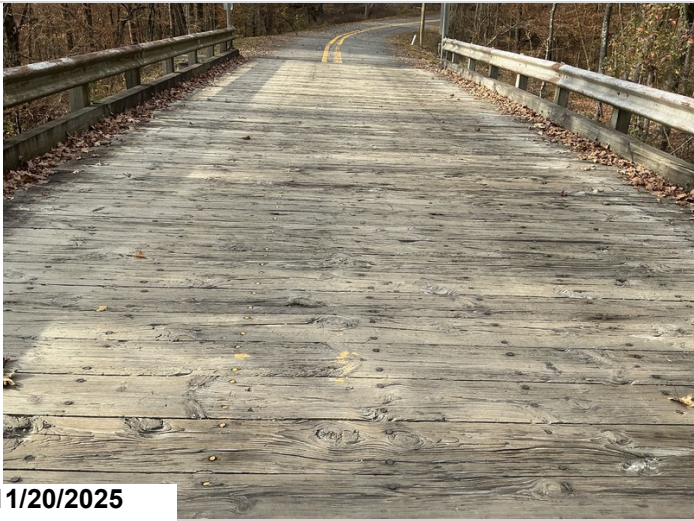
Deck view

Overall, the deck is in good condition with minor cracking and minor to moderate weathering and traffic abrasion.
