Asset #A3432(Routine)

I-30 WB Log 104.52 over NINE MILE CR

Location: 6.1 MI NO JCT I-30 & 270

Team Lead: Shane Byrd, Inspection Date: 08/25/2021

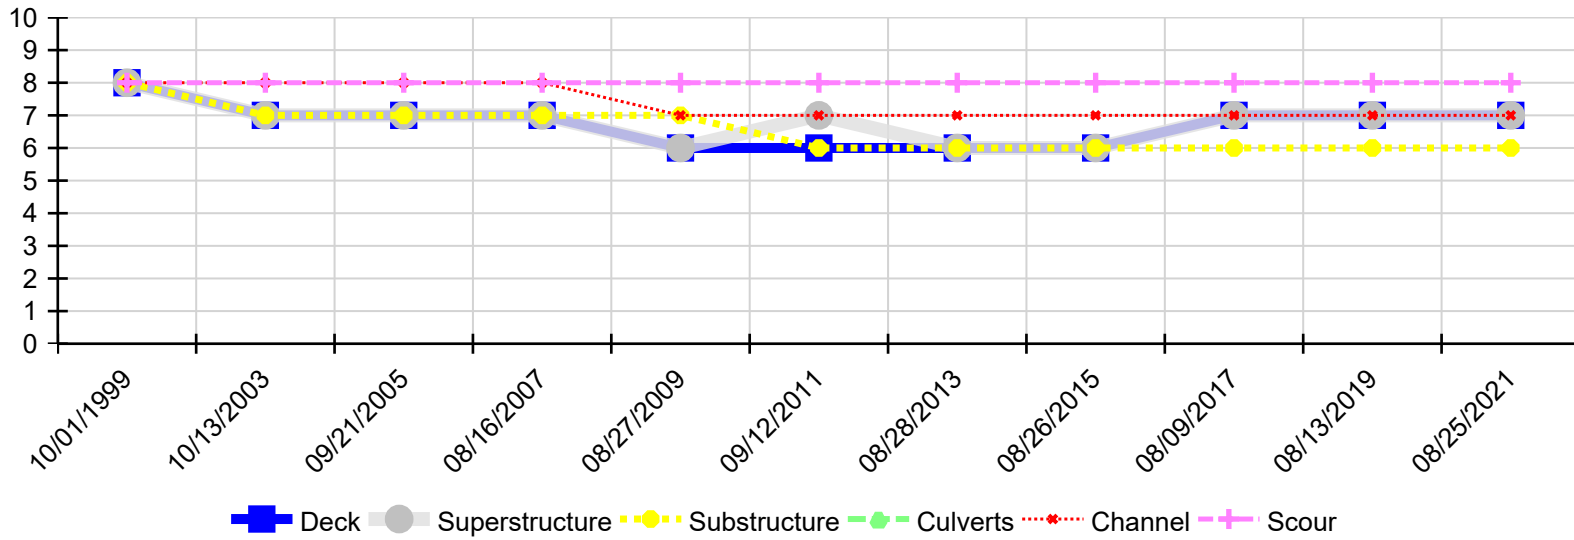
Condition History

Inspection Date	Deck	Superstructure	Substructure	Culverts	Channel	Scour
08/25/2021	7	7	6	N	7	8
08/13/2019	7	7	6	N	7	8
08/09/2017	7	7	6	N	7	8
08/26/2015	6	6	6	N	7	8
08/28/2013	6	6	6	N	7	8
09/12/2011	6	7	6	N	7	8
08/27/2009	6	6	7	N	7	8
08/16/2007	7	7	7	N	8	8
09/21/2005	7	7	7	N	8	8
10/13/2003	7	7	7	N	8	8
10/01/1999	8	8	8	N	8	8
