Asset #B3424(Routine)

I-30 EB Log 97.06 over Ouachita Rvr; Riverview

Location: 1 MI S OF JCT 270

Team Lead: Shane Byrd, Inspection Date: 06/20/2022

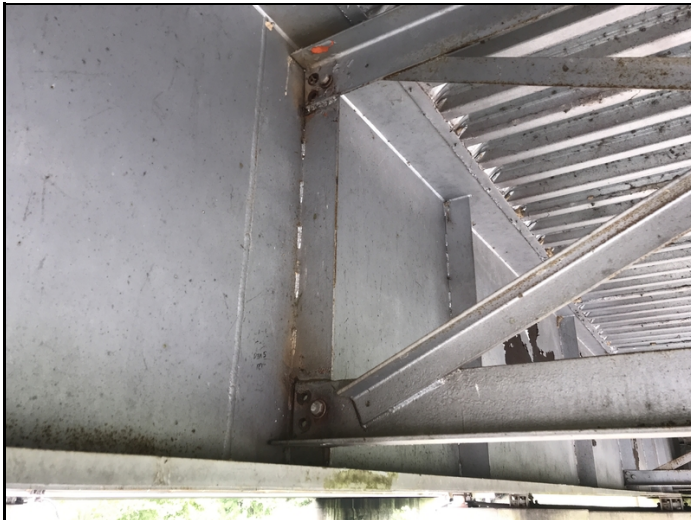
Span 6 g3 d5 diaphragm bolt holes have become misaligned and diaphragm has been welded in place

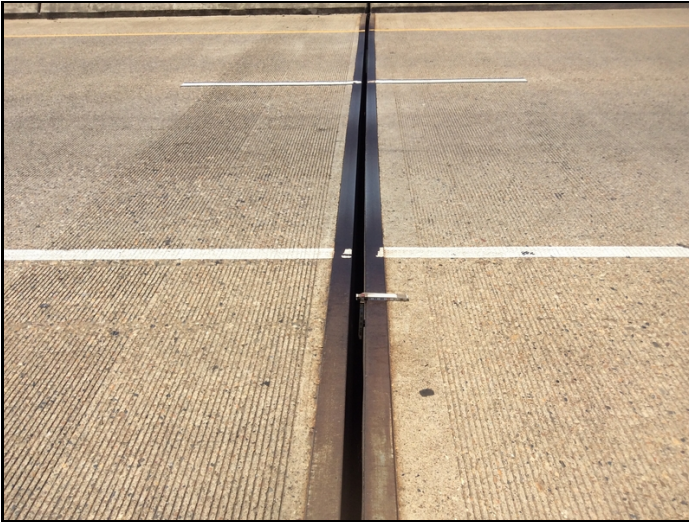
(302) Pier 1, 8' has fallen through, 6' leaking. Joint seal at pier 2 has fallen. Pier 6, 4' has fallen through.

Pier 2, joint seal has fallen through.

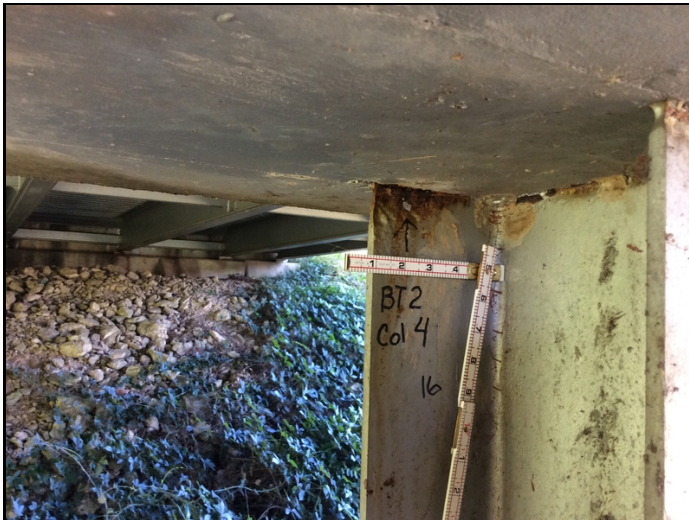
(225) Piling at bent 3 have corrosion at the bottom of the cap. Bent 3 pile 5 has section loss at the top of the pile.							
234	Reinforced Concrete Pier Cap	LF	324	312	6	6	0
1010	Cracking	LF	3	0	3	0	0
1080	Delamination/Spall/Patched Area	LF	3	0	3	0	0
1090	Exposed Rebar	LF	6	0	0	6	0

Measurable section loss to the flanges below the cap. Also small hole in the flange at this location. Worst case at this bent.

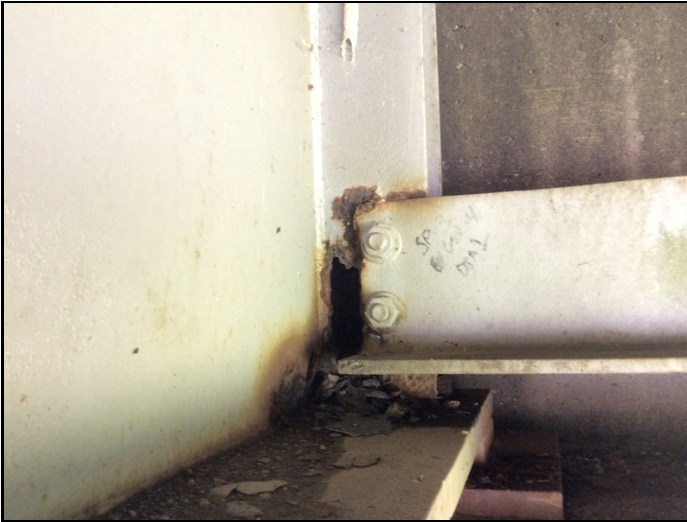
Hole in the diaphragm bracket at span 3 girder 4 diaphragm 1 at pier 1.

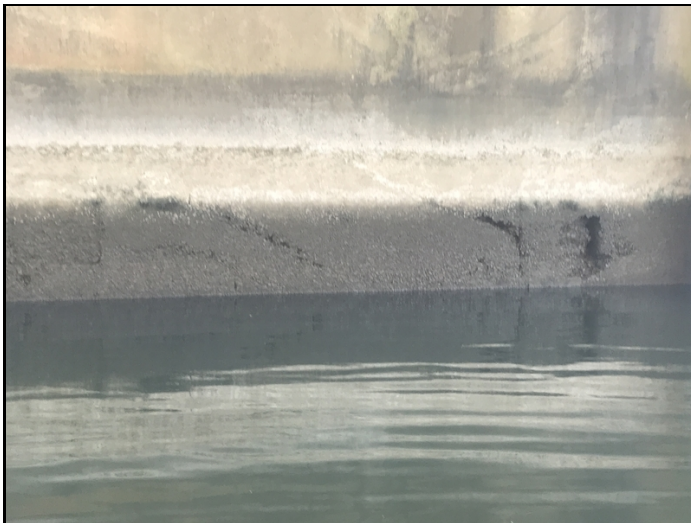
(210) Pier walls have spalls and areas of severe abrasion at water line, cracks and cracks with efflorescence and spalls exposed reinforcing steel. Piers 4 & 5 have squared hole beneath the water line. May have been for utilities in the past.							
215	Reinforced Concrete Abutment	LF	81	65	16	0	0
1120	Efflorescence/Rust Staining	LF	16	0	16	0	0

Piers 2 thru 5 have areas of severe abrasion at water line.

Bent 5 pier wall has areas of severe abrasion at water line.
