**Asset #B5027**(Routine, Underwater type 2)

**I-30 EB log 93.51 over CREEK**

**Location: 4.45 MI SW OF US 270**

**Team Lead: Chris Doggett, Inspection Date: 10/26/2022**

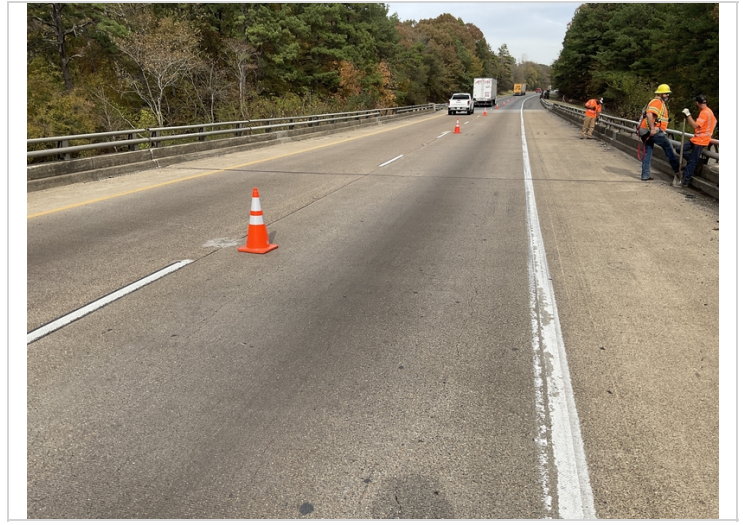
Deck view

(12) Deck has a 2" wearing surface. Wearing surface has moderate to large unsealed cracks in all spans.							
107	Steel Open Girder/Beam	LF	1435	1294	62	77	2
1000	Corrosion	LF	140	0	62	76	2
1010	Cracking	LF	1	0	0	1	0
515	Steel Protective Coating	SF	7937	4447	2100	1330	60
3420	Peeling/Bubbling/Cracking	LF	130	0	0	130	0
3440	Effectiveness (Steel Protective Coatings)	LF	3360	0	2100	1200	60

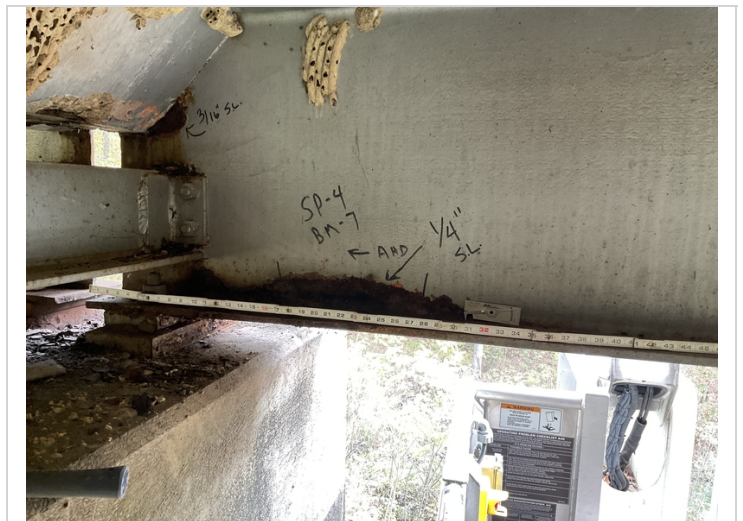
Section loss at the haunch and above diaphragm 2022

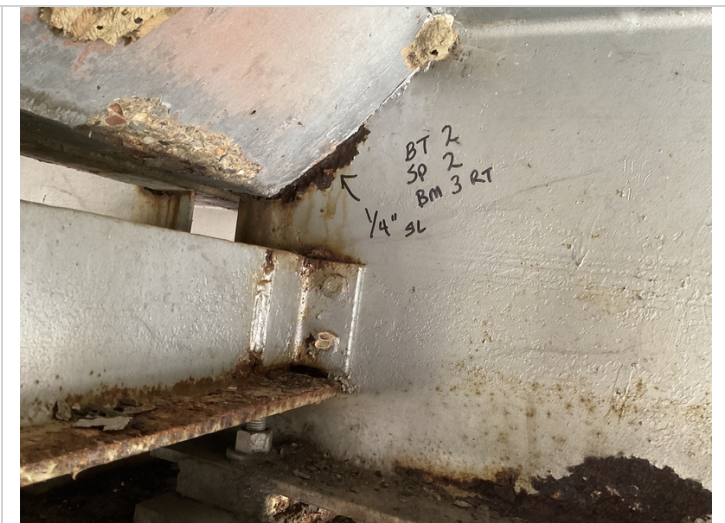
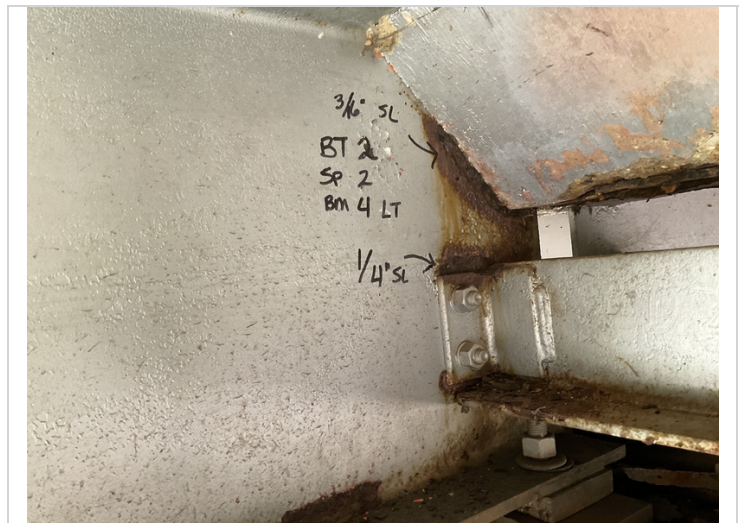
(234) Small horizontal cracks in the caps of bents 2 and 3. Bent 3 ahead face at the top between beams 5 & 6, small delam. Bent 4, back side, two exposed rebar and on the bottom of the cap on the right end. Bent 5 ahead side between piles 5 and 6 cap has a spall with exposed rebar.							
302	Compression Joint Seal	LF	254	0	189	65	0
2310	Leakage	LF	189	0	189	0	0
2330	Seal Damage	LF	65	0	0	65	0

Ahead side of bent 3 between beams 5 and 6: spall and delam approximately 6 feet in length

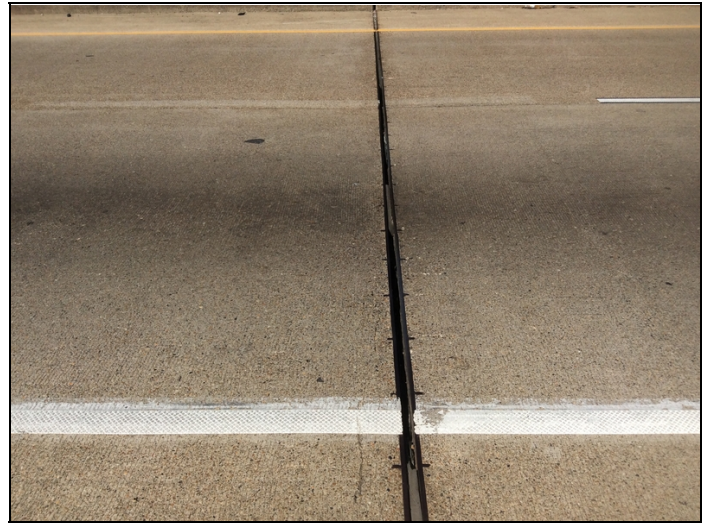
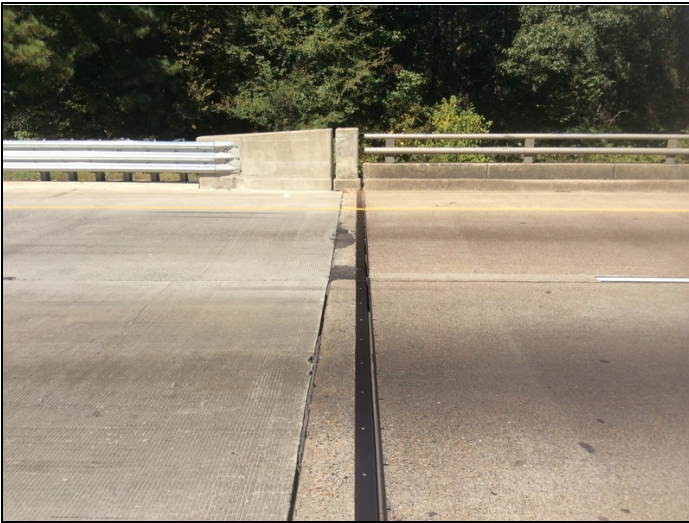
(302) All the seals leak. Sections of the seal are missing at all bents.							
311	Movable Bearing	EA	35	13	22	0	0
1000	Corrosion	EA	19	0	19	0	0
2210	Movement	EA	3	0	3	0	0

Bent 5 joint seal is damaged and leaking. Common all joints.

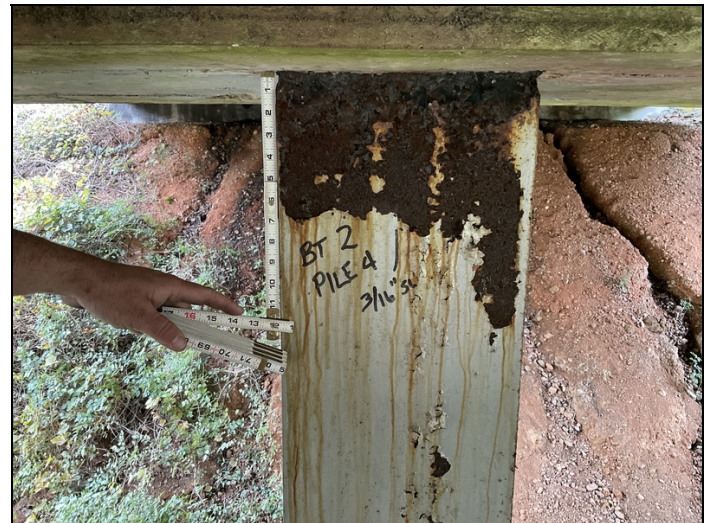
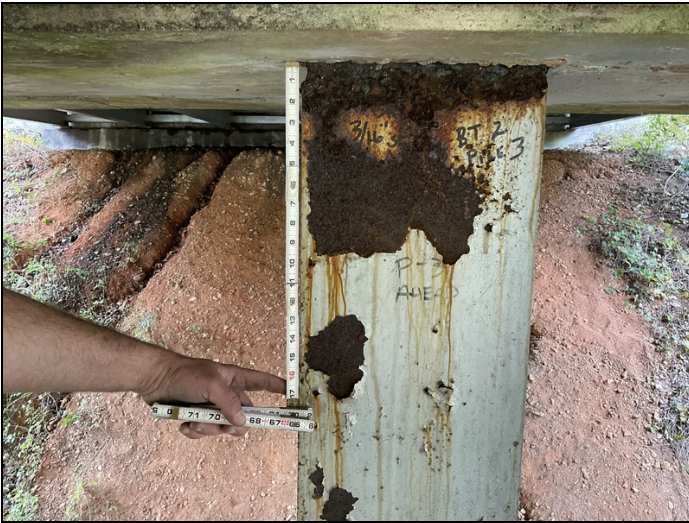
(225) Bent 5 ahead side bottom bracing on piles have broke welds at piles 2 thru 4. Bent 2 piles 5 and 6 have active corrosion and pitting to 1/8" deep at the top under the cap. Bent 5 piles 2-5 have section loss at top of piles.							
234	Reinforced Concrete Pier Cap	LF	161	140	21	0	0

Bent 5, pile 4: top of the pile has up to 3/16" section loss adjacent to the cap. Similar condition at piles 2,3&4.

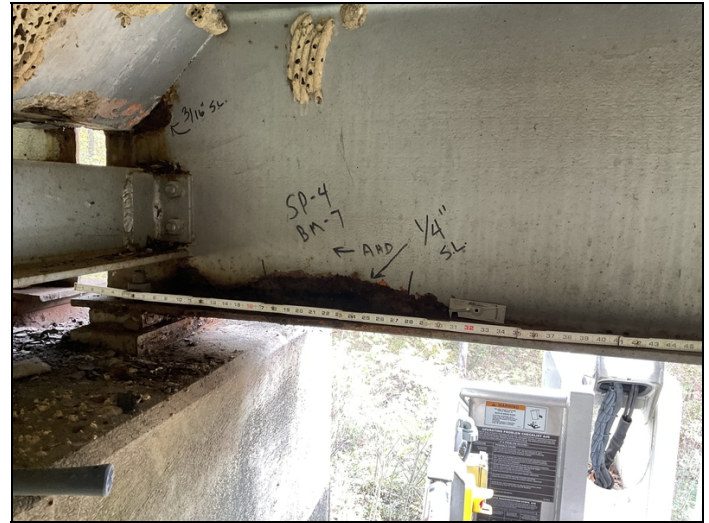
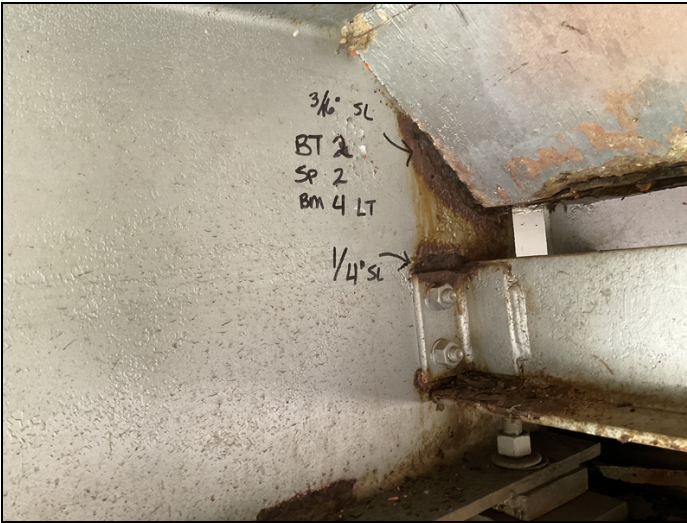
Section loss at the haunch and above diaphragm 2022

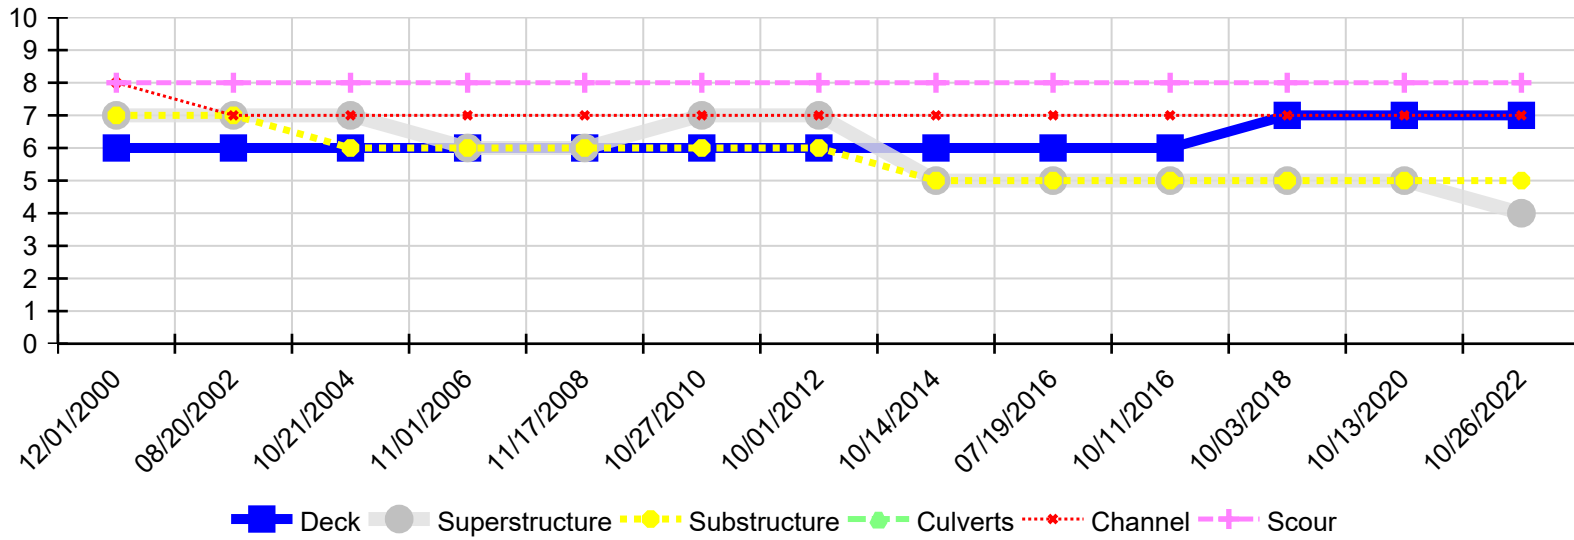
Condition History

Inspection Date	Deck	Superstructure	Substructure	Culverts	Channel	Scour
10/26/2022	7	4	5	N	7	8
10/13/2020	7	5	5	N	7	8
10/03/2018	7	5	5	N	7	8
10/11/2016	6	5	5	N	7	8
07/19/2016	6	5	5	N	7	8
10/14/2014	6	5	5	N	7	8
10/01/2012	6	7	6	N	7	8
10/27/2010	6	7	6	N	7	8
11/17/2008	6	6	6	N	7	8
11/01/2006	6	6	6	N	7	8
10/21/2004	6	7	6	N	7	8
08/20/2002	6	7	7	N	7	8
12/01/2000	6	7	7	N	8	8
