Asset #06658(Routine)

US 67 SB RAMP/40 over I-40 & US67 RAMPS

Location: .3 MI SO MCCAIN BLVD

Team Lead: Keith Harris, Inspection Date: 12/27/2021

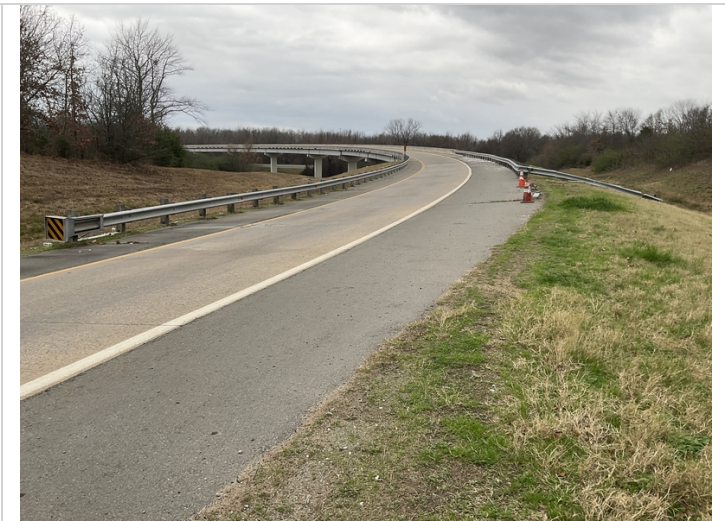
Approach

(321) Small cracks in both approach slabs.							
331	Reinforced Concrete Bridge Railing	LF	3094	1054	2040	0	0
1130	Cracking (RC and Other)	LF	2040	0	2040	0	0
