Bridge Inspection Report

05364
SH 229 S-O LM 1.25
over
COOKS CREEK

Structure Number: 05364

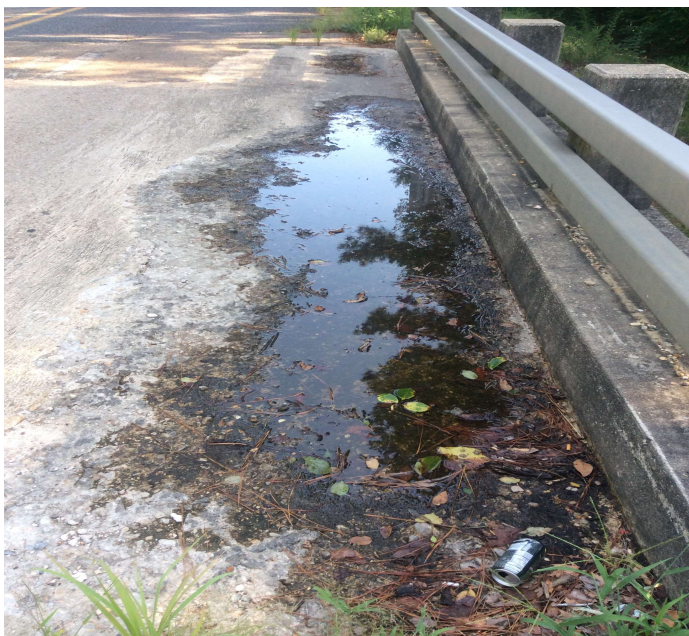
Large deck spalls along right gutter line span 1 and span 3. These are up to 2 feet wide and are full length of the spans.

PHOTO 3 Description Spall span 3 right side
