Bridge Inspection Report

03794

SH 7-S-3 LM 15.06

US 79-SEC 4 LOG MI 0.60

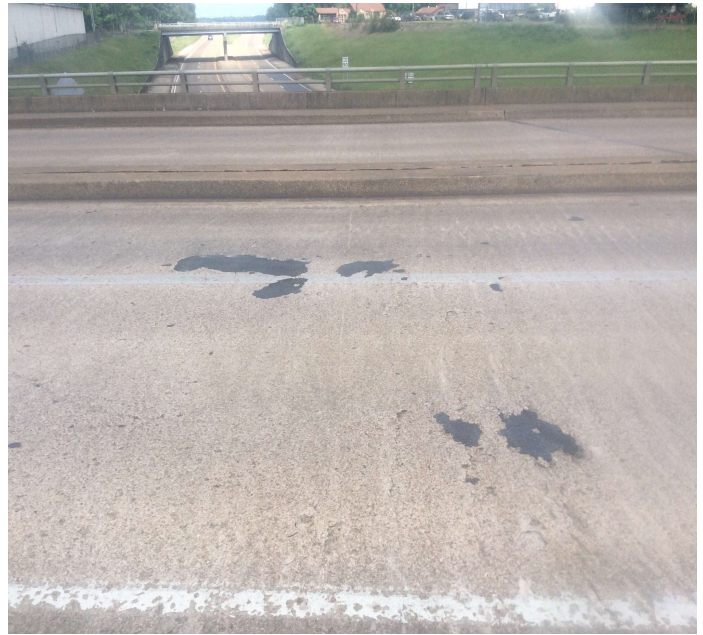
Sealable deck cracks all spans, bent 2 right has several small potholes, no exposed steel. Both approach spans have cracks.

PHOTO 1 Description 03794 deck cracks span 1 rt.
