Bridge Inspection Report

02157

US 71 Benton 1

LITTLE SUGAR CREEK

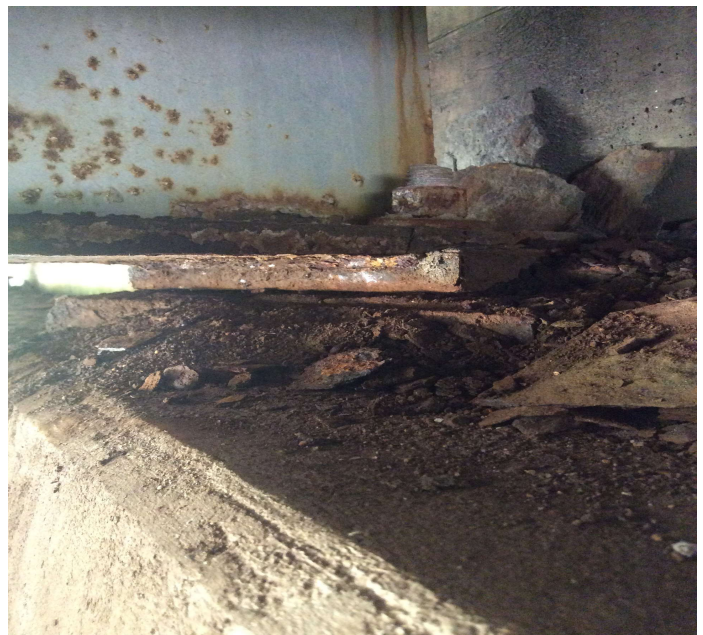
Abutment #1 and #2 caps have debris heavily corroded bearings.

PHOTO 1 Description Typical view of bearings at Abutment 2 SB lanes
