Bridge #M2052(Routine, Fracture Critical)
SH 148-SEC 02-4.08 over National or Ditch #6

Location: 1.1 MI W JCT I 55

Team Lead: Richard Jones **Inspection Date:** November 10, 2021

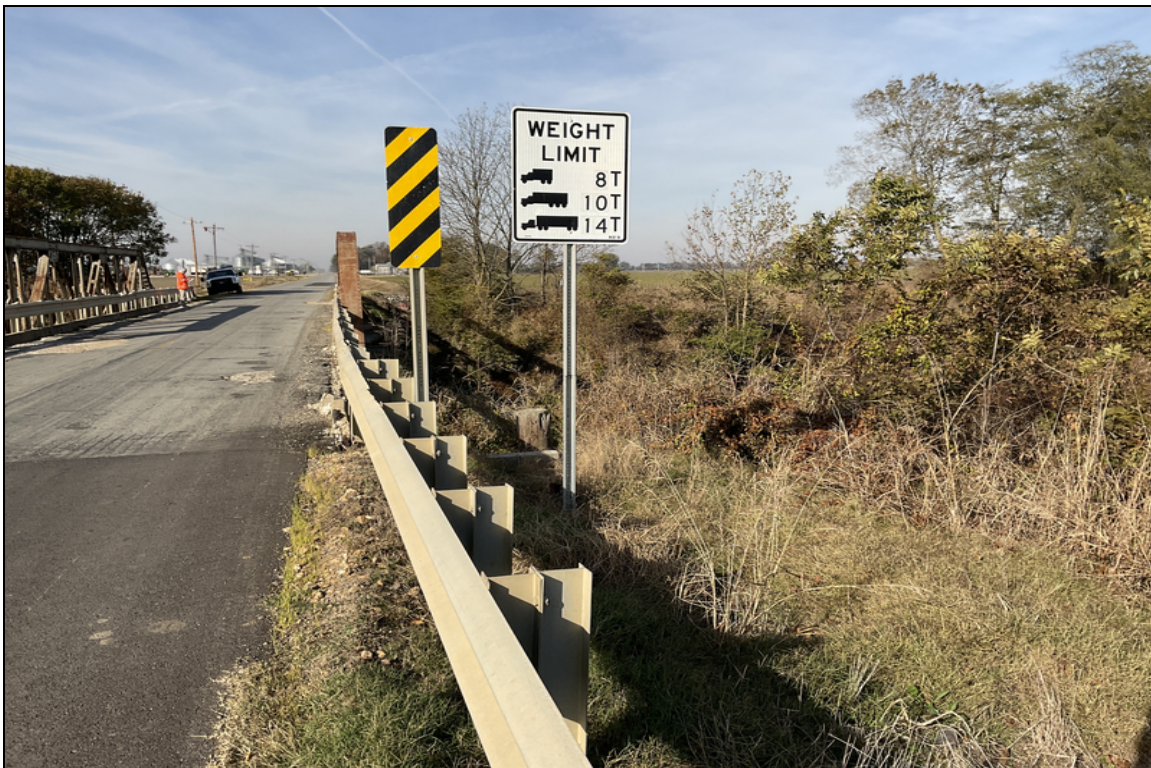
Load posting at beginning

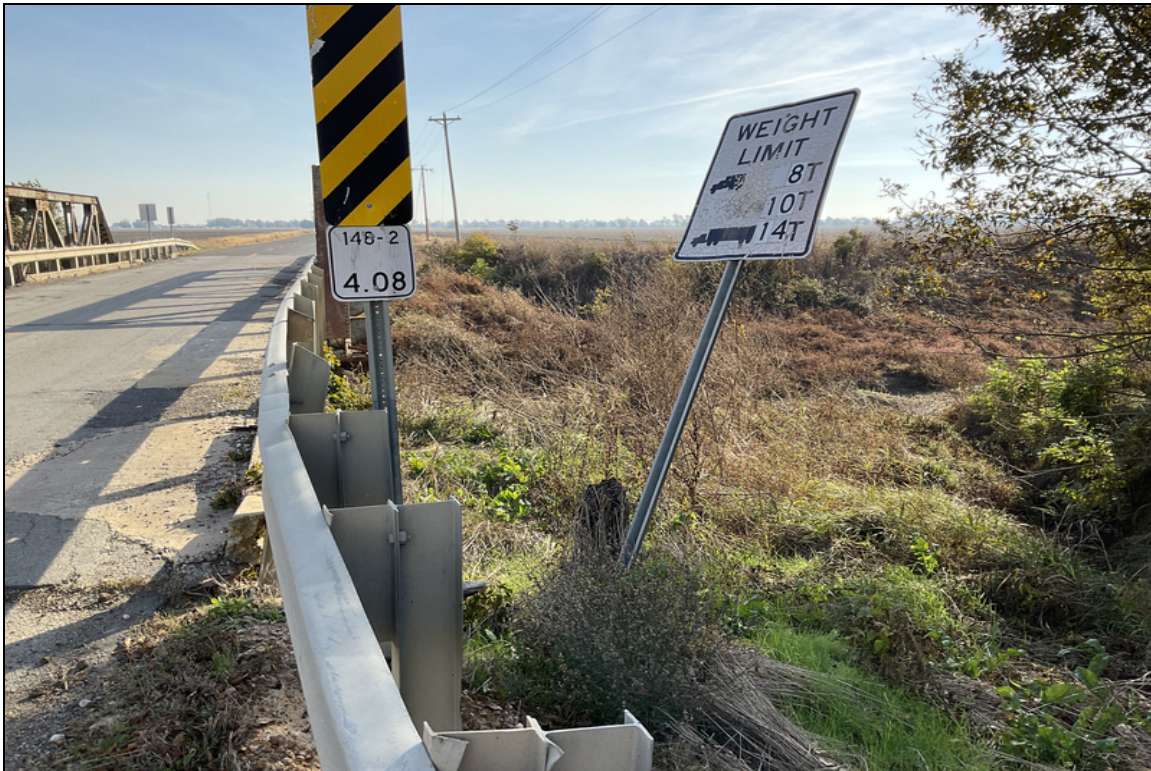
Load posting at end

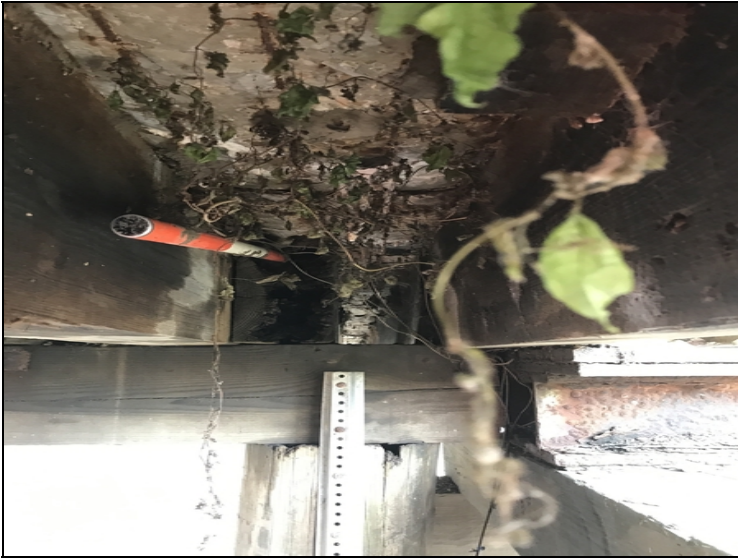
Span 3 bent 3 timber stringers 3, 13, and 14 have 2' on end that is decayed with up to 50% loss of section.
Span 3 bent 4 stringer 8 is decayed and hollow on end.

Span 3 stringer over bent 3

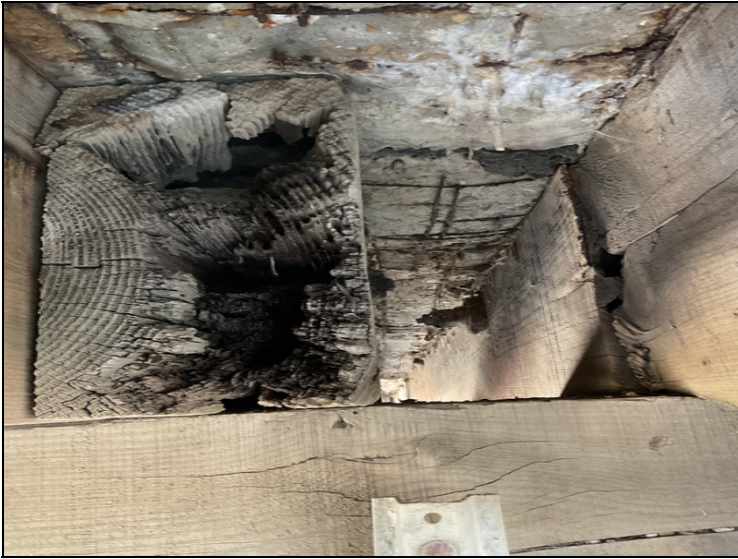
Span 3 bent 3 stringers 13 and 14

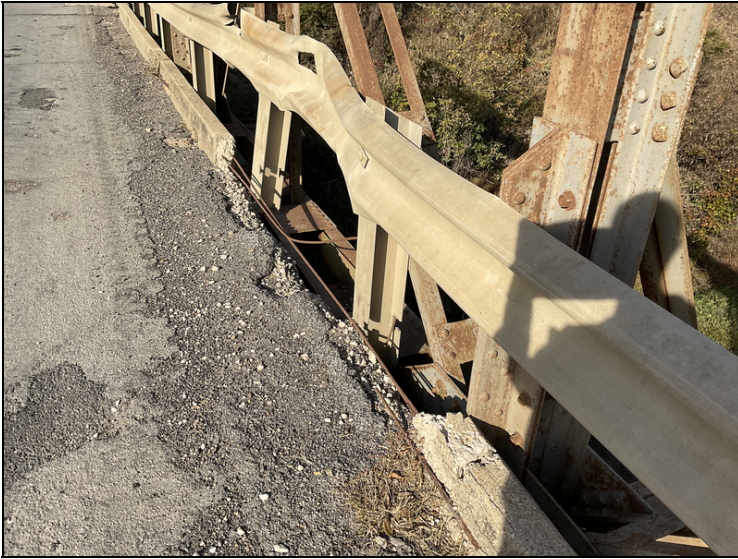
Span 3 Rt

Lt and Rt edges of deck have advanced concrete disintegration. Rt curb is missing for most of spans 1, 2, 4, and 5. Lt and Rt gutters/edge of travel lanes have several full depth patches. Most patches are in fair to poor condition.

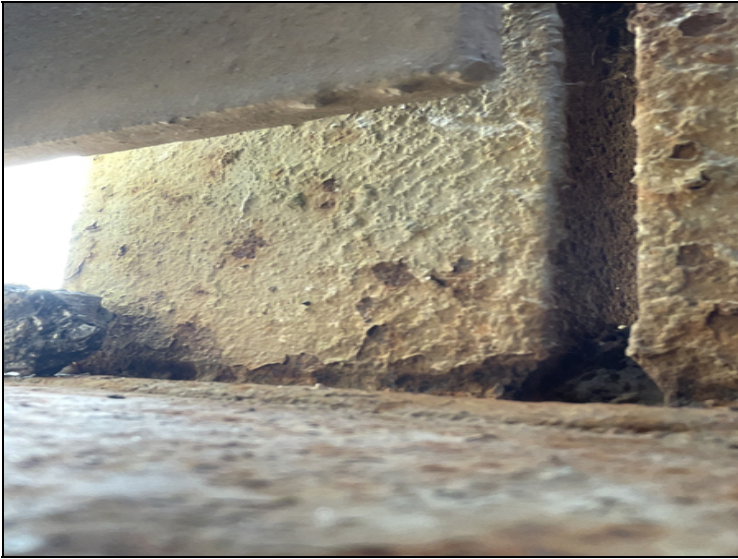
Bottoms of truss verticals have pack rust buildup between angles with up to 1" of distortion to angles.
Truss verticals have a line of section loss along connection to lower chord.

L1 Lt section loss to 1 angle of vertical

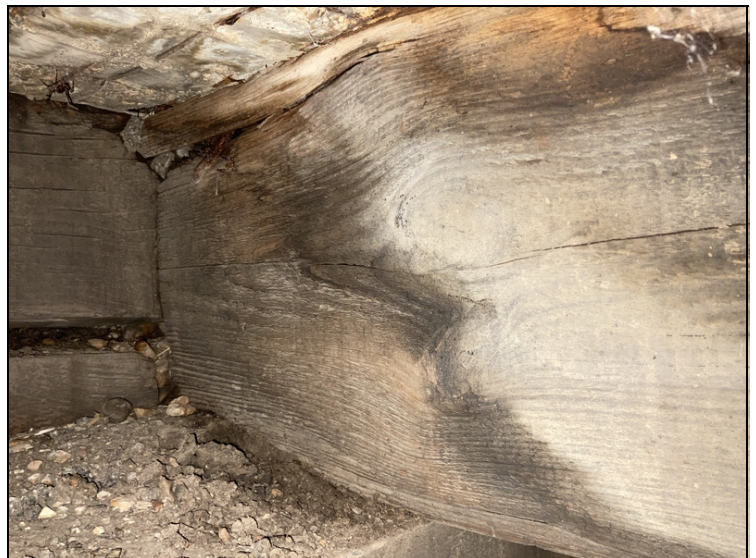
Bent 1 girder 11

Span 1 bent 1 girder 11 has core decay on end. Bottom of girder has section loss over cap.

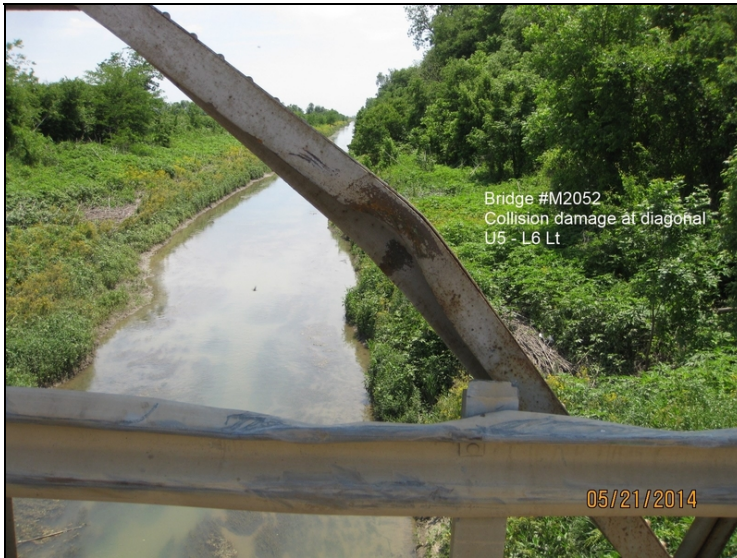
M2052 U5 - L6 diagonal Lt 05212014

Majority of truss verticals and diagonals have collision damage.

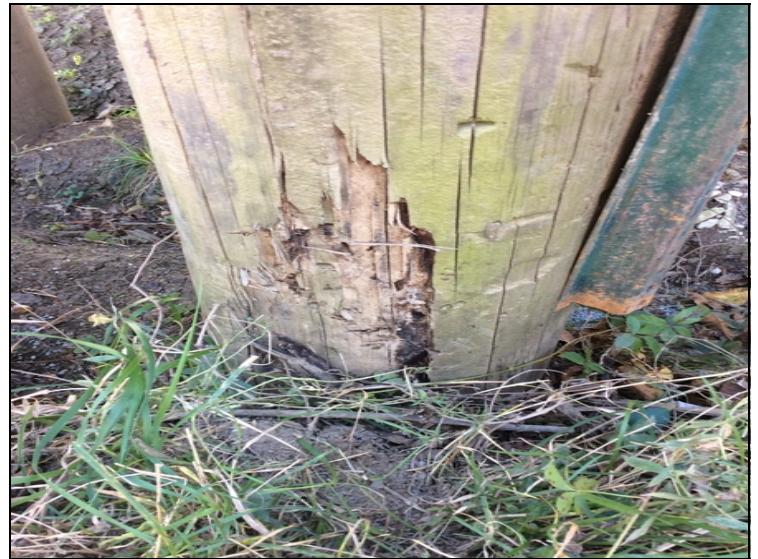
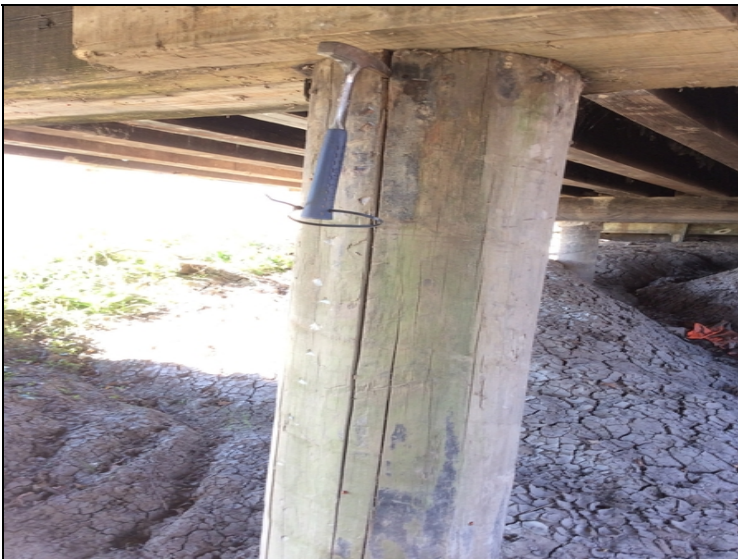
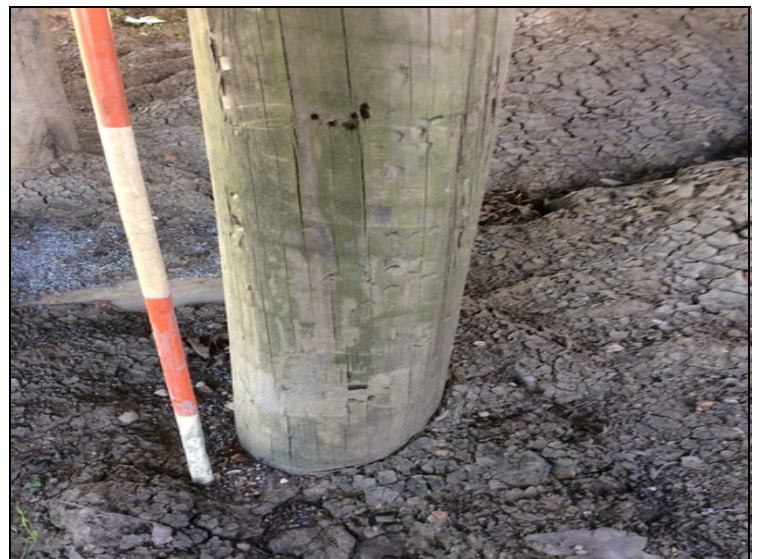
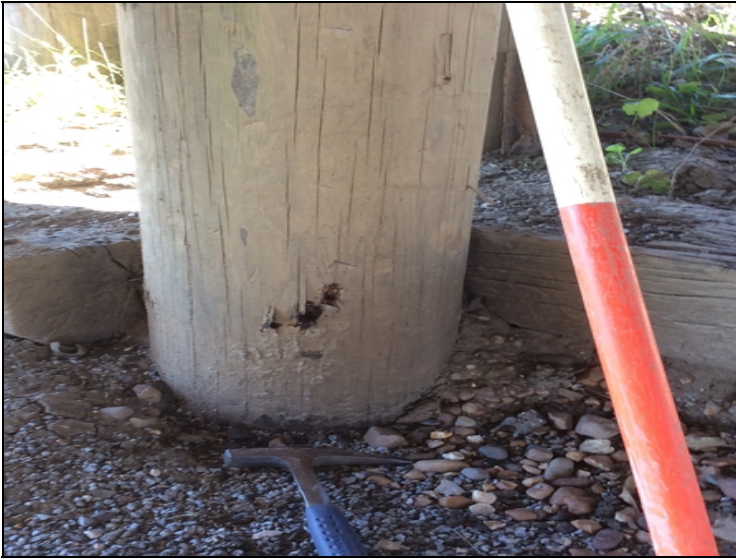
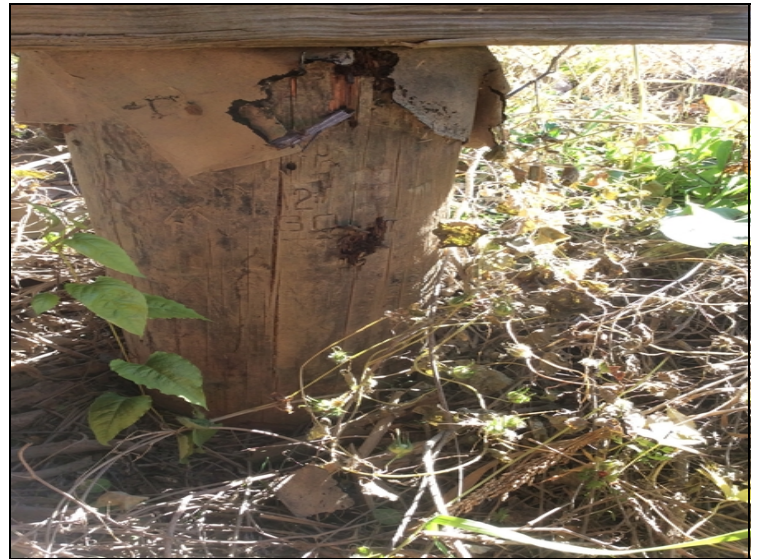
Bent 3 pile 7 top 3' is decayed and hollow.
Bent 5 pile 1 is decayed & hollow.
Bent 5 pile 5 is decayed and partially hollow.
Bent 6 pile 3 is decayed and partially hollow.

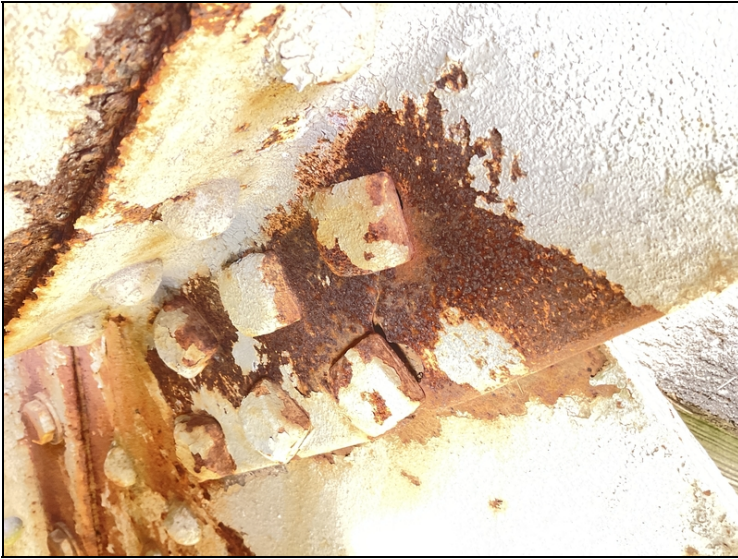
2021 - Interior angle of U5 - L6 diagonal Lt bottom

Lt truss - U5 – L6 diagonal has collision damage and is bowed and twisted up to 11" out of alignment. Interior angle of diagonal has a crack at top and bottom connections. Angle is cracked in the vertical plane through 1 bolt hole at top and bottom connections. Cracks appear to have arrested at 2nd bolt hole.

to District bridge crew for repair. Several angles and plates make up this member; crack is one of the steel angles. KAW 11/27/18
