Asset #02460(Routine, Underwater type 2)

US 49-02- LM 11.86 over LOCUST CREEK

Location: 4.10 MI N JCT OF SH 135

Team Lead: Richard Jones Inspection Date: 05/13/2024

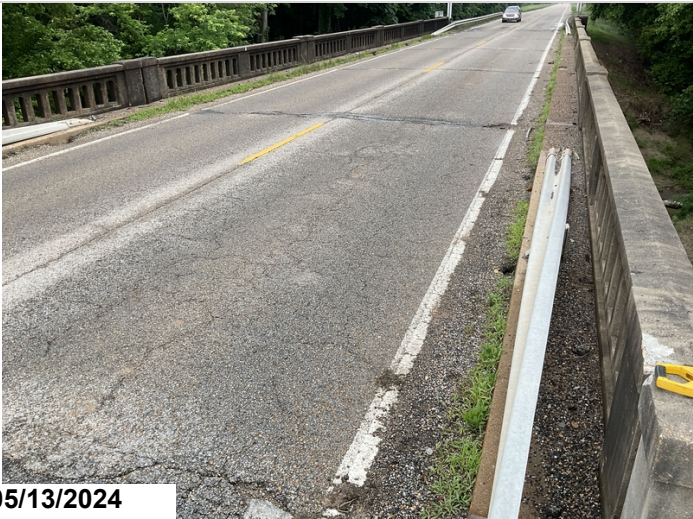
Wearing surface

Deck has areas of deterioration near joints.

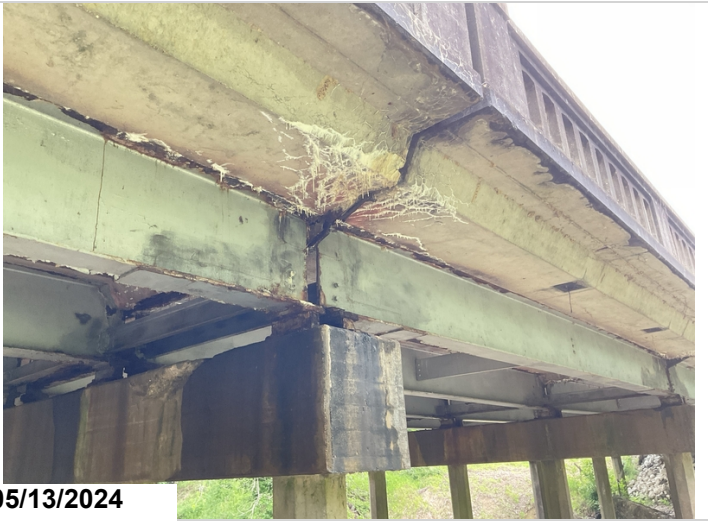
Overhang at several joints

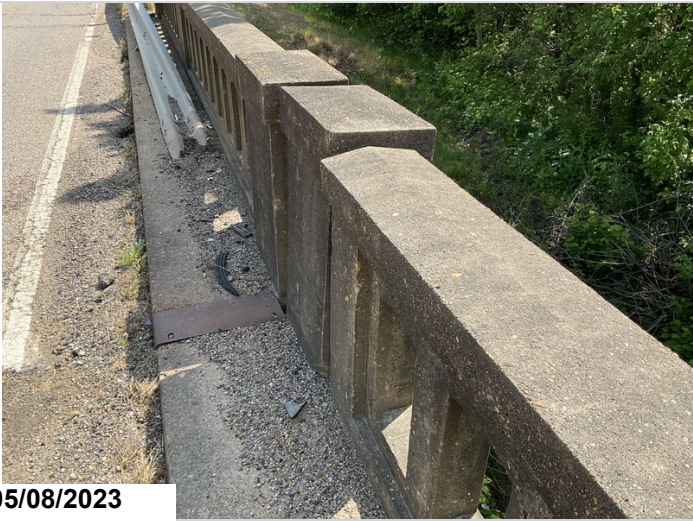
Bent 2 Lt

(331) Concrete rails have a few minor cracks, some with light efflorescence. Span 1 Rt overhang has a 2' spall near mid span. Lt bridge rail over bent 2 is leaning towards channel.

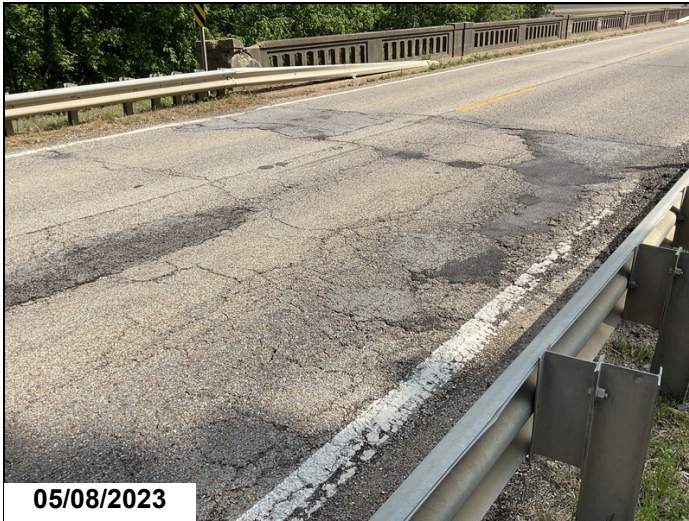
Bent 6 approach

ELEMENTS	DESCRIPTION	UNITS	TOTAL	CS1	CS2	CS3	CS4
	Bridge rail end posts at bent 6 have spalls from past collision damage. Rt wing has rebar exposed.

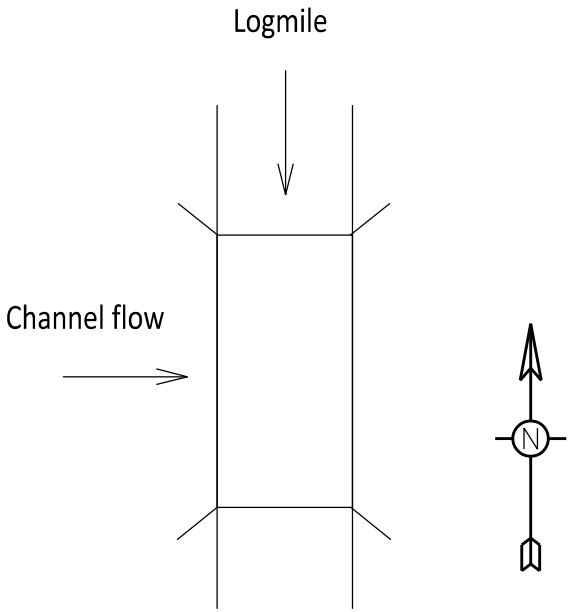
Channel scour has widened the original channel since construction in 1947 and caused loss of pile penetration at interior bents.

Bridge was constructed from South to North.  
Bridge is logged from North to South.

Channel sounded from top of deck on Lt side (down stream side)
