Bridge Inspection Report

02870
SH 77-02- LM 7.16
over
LITTLE RIVER

Structure Number: 02870

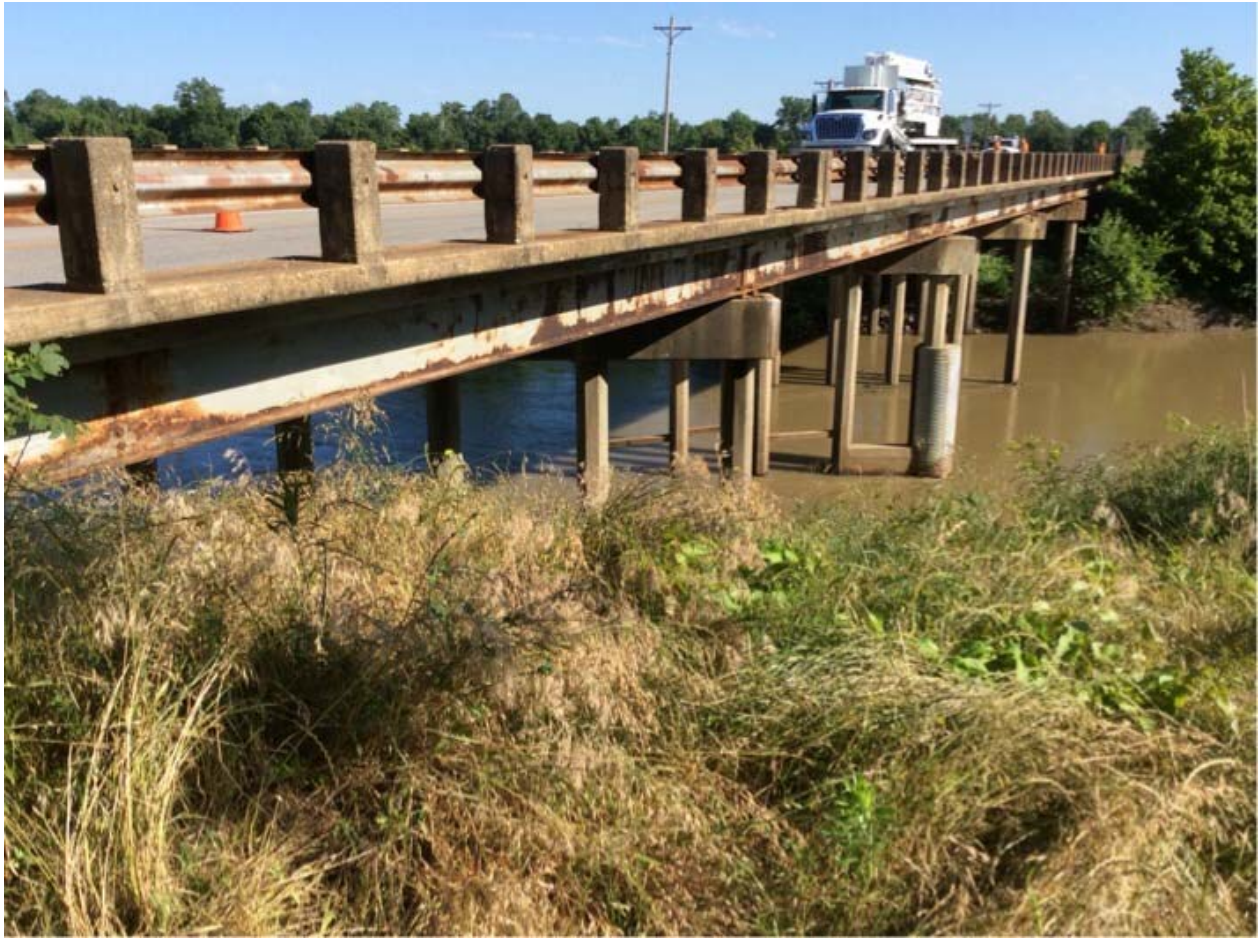
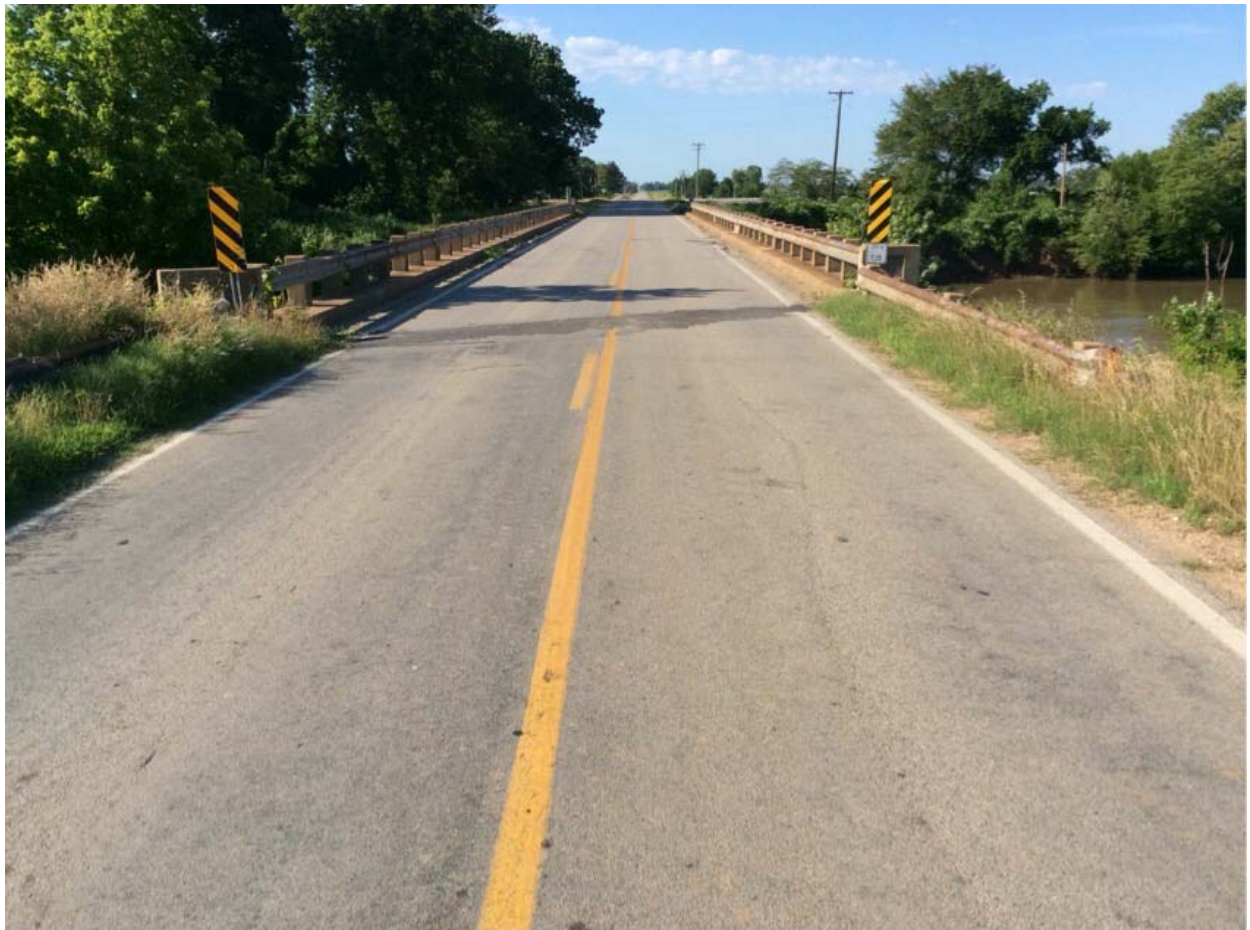
PHOTO 1 Description

Lt and Rt curbs are deteriorated with section loss.

Lt and Rt overhangs have moderate deterioration, cracking with efflorescence, and several spalls with rebar exposed.
