Bridge Inspection Report

02873

SH 77-02- LM 5.97

LITTLE RIVER

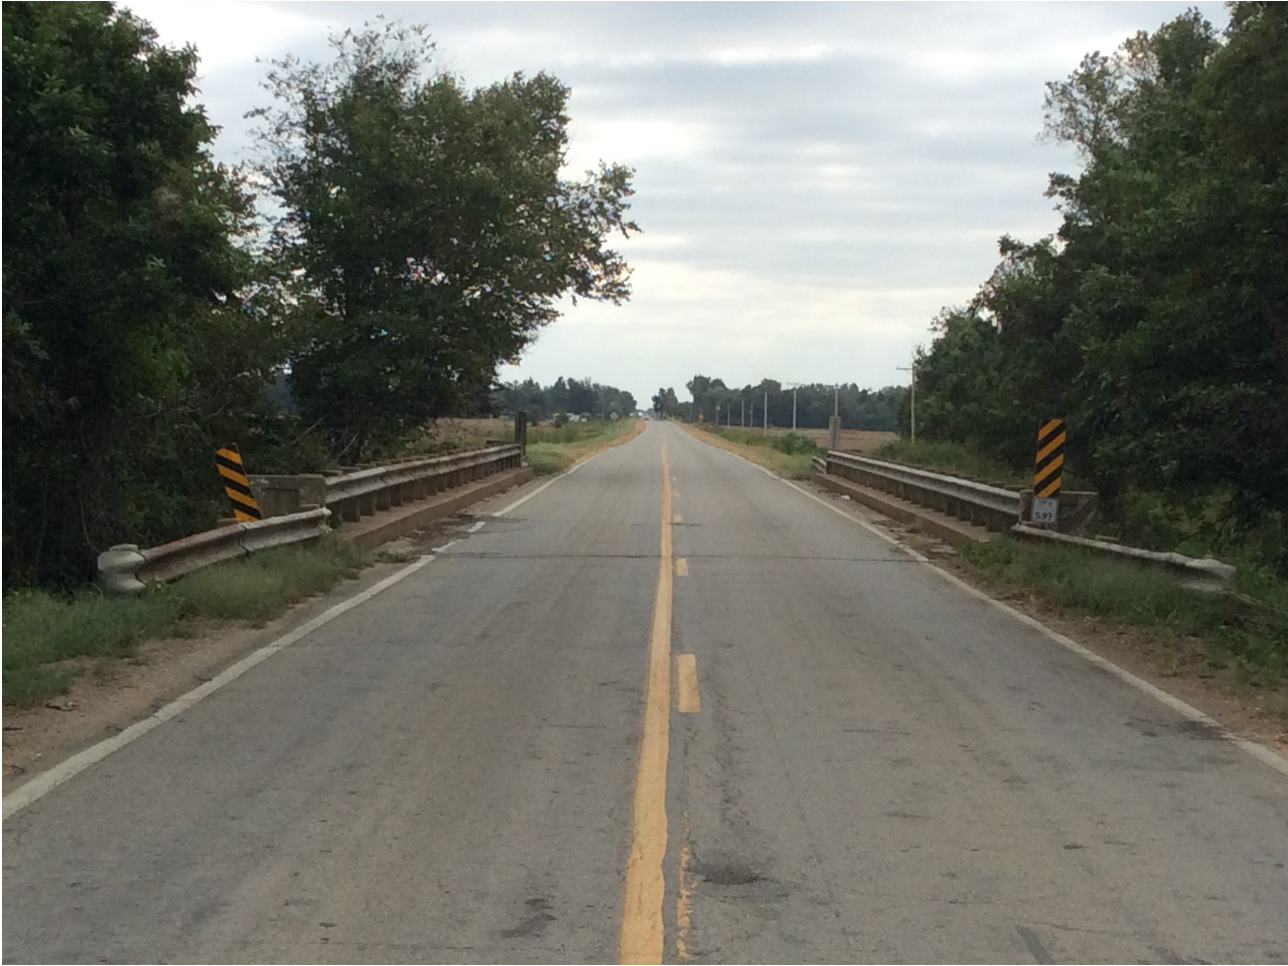
| | Bent 1 Abutment Cap has 3LF cracks. Heavy erosion due to Roadway Runoff Bents 1, up to 3ft. deep x 2.5ft. back under Abutments, see 2015 photo. Heavy erosion due to Roadway Runoff Bents 4, up to 2ft. deep x 2ft. back under Abutments, see 2015 photo. | | | | | | |

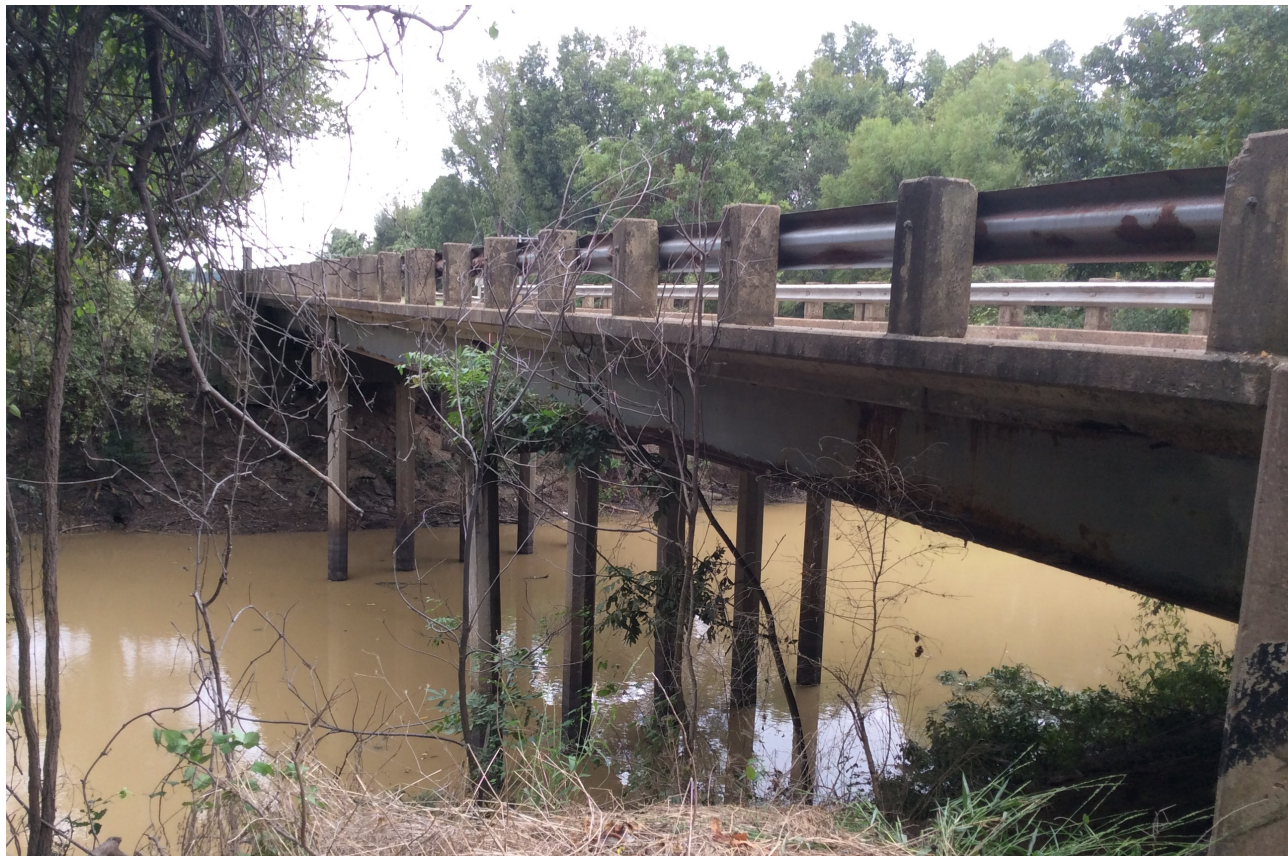
Span 3 Girder 3 Bearing Bent 4 has heavy rust with areas of 50% section loss, see 2015 photo.
