Bridge Inspection Report

02881
SH 77-02- LM 6.34
over
LITTLE RIVER

Facility Carried: SH 77-02- LM 6.34

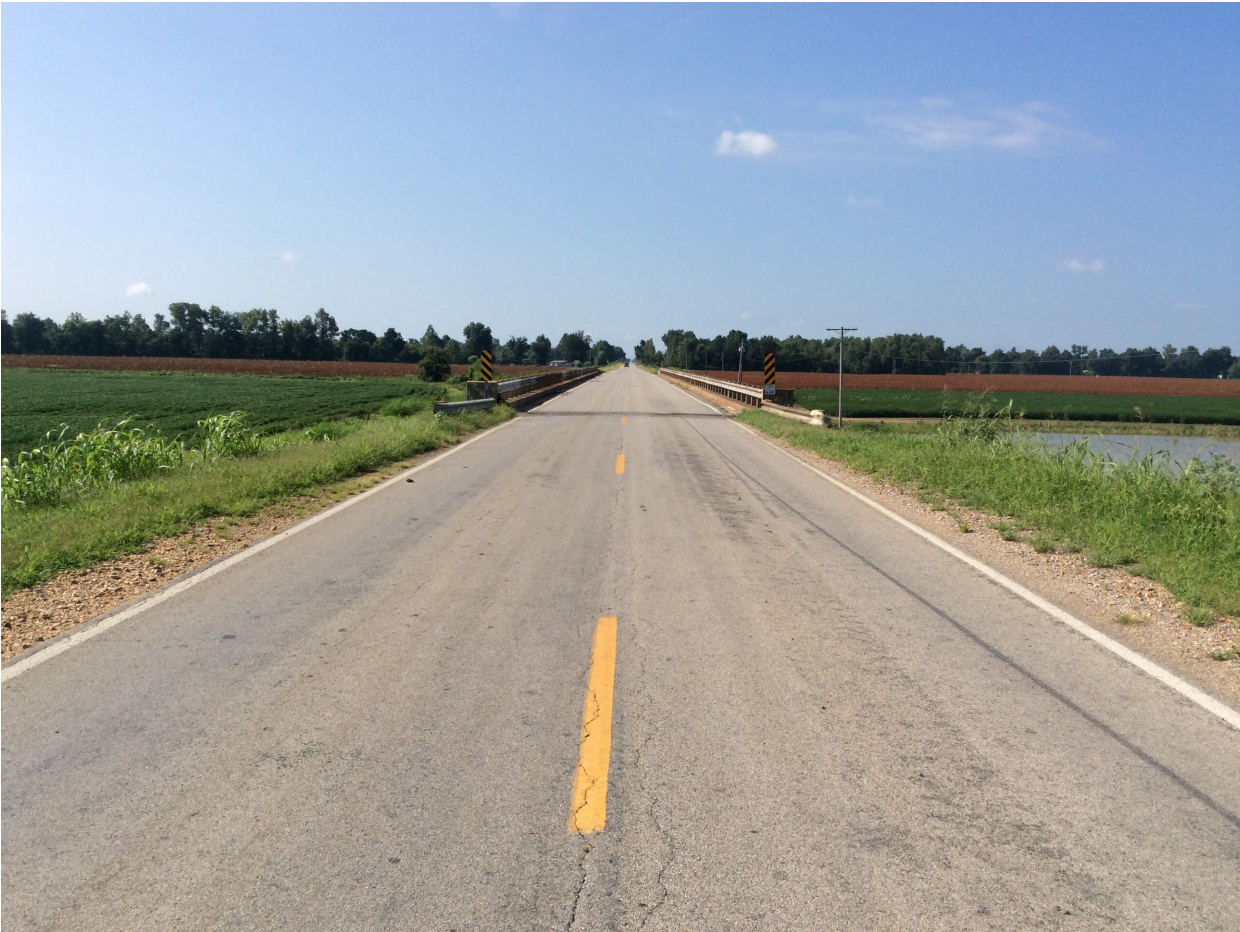
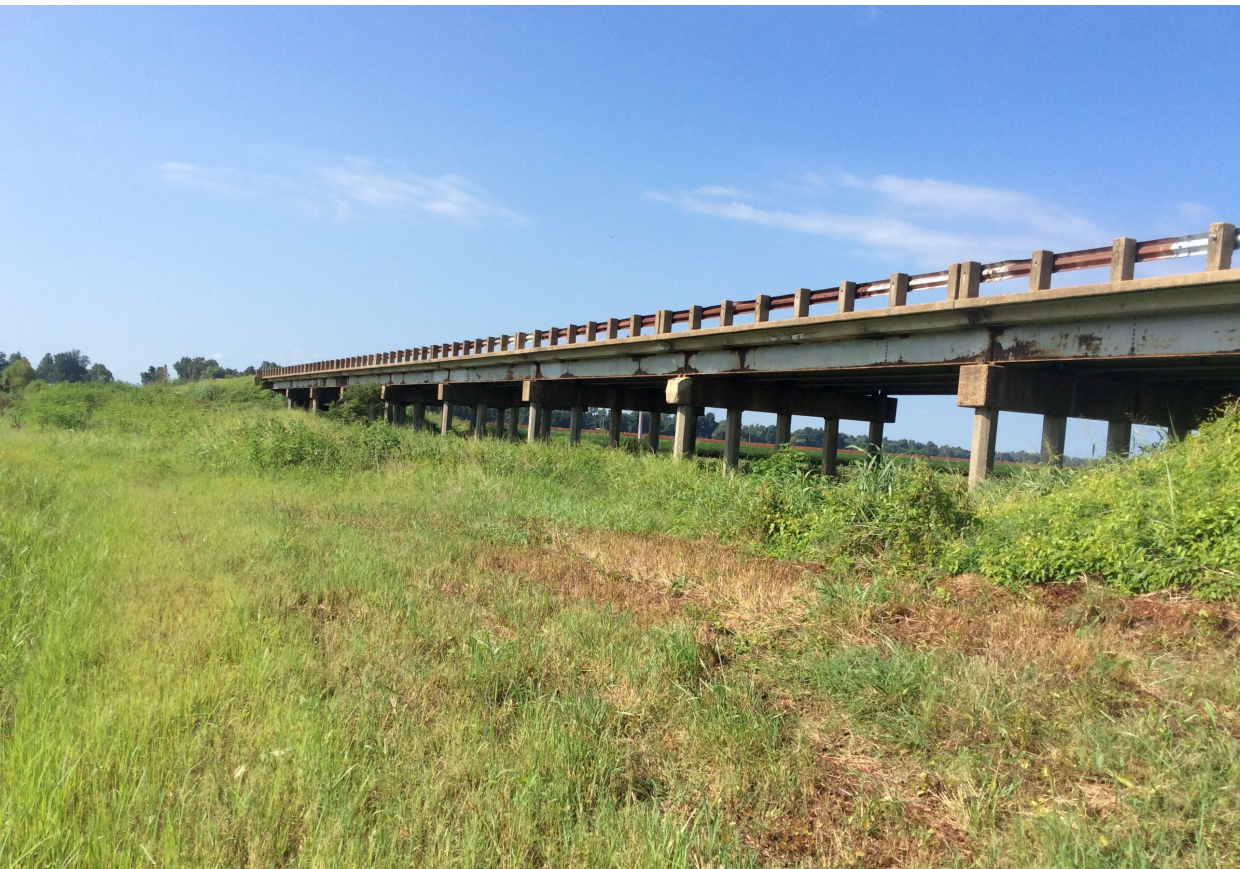
60% paint deterioration and rust with pitting.

3 ft. on ends of Majority of Girders have rust with 1/8 in. sect. loss on bottom flange and web at concrete haunch.
