# Bridge Inspection Report

**05266**

**US 412-09- LM 0.83**

**EIGHT MILE CREEK**

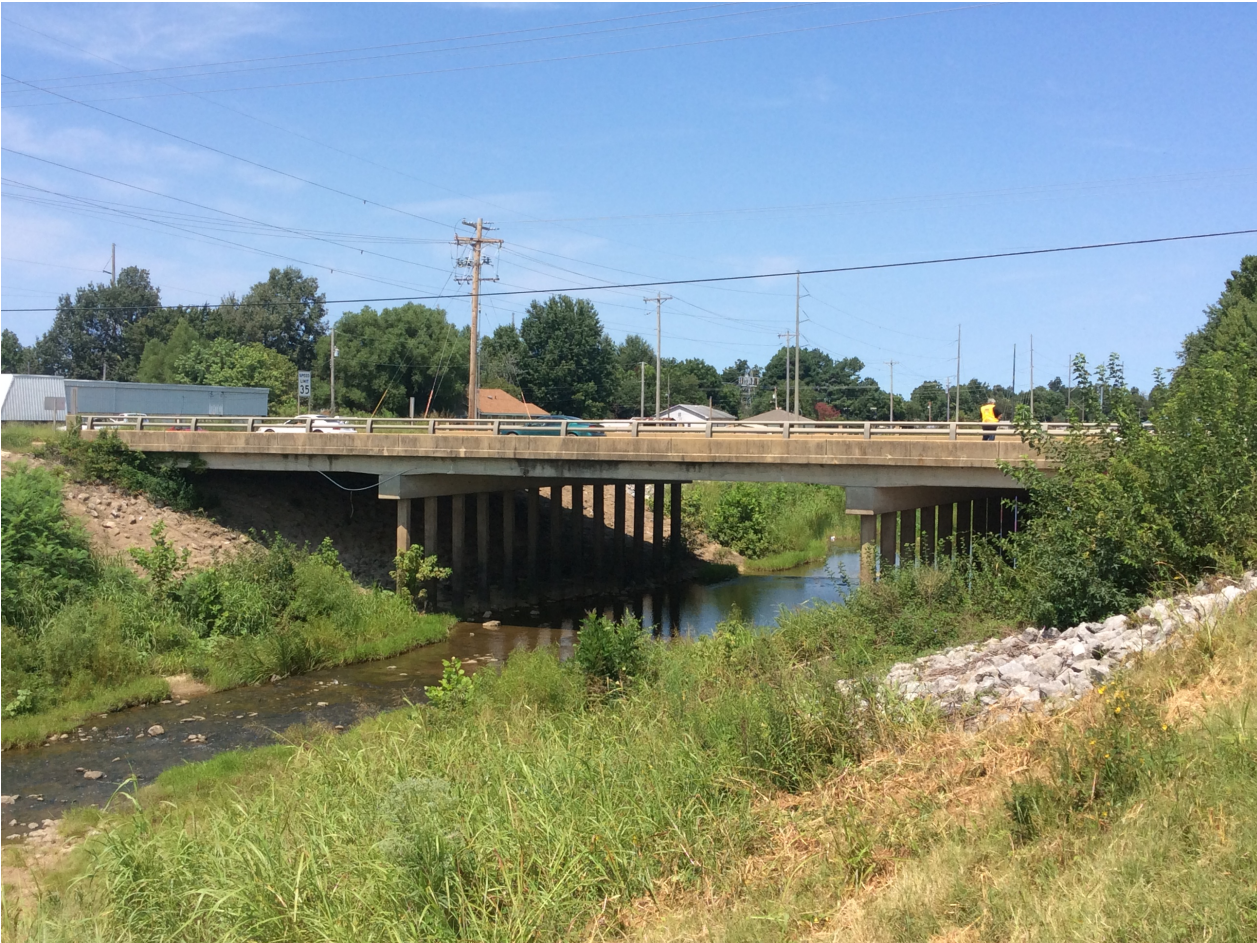
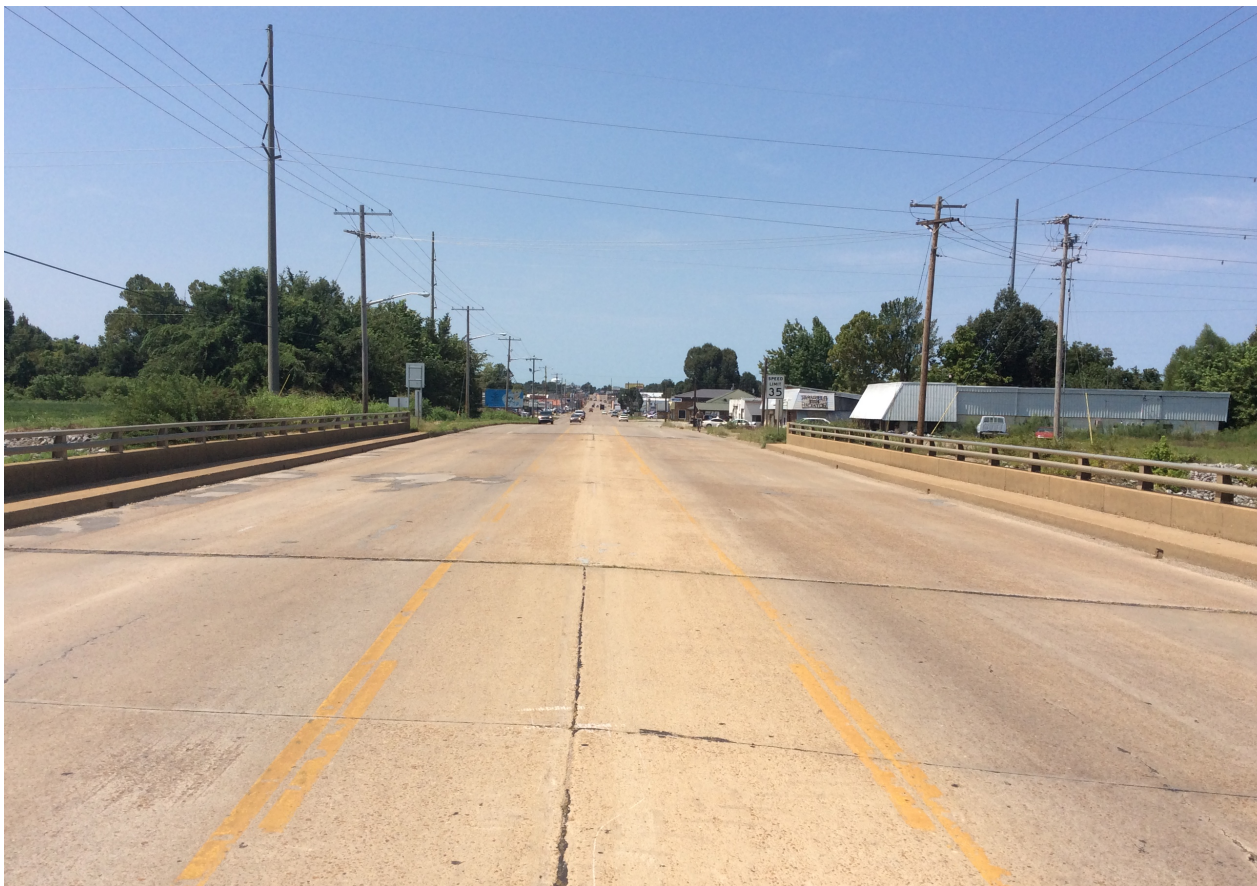
Spans 1 thru 3 Concrete Deck has several spalls, pending spalls, & concrete delaminating around patches (3% to 4% total of area of deck, (250 sf) ).

Span 3 near Bent 3 in west bound lanes has 4 spalled out areas, 8 in. to 12 in. in diameter, with rebar exposed, see 2013 Photo.
