Bridge Inspection Report

M2853
SH 312-01- LM 0.82
over
NATL DITCH

Structure Number: M2853

Facility Carried: SH 312-01- LM 0.82

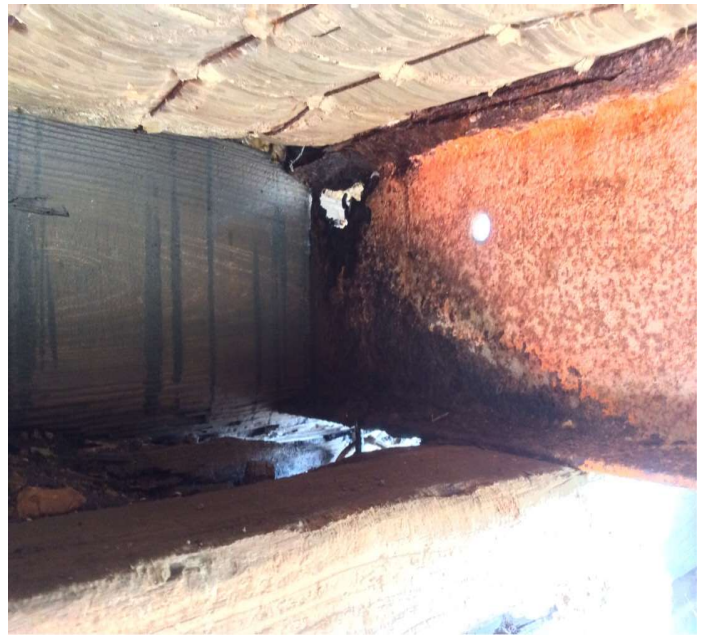
PHOTO 1 Description Span 1 girder 3 over bent 1.

Span 1 Girder 3 over Bent 1 has a 2in. x 2 1/2in. hole rusted thru web near Top Flange.

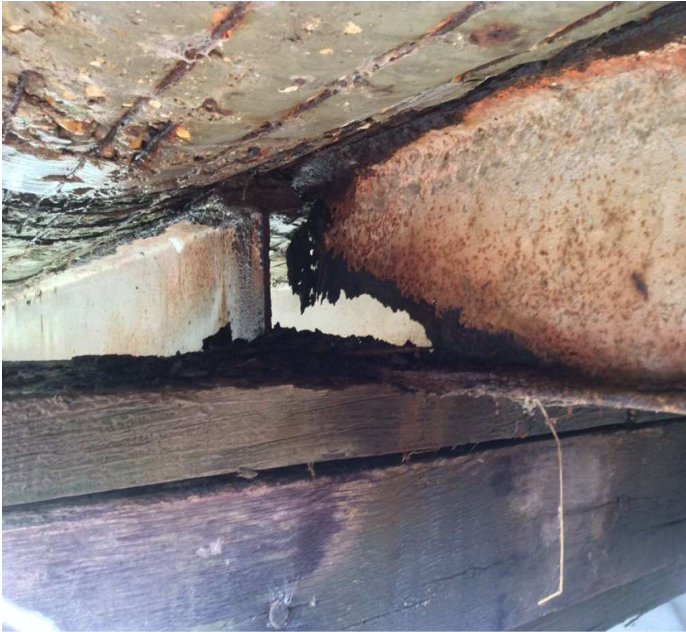
PHOTO 1 Description Span 1 girder 4 over bent 1.

Span 1 Girder 4 over Bent 1 has a 6in. x 3/4in. hole rusted thru web near Bottom Flange.
