Bridge #02138(Routine)
SH 77-02- LM 0.71 over DITCH NO 13

Location: .70 MI S JCT SH 18

Team Lead: Tim Myrick Inspection Date: August 26, 2020

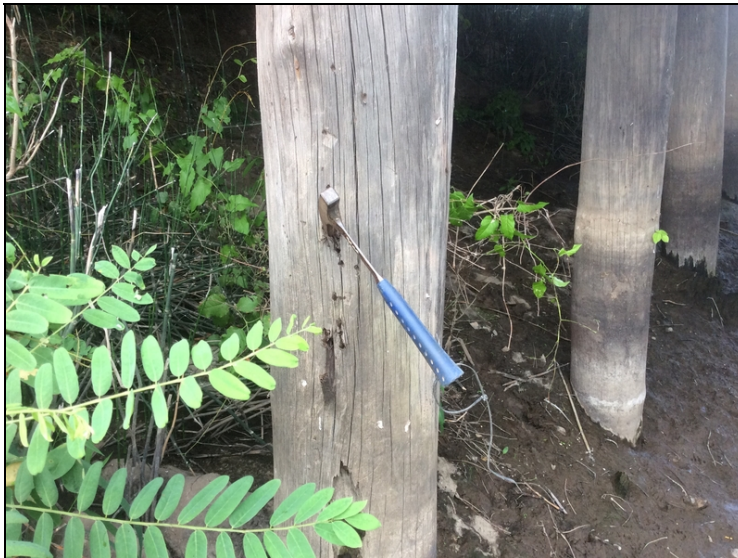
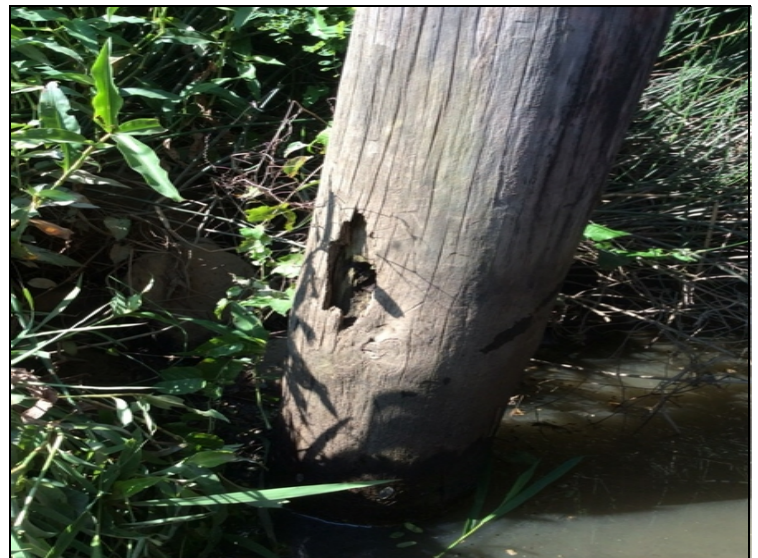
Bent 2 pile 4 & 5 has up to 1" of outside decay.

Bent 2 pile 4 & 5 have up to 1" of outside decay.

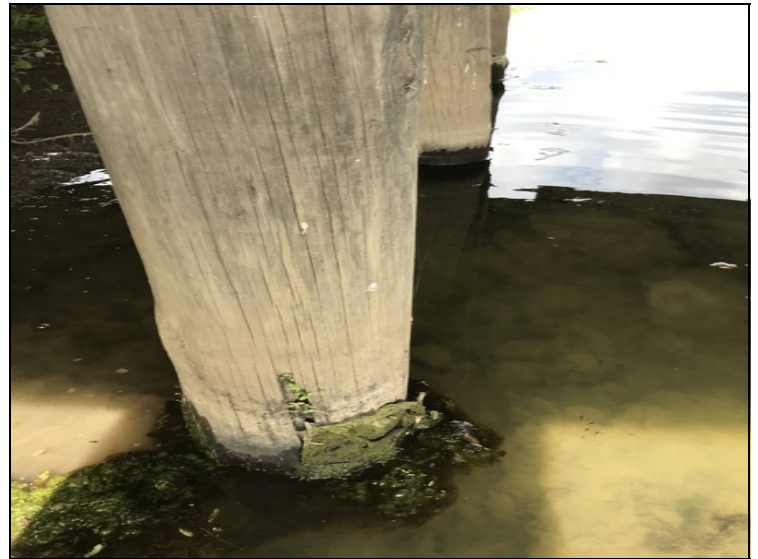
B3 p2

Bent 3 pile 1 & 2 has up to 2" of outside decay approximately 3' up from ground line and partially hollow.

Bent 3 pile 1 has up to 2" of outside decay, 4' high, approximately 3' up from ground line.

Bent 3 pile 2 has 1" outside decay and partially hollow.

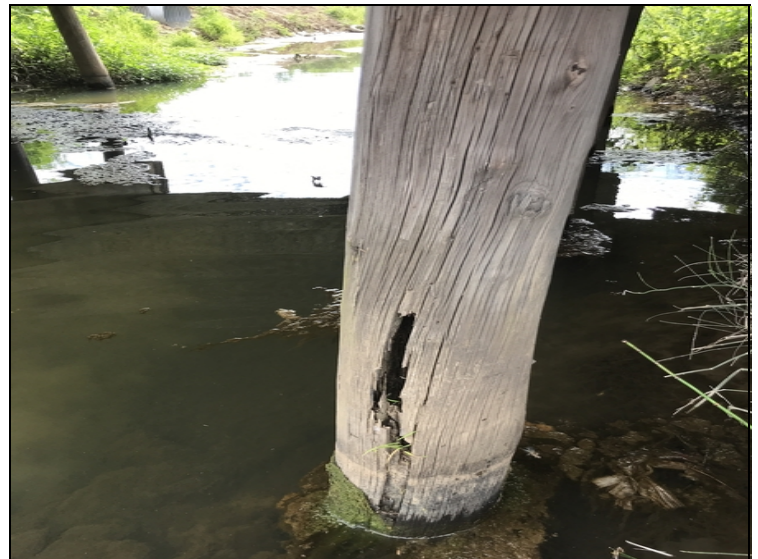
B3 p5

Bent 3 pile 4 has 1" outside shell, decayed & hollow.
Bent 3 pile 5 bottom 4' has a 1" shell, hollow.

Bent 3 pile 4 has 1" outside shell, decayed & hollow.

to Dist Bridge Crew for repairs when they have time - KAW 8/30/18
Bridge Crew currently working on other priorities, will continue to monitor. KAW 6/28/19
