Bridge #02141(Underwater type 2, Routine)
SH 77-02- LM 10.42 over Little Rvr Lt Hand Chute

Location: 1.8 MI N JCT SH 140

Team Lead: Alan Walter **Inspection Date:** June 18, 2020

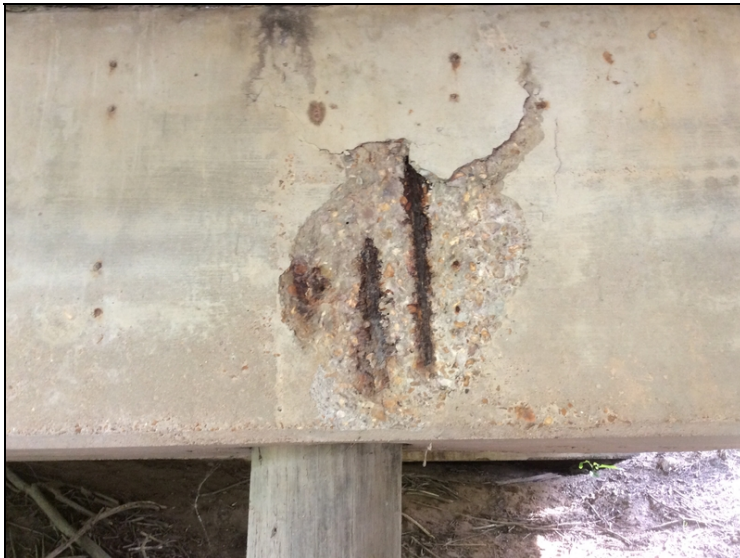
Left end bent 1

Bent 1 Cap has a 2' x 6" spall with no exposed rebar.

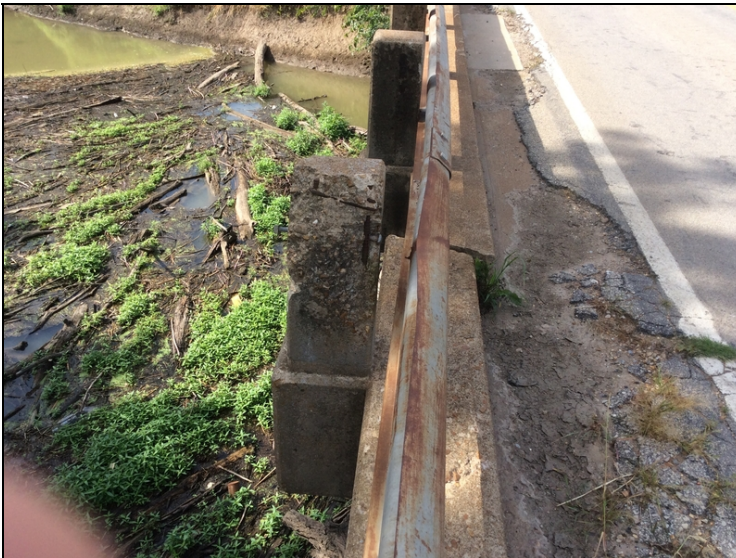
Bent 5 left guardrail

Metal Bridge Rail
Rail has 60% paint deter. and rust forming.
Lt rail is loose at spans 4 and 5.

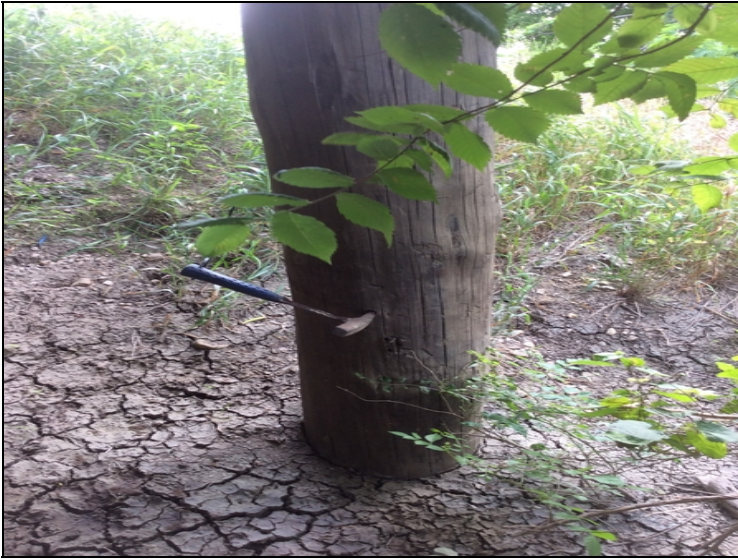
B2 p1

Bent 2 Pile 1 is decayed and partially hollow near ground line.
Bent 3 Pile 1 is decayed and partially hollow 4' above ground line.
Bent 4 piles 2 & 4 are decayed & partially hollow.
Bent 6 pile 5 checks and decayed and partially hollow.
Bent 7 Pile 2 has a ½" split..
Bent 7 Pile 1 is decayed and partially hollow 3' above ground line.
Bent 8 pile 3 decayed and partially hollow'

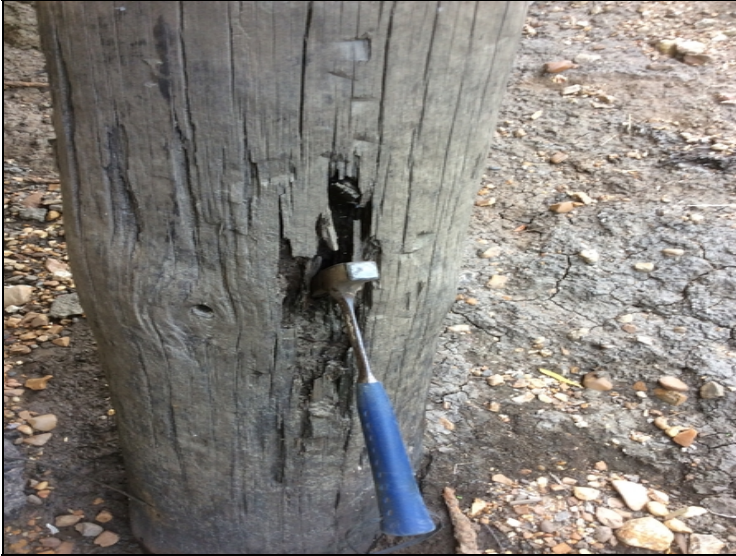
Bent 8 pile 5

Bent 5 pile 2 has a 1" shell & hollow.
Bent 5 pile 5 has open cracks and moderate checking, decayed and hollow and beginning to crush.
Bent 6 Pile 3 is decayed and mostly hollow 1 1/2" shell and hollow.
Bent 8 pile 2 has a 1/2" shell decayed & hollow.
Bent 8 Pile 5 is decayed hollow with a 1" shell.
