Bridge #02870(Routine)
SH 77-02- LM 7.16 over LITTLE RIVER
Location: 1.1 MI N JCT OF SH 158

Team Lead: Richard Jones **Inspection Date:** July 28, 2021

IDENTIFICATION	
(1) State Names	Arkansas
(8) Structure Number	02870
(5) Inventory Route	77
(2) Highway Agency District	10
(3) County Code	93-Mississippi County, Arkansa

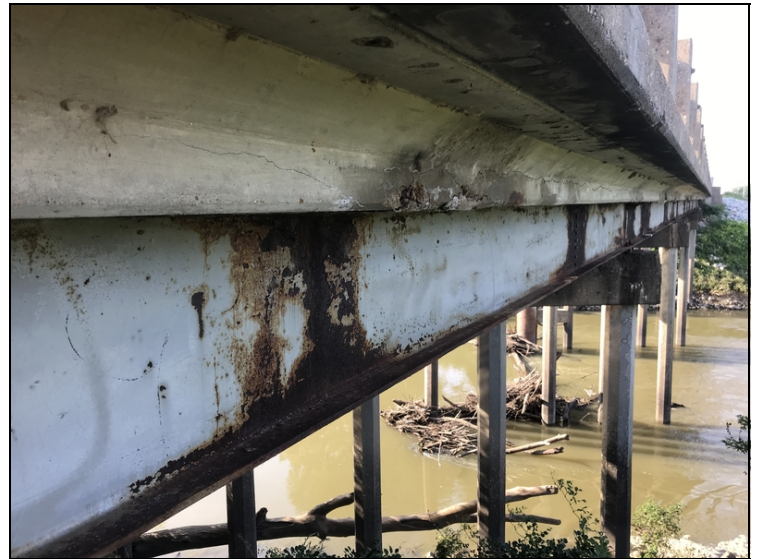
S5 b6 g3

Span 5 bent 6 girder 1 has a 6" x 2" hole in web at haunch.
Span 5 bent 6 girder 3 was T-spliced sometime in the past. Girder has a 5" x 1" hole in web at haunch.
Span 5 bent 6 girder 4 was T-spliced sometime in the past. Girder has a 4" x 1" hole in web at haunch. T-splice has rust with minor measurable section loss.

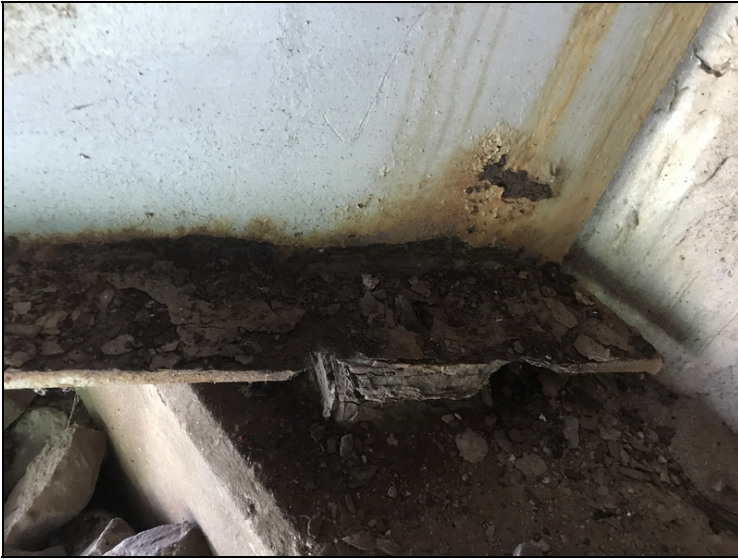
S1 b1 g4

Span 1 bent 1 girder 4 has a 1.5" diameter hole in web below haunch. Bottom of web has a 6" area of moderate section loss over bearing. Bottom flange has heavy section loss with holes rusted through near bearing.

to Dist Bridge Crew for repair as priorities allow KAW 7/6/2020

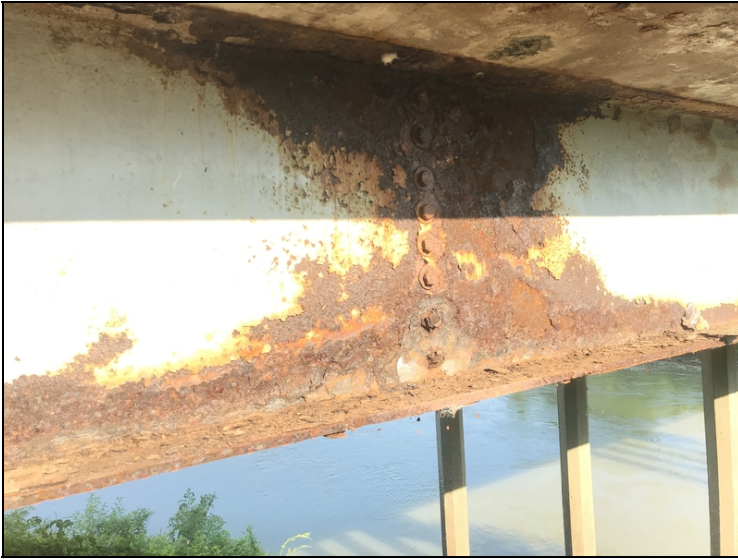
Span 5 girder 1 near bent 6

Paint system has mostly failed or is ineffective. Steel girders have scattered rust throughout. Ends of girders are rusted with areas of section loss at web below concrete haunch, along bottom of web, and along bottom flange. Exterior girders 1 and 5 have flaking rust and section loss near drain openings.

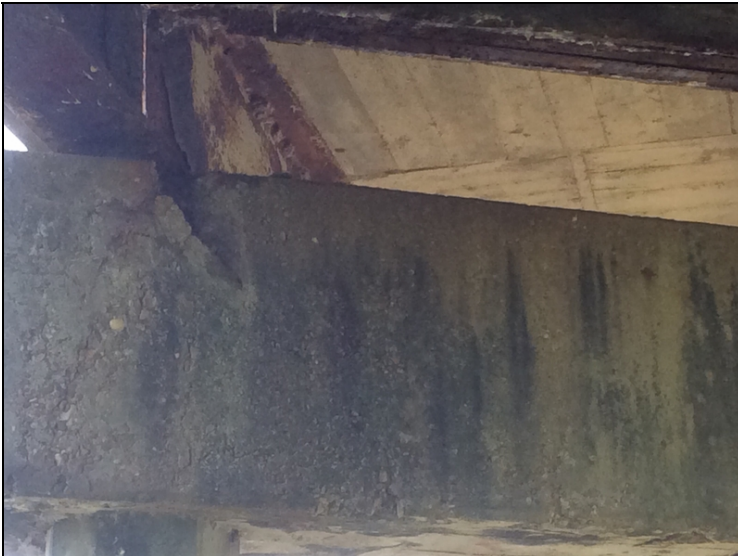
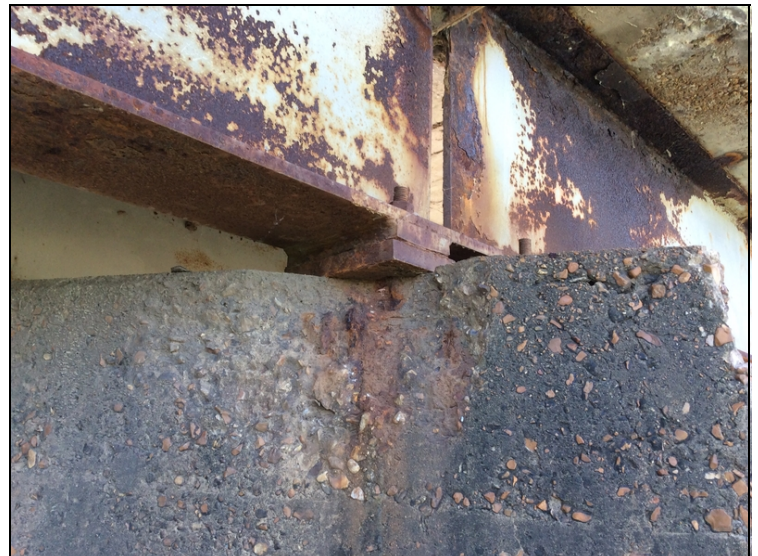
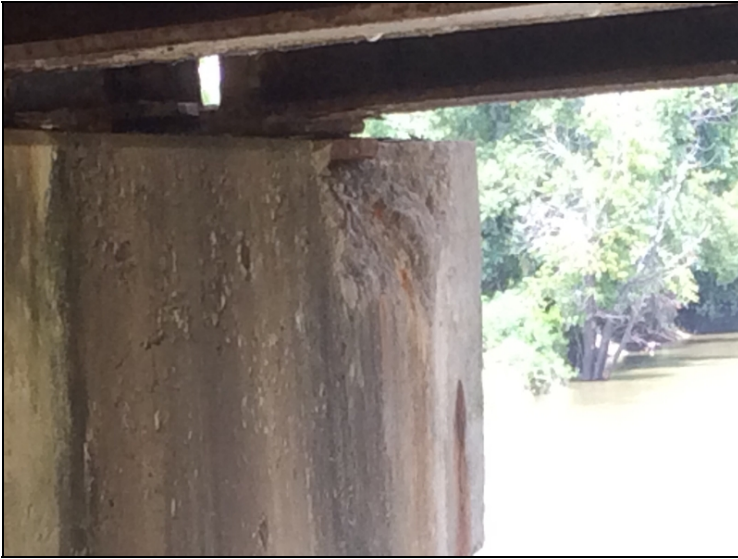
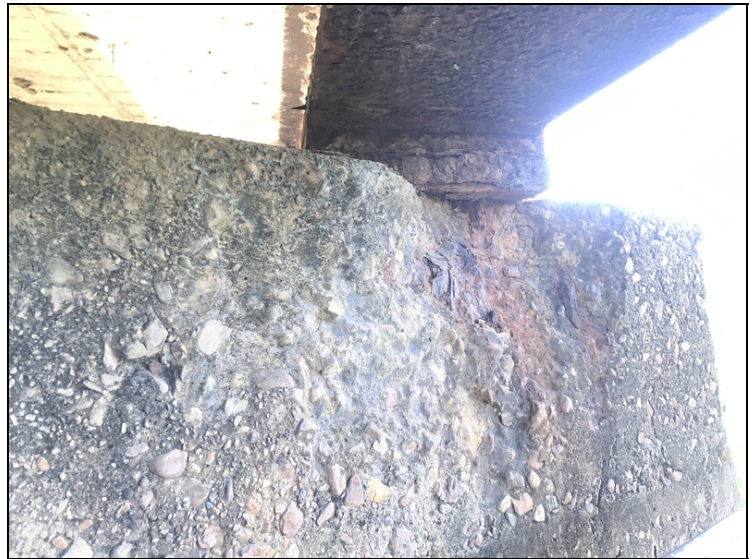
Span 1 bent 2 bearing 5

Caps have spalls under bearings with loss of bearing area at:
Span 1 bent 2 bearing 5; span 4 bent 4 bearing 5; span 5 bent 5 bearing 5

Bridge Crew completing similar repairs on bridge just north of this loc. will repair these when schedule allows. KAW 3-31-2020

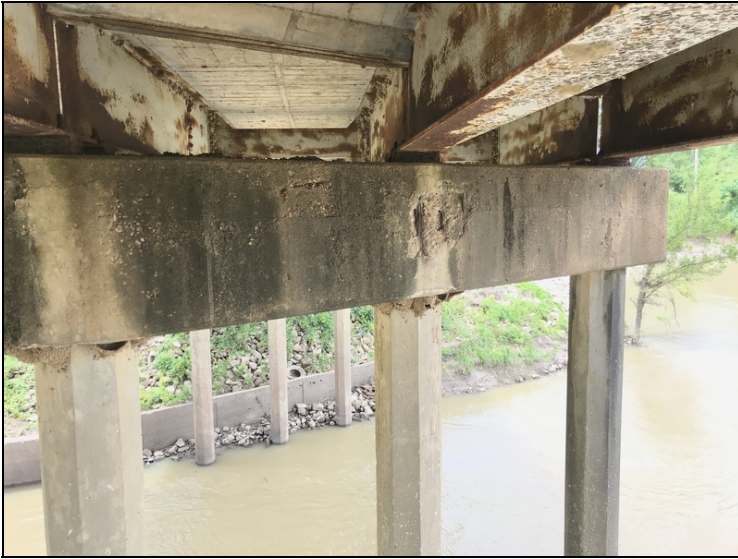
S3 b4 g4

Concrete abutments have several shallow spalls with rebar exposed.
Concrete caps at interior bents have several large spalls with rebar exposed. Caps have several cracks, delaminated areas, and areas of abrasion.

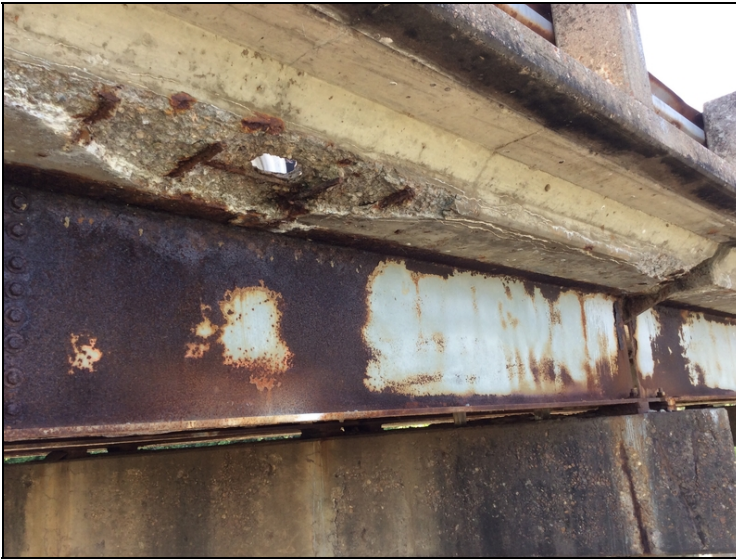
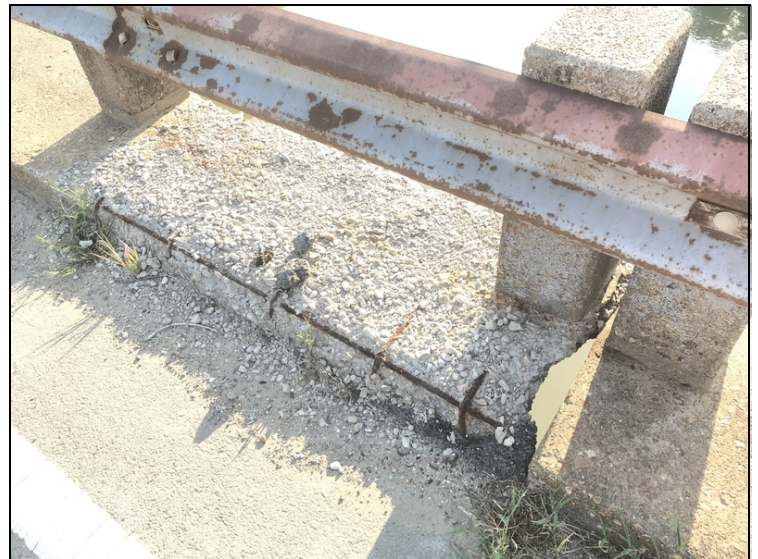
Span 2 Lt curb near bent 3

Curbs and overhangs have areas of concrete disintegration near joints. Several areas have rebar exposed. Overhangs have several longitudinal cracks.

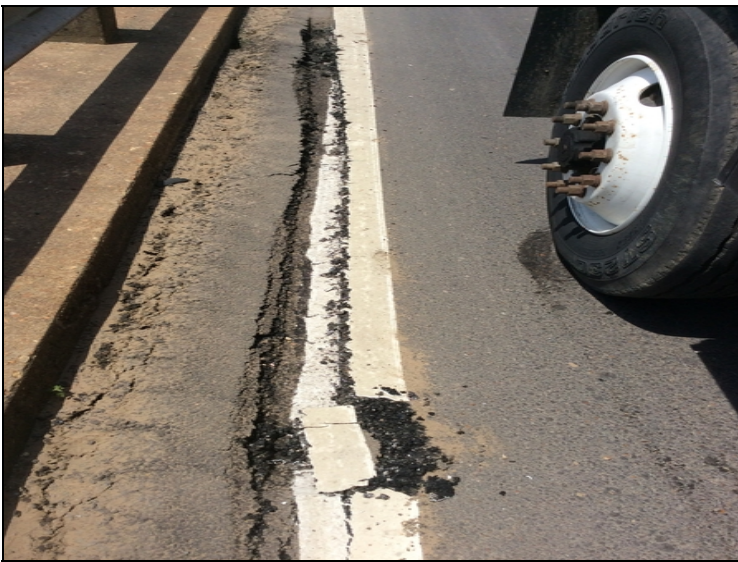
Asphalt wearing surface has cracks with a few delaminated areas over joints.
Rt gutter line has a 5 in. wide x 40 ft. long spall due to outrigger on snoopers, see 2018 photo of span 3.

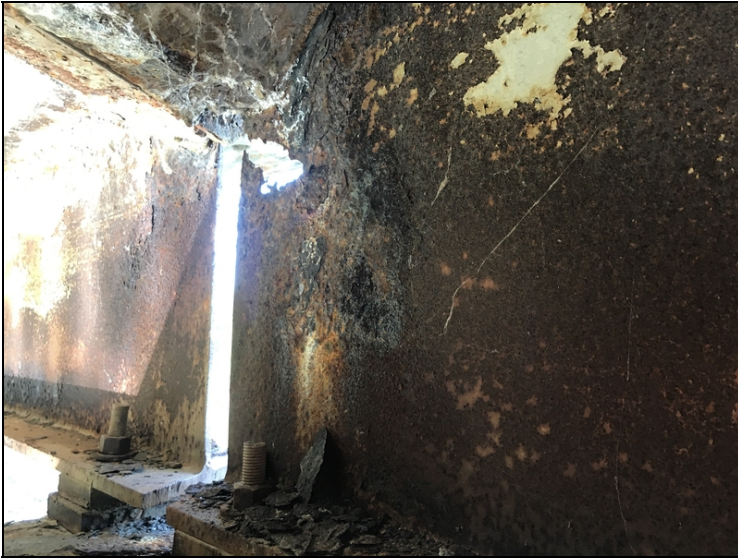
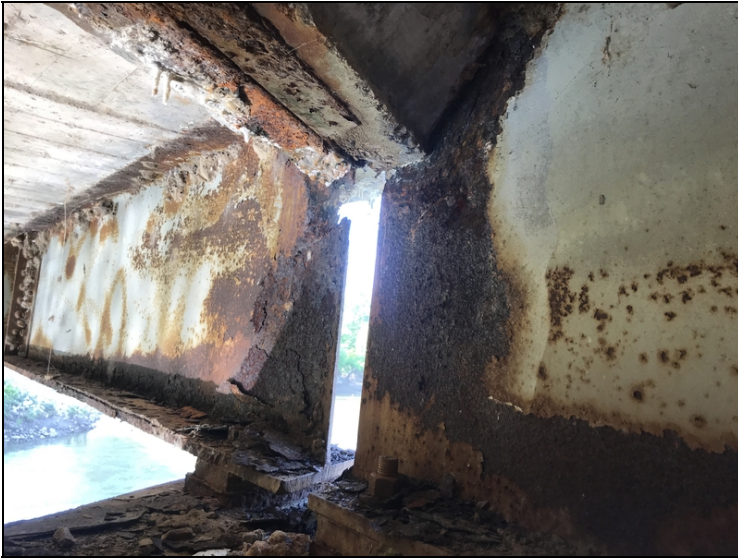
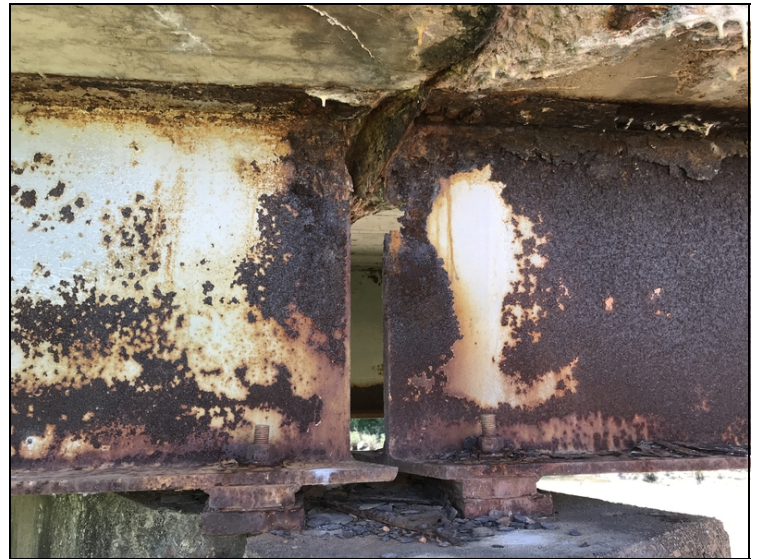
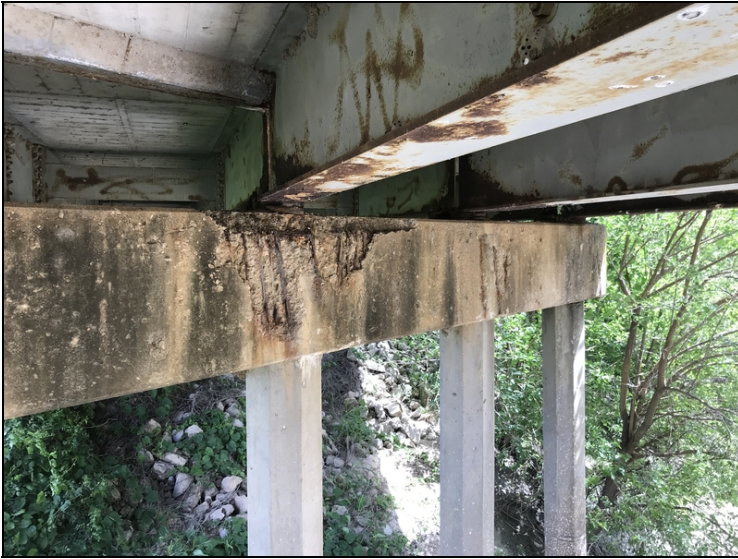
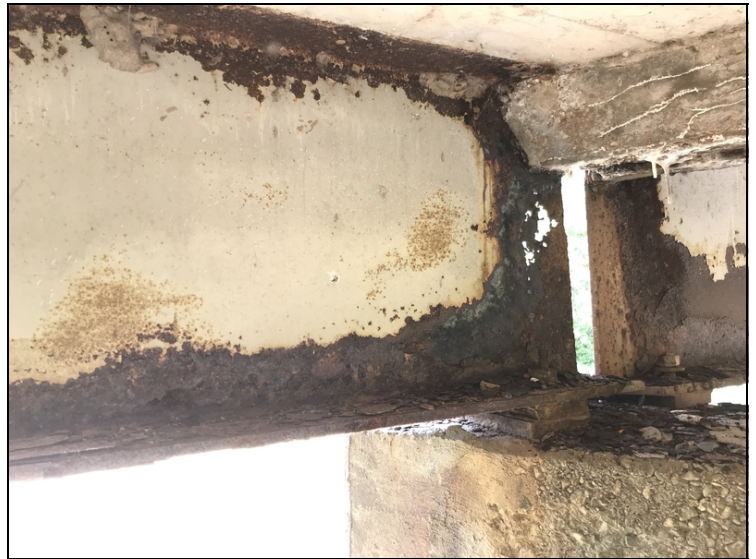
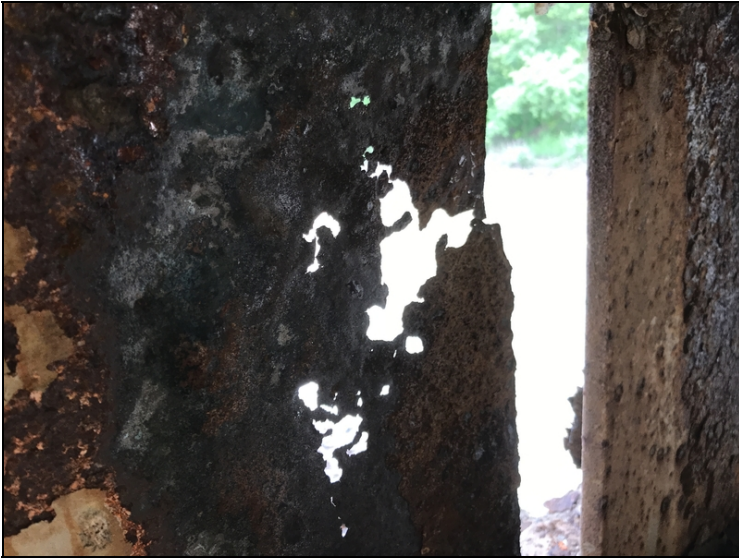
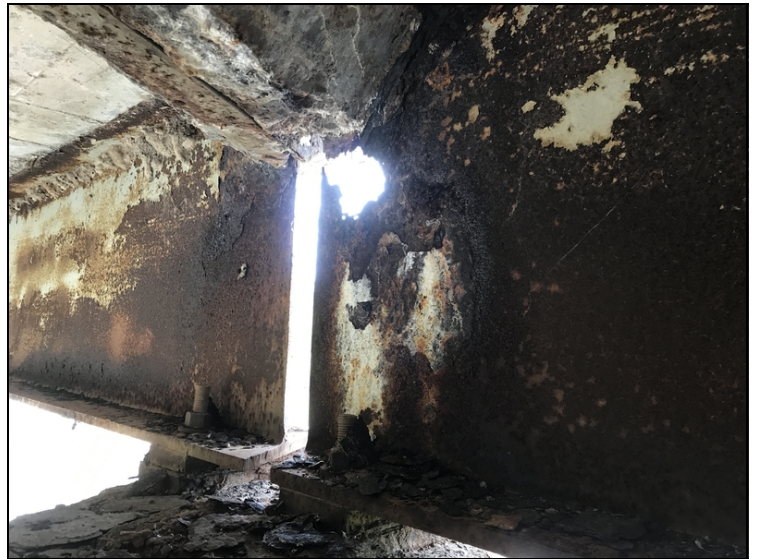
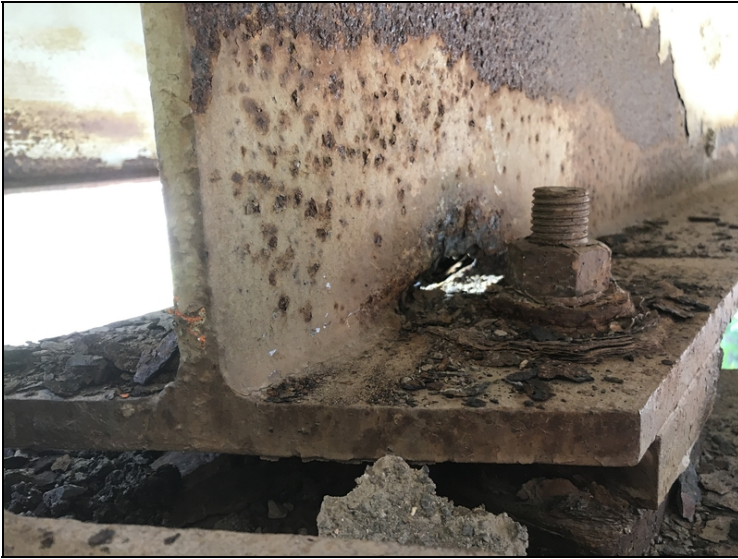
Paint system has mostly failed or is ineffective. Steel girders have scattered rust throughout. Ends of girders are rusted with areas of section loss at web below concrete haunch, along bottom of web, and along bottom flange.

Exterior girders 1 and 5 have flaking rust and section loss near drain openings. Bearings have heavy pack rust and section loss. Several anchor bolts are missing.

To District Bridge Crew for repair when their schedule allows. KAW 7/18/19

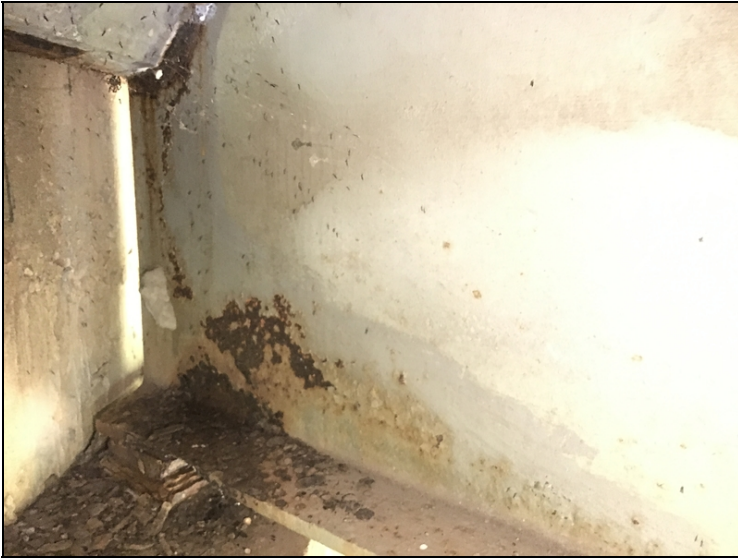
Span 1 bent 1 girder 4 has a 1.5" diameter hole in web below haunch. Bottom of web has a 6" area of moderate section loss over bearing. Bottom flange has heavy section loss with holes rusted through near bearing.

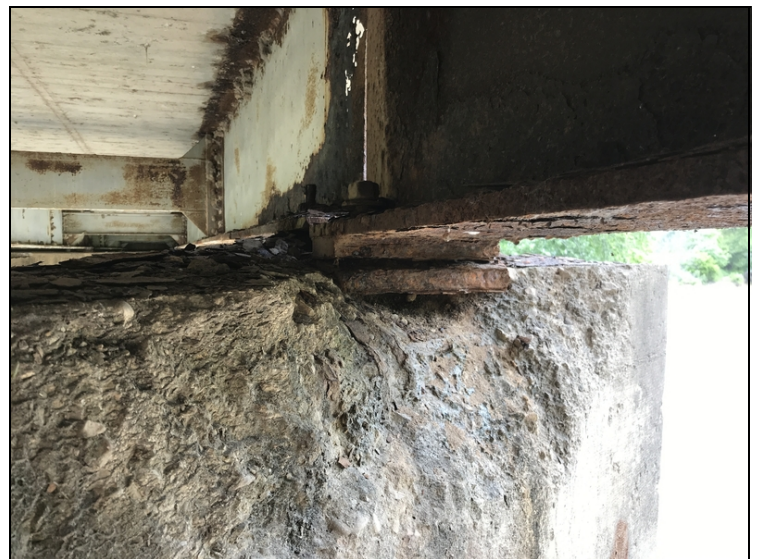
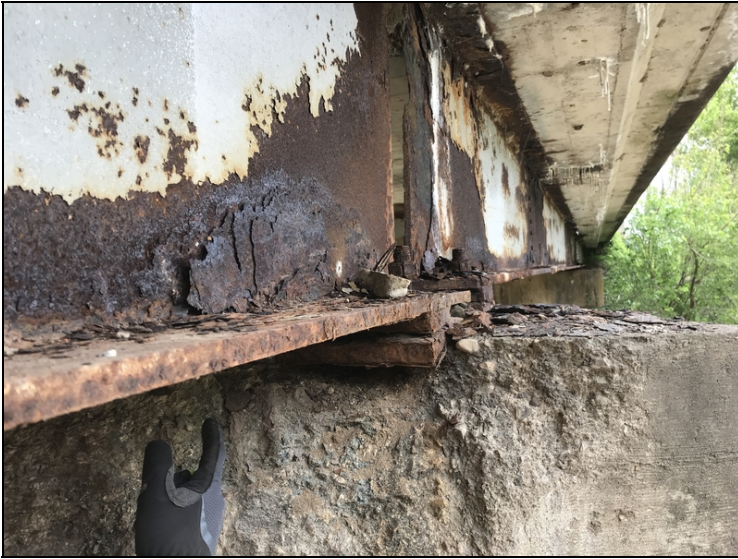
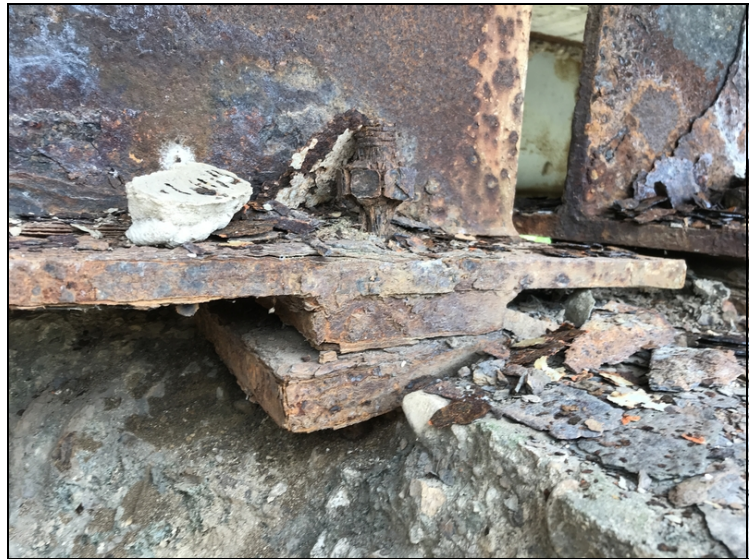
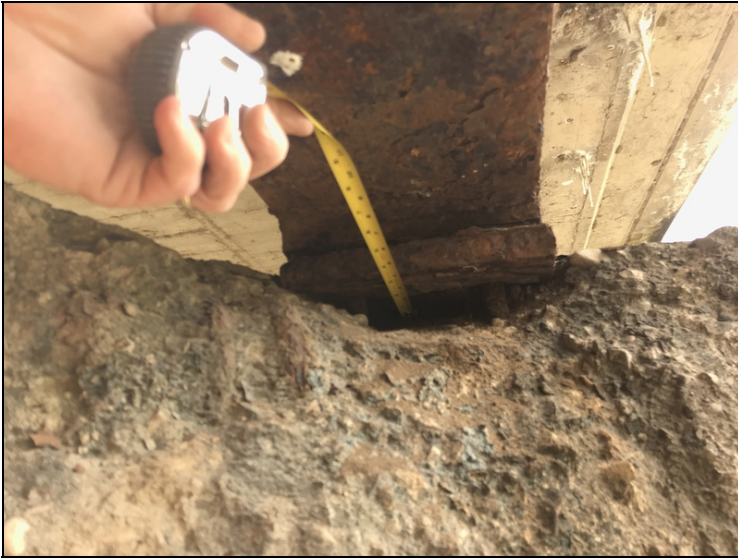
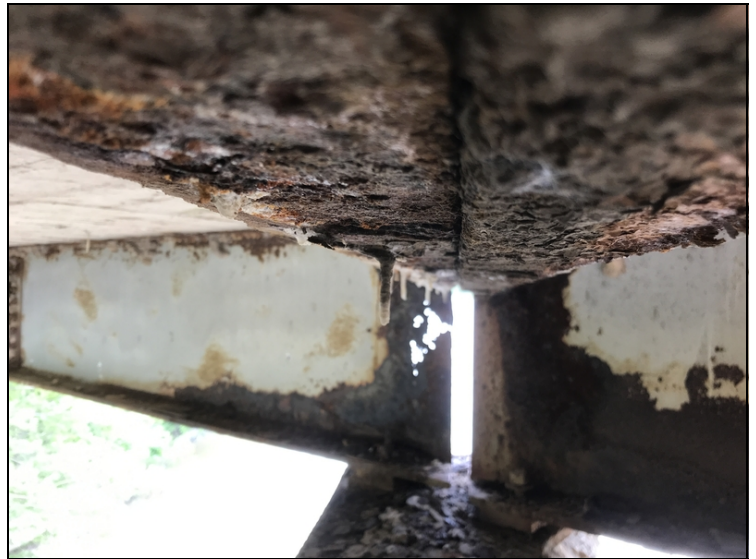
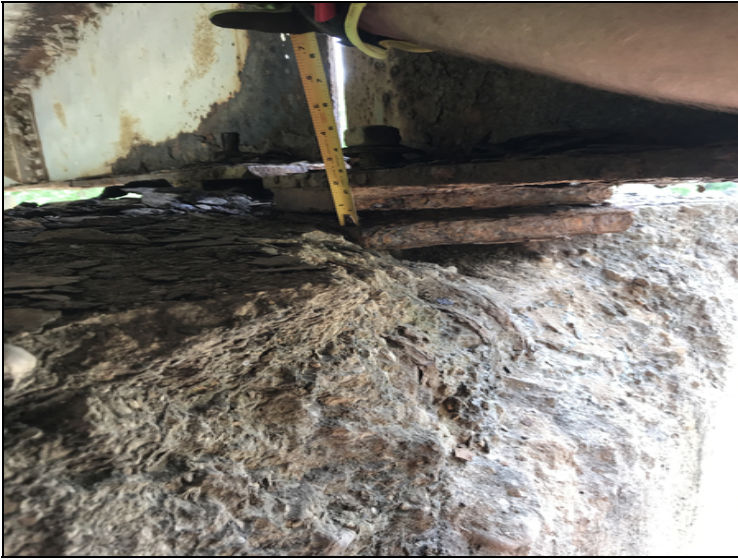
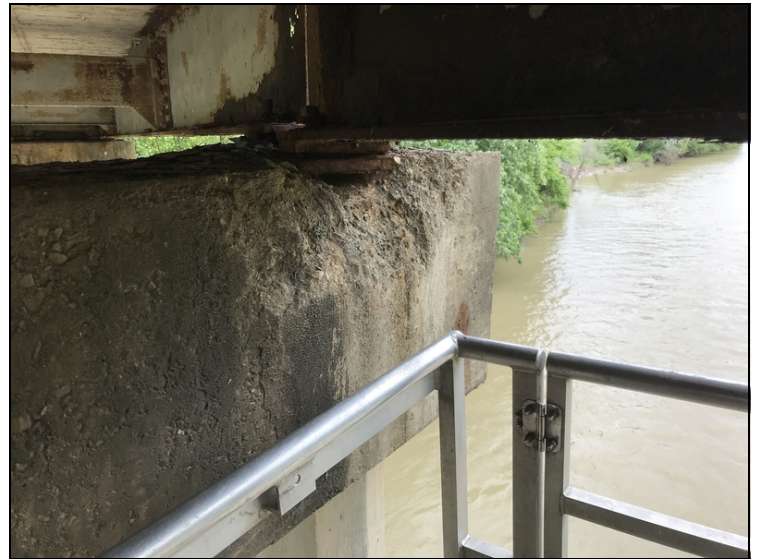
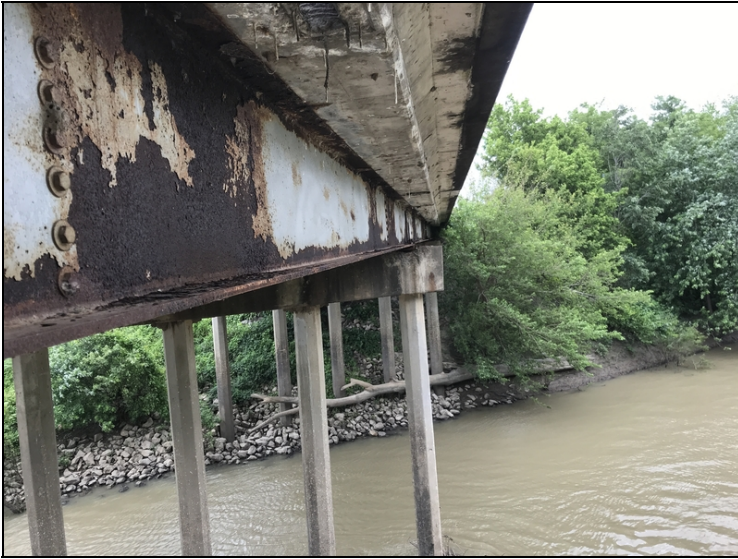
Span 3 bent 3 girder 1 has settled 3/4" due to a 3' x 1' spall in cap under bearing 1. Deck, girder, and concrete post all measure 3/4" lower than previous span. Masonry plate has 60% loss of bearing currently and has up to a 1/2" gap between masonry plate and sole plate. Concrete beneath the bearing is disintegrated.

7/28/21 No change in condition observed during routine inspection. - RRJ

10/6/20 Load Rating lowered legal limit due to current conditions. It is properly signed, lowering priority to A. - ADN

07012020 Dennis Vire , Bearing and beam still supported above rebar cage. Primarily a ride-ability issue. No change in Posting Recommendations at this time.

to Dist Bridge Crew for repair as priorities allow KAW 7/6/2020
