District 10, Mississippi County

Bridge #02881 (Routine)
SH 77-02- LM 6.34 over LITTLE RIVER

Team Lead: Tim Myrick Inspection Date: November 24, 2020

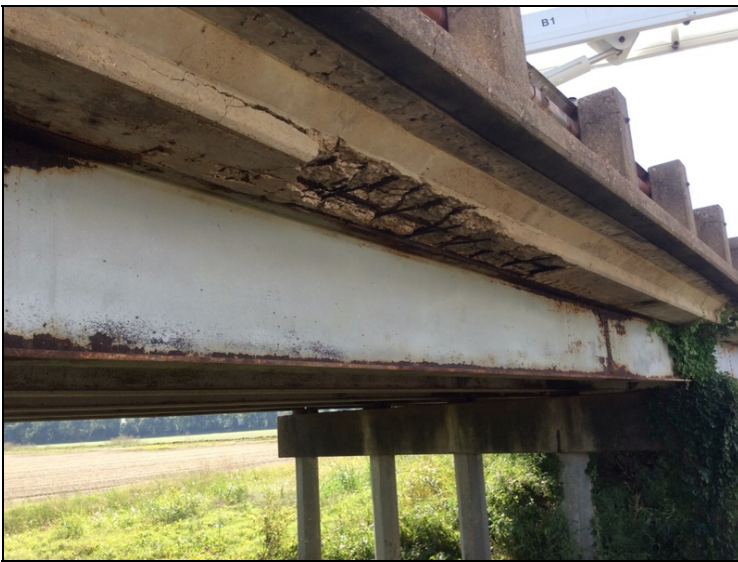
Span 8 has a 12ft. X 1ft. X 4in. deep spall with exposed rebar on right Overhang, see 2016 deficiency Photo.

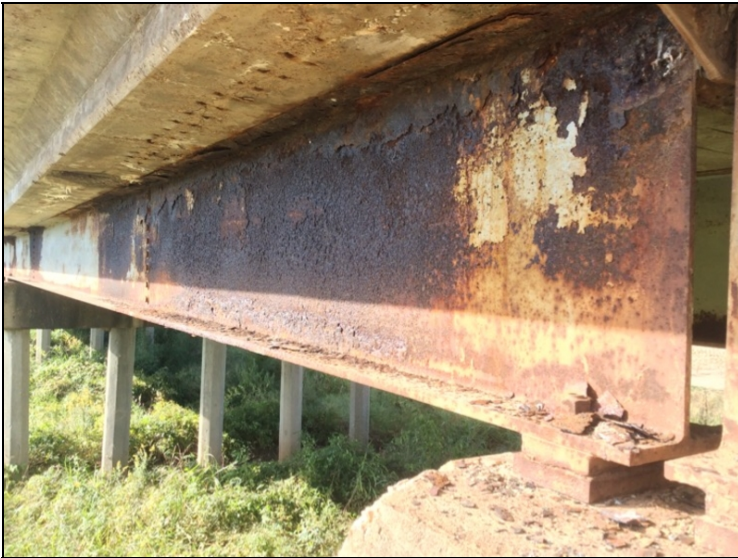
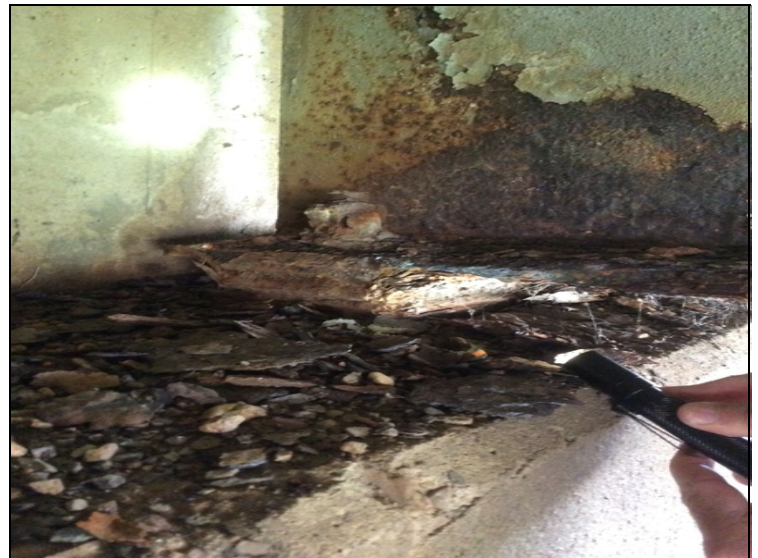
Is rusted with 1/8in. loss of section on web and bottom flange, mainly near drains, see 2016 deficiency photo.

Span 9 Girder 4 over Bent 10 has a knife edge in bottom flange near bearing, see 2016 photo.

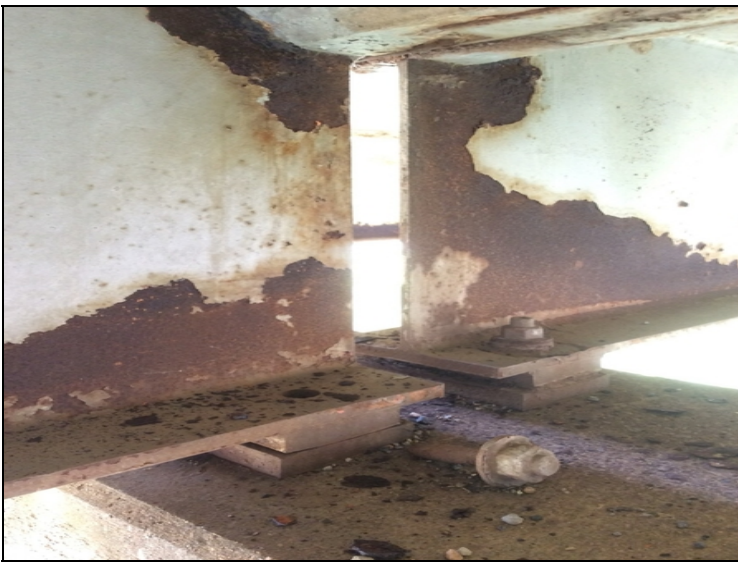
Span 3 Girder 2 Bent 4
Has 2 anchor bolts rusted off.

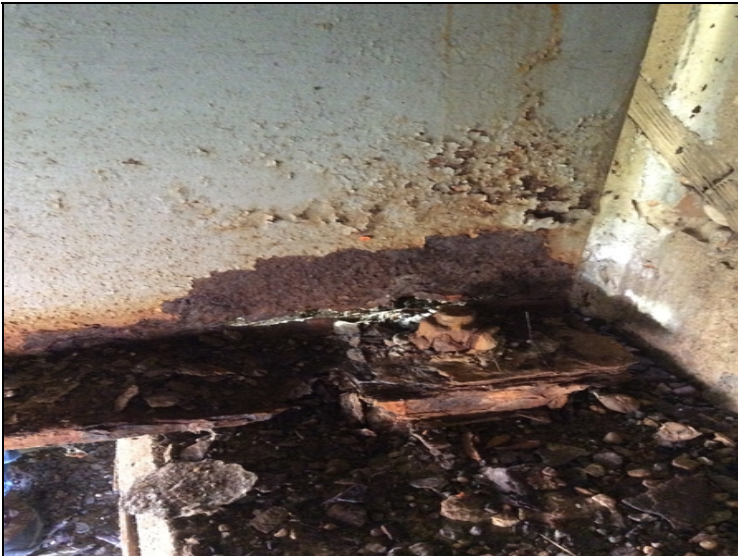
Span 9 Girder 2 over Bent 10 has 12in. X 1in. hole rusted thru web near bottom flange and a 2in. x 2in. hole in bottom left flange & a 3 ½ in. diameter hole in right flange near bearing, see 2016 photo.

Girder 9 has been repaired by District 10 Bridge crew 3/19/2020 see photo 2020

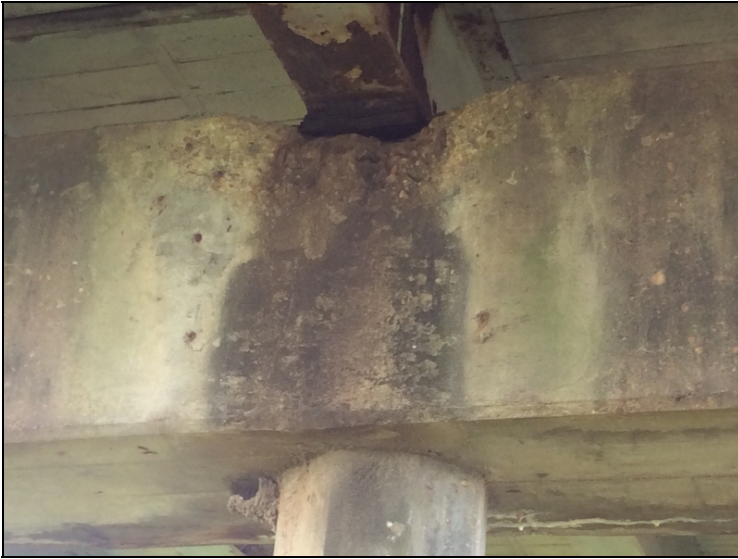
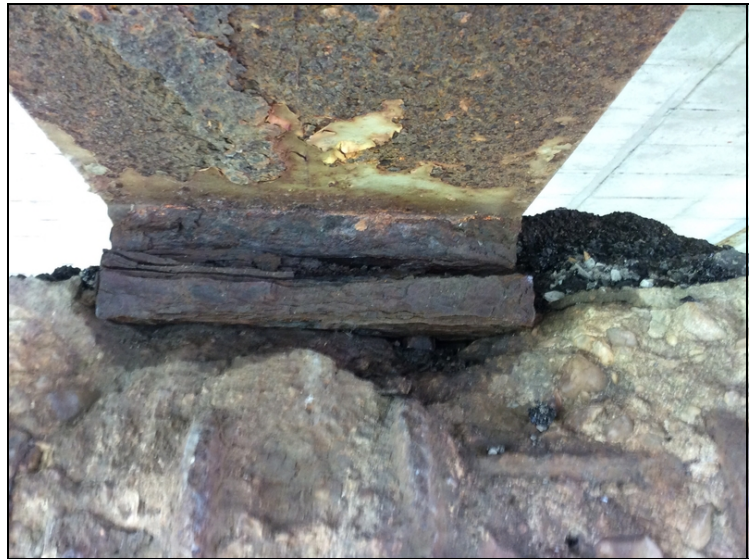
Bent 6 cap right end has heavy deterioration & section loss with 60 % loss of bearing area under span 6 girder 5 bearing, see 2018 photo.

bridge crew is review caps and beams to schedule repairs

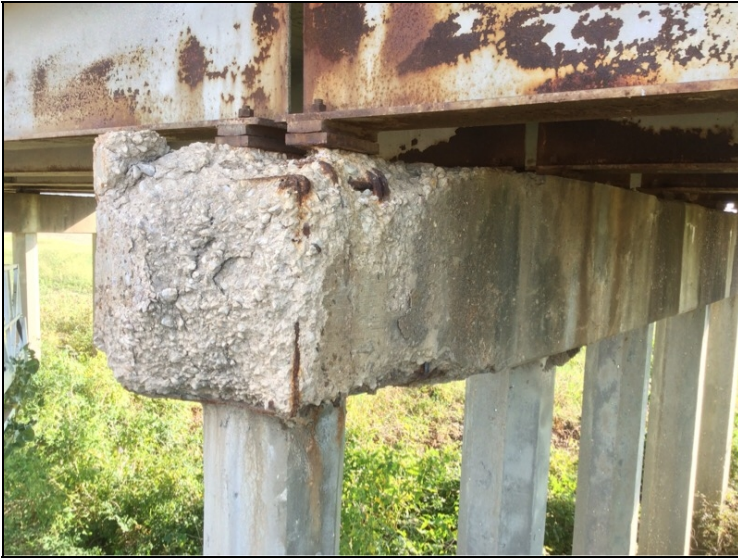
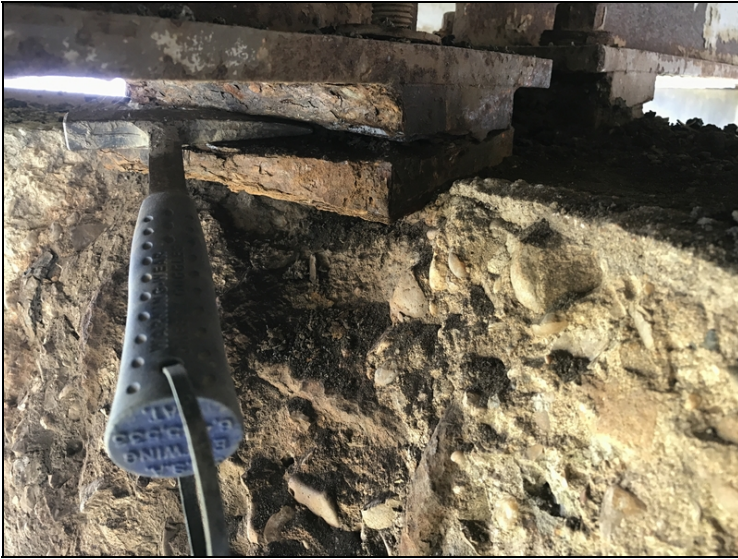
Bent 4 cap top at girder 3

Top of Concrete Cap Bent 6 & between Girders 3&5 has moderate deterioration of up to 3 inches deep with section loss & rebar exposed with 30% of loss of bearing Spans 5&6 Girder 5, (water retention on top of Cap), See 2017 photo.
