District 10, Mississippi County

Bridge #03781(Routine)
SH 140-02- LM 9.08 over NATIONAL DITCH

Team Lead: Richard Jones Inspection Date: July 28, 2021

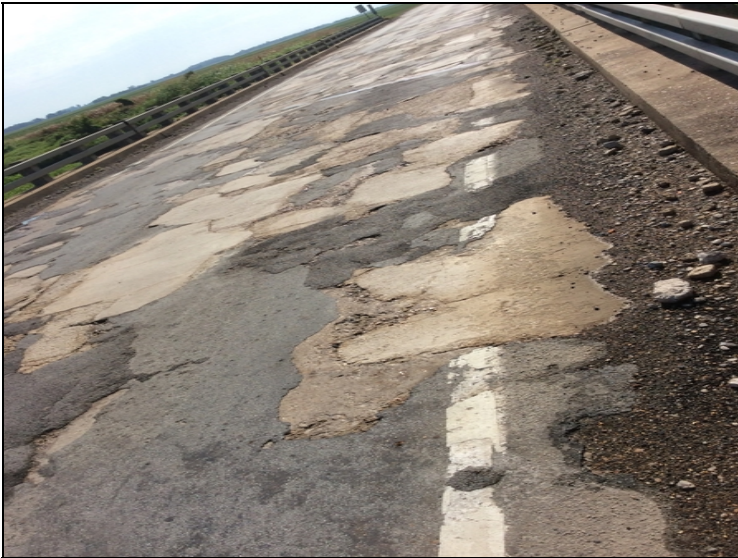
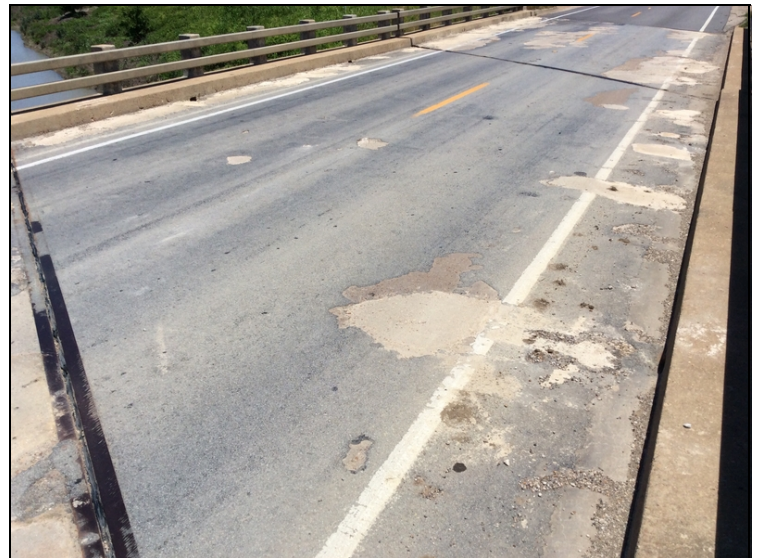
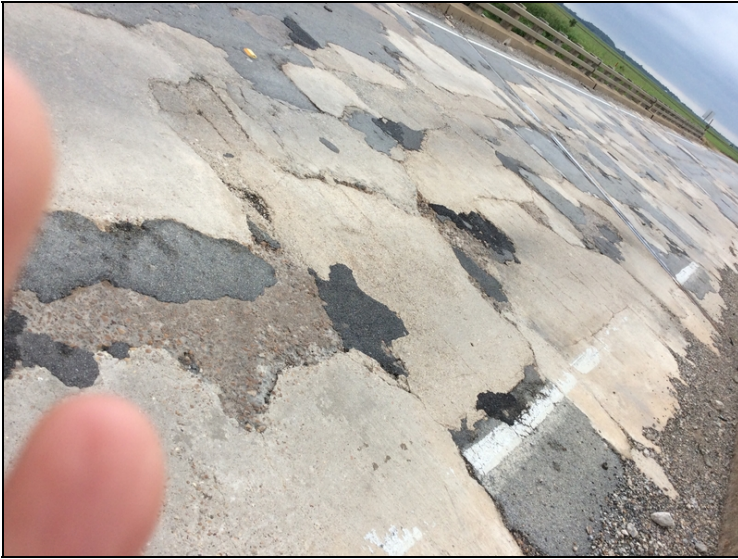
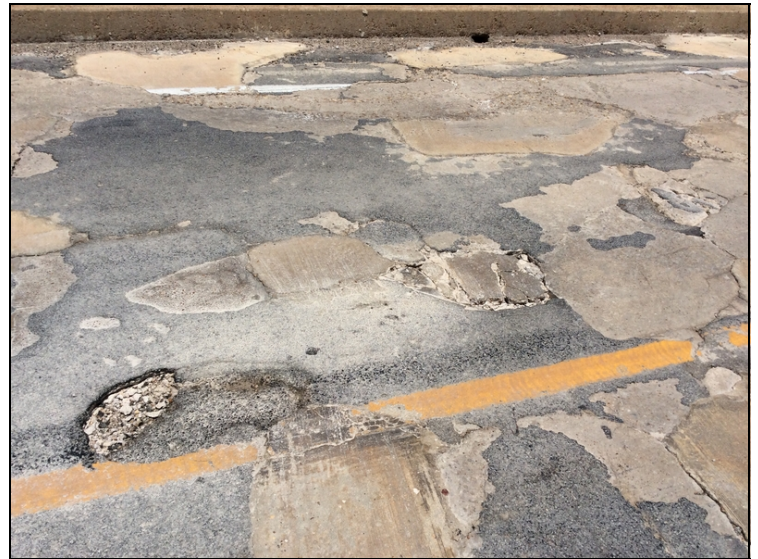
Asphalt wearing surface has some cracked areas & a few potholes and impending failures. Deck has several large patches, delaminated areas and spalls. Patches are in poor condition. Over 50% of deck area patched and/or delaminated.

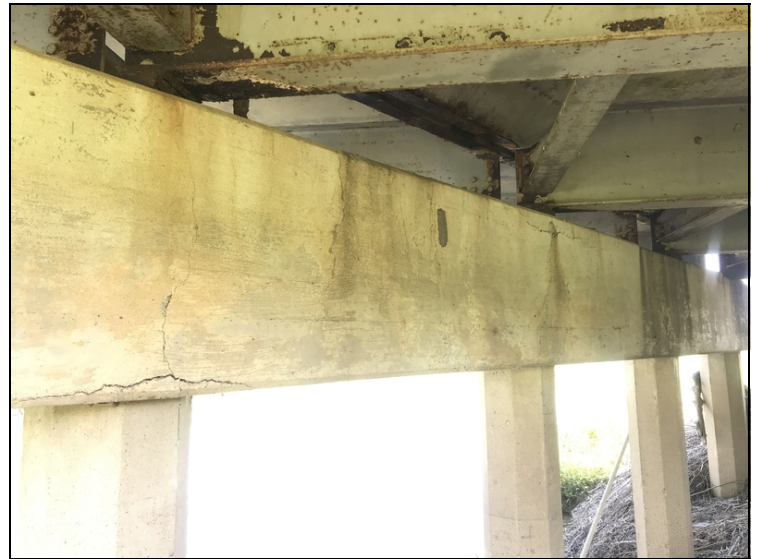
Concrete caps at bents 2 - 5 have several vertical and horizontal cracks; some with efflorescence. Caps have a few small spalls with exposed rebar. Caps have several delaminated areas along horizontal cracks near top and bottom edges of caps.

S4 b5 cap
