# Bridge Inspection Report

**06351**  
**WILLOW STREET**  
**over**  
**I-555, ML AND FR RDS**

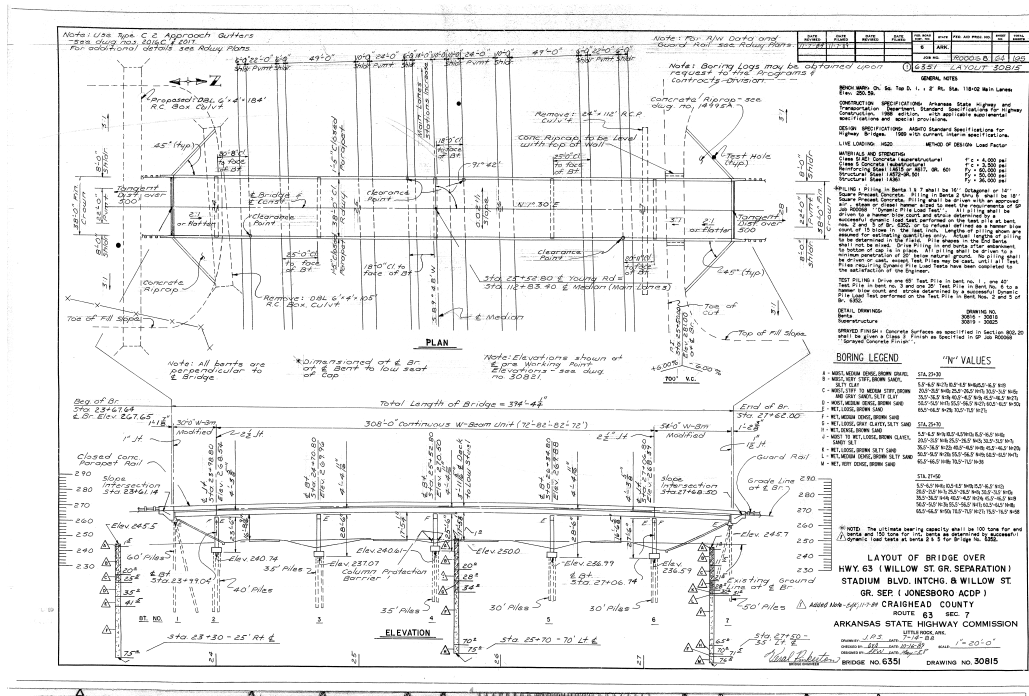
Description	06351 Layout View
-------------	-------------------

Description	2019 underclearance
-------------	---------------------

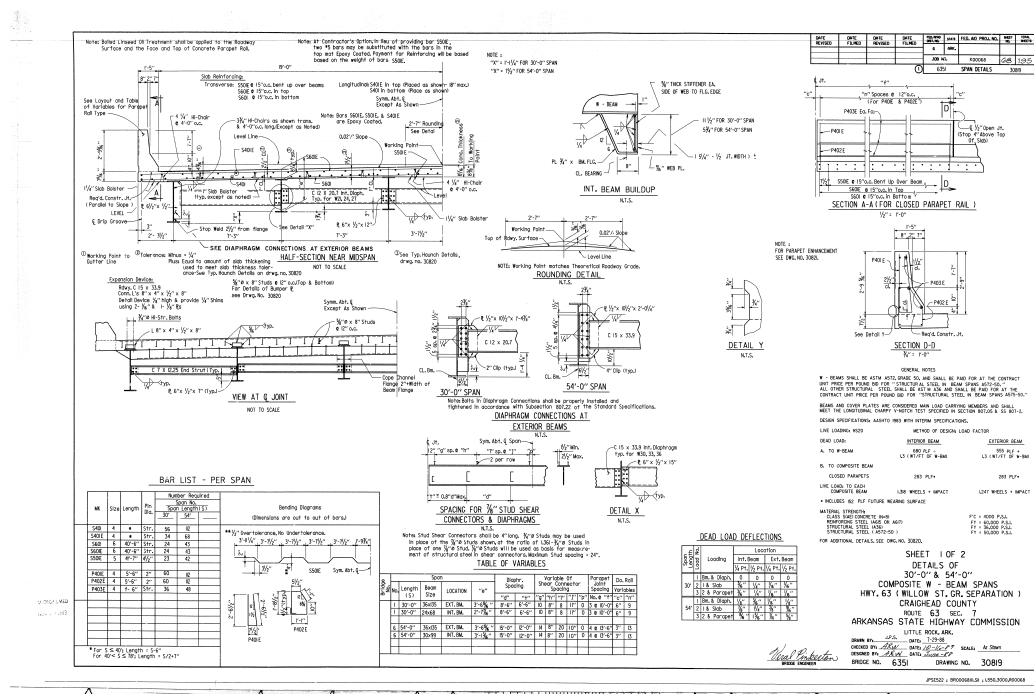
PHOTO 2

Description 06351 Cross Section View
