Bridge #M0603(Routine, Underwater type 2)

SH 25-06- LM 1.39 over CANEY CREEK

Team Lead: James Adams **Inspection Date:** October 15, 2019

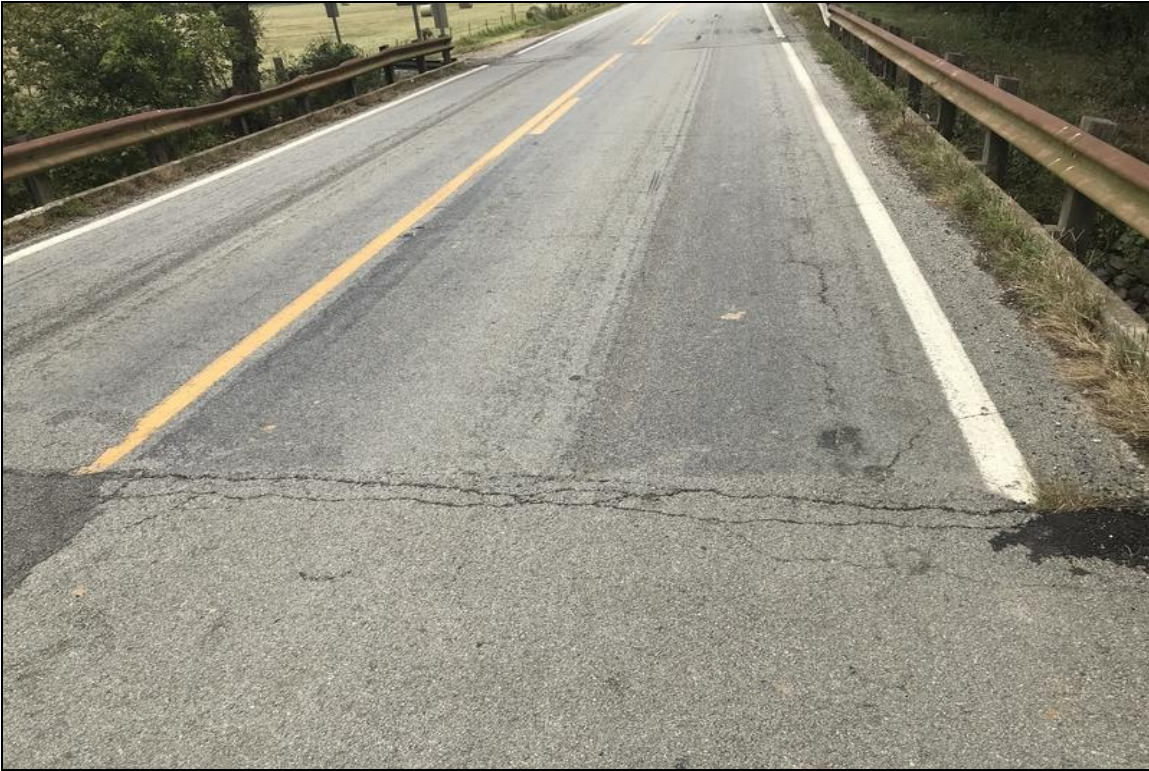
Deck

Wearing surface has a few longitudinal and transverse cracks.

Soffit has cracking with some leakage through deck over Bents 1 and 5.

Left and right overhangs have several cracks with efflorescence.

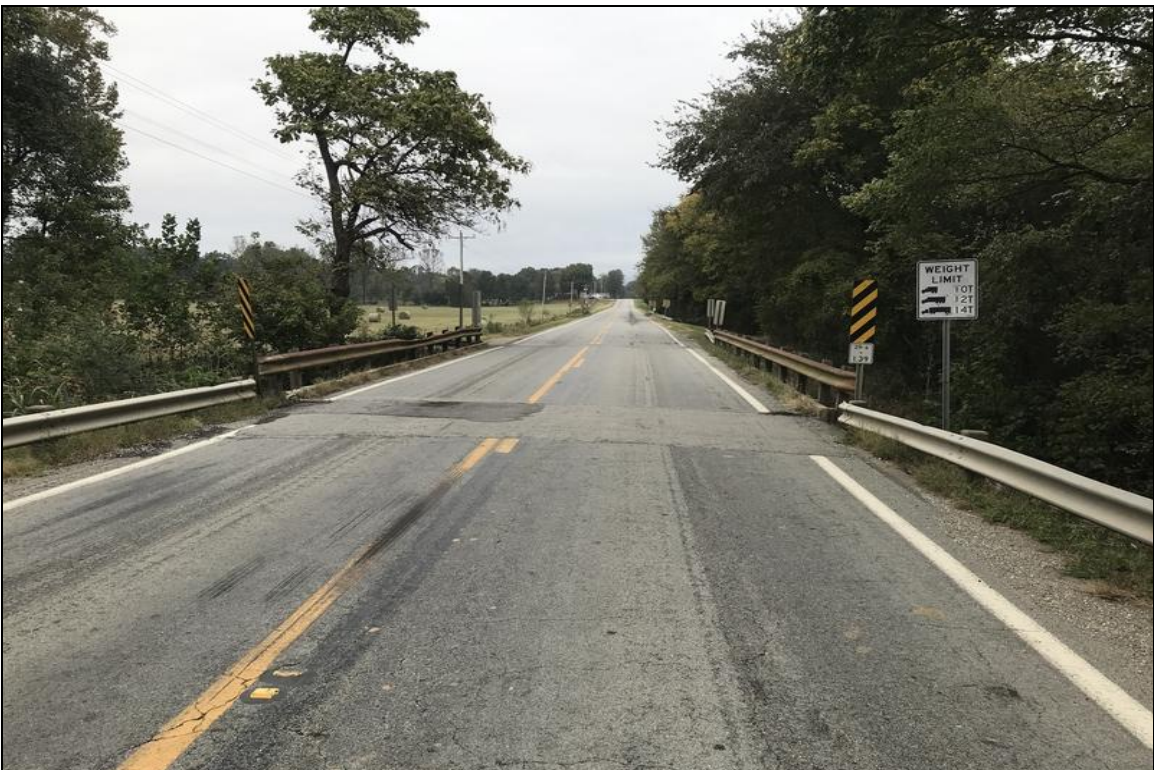
Roadway

Approach roadways have minor settlement at bridge ends, some repairs have been made with asphalt.
