Bridge #B5205(Routine)

I-555 over LOST CR.

Location: 4.43 MI NW OF SH 1B

Team Lead: Richard Jones Inspection Date: April 14, 2020

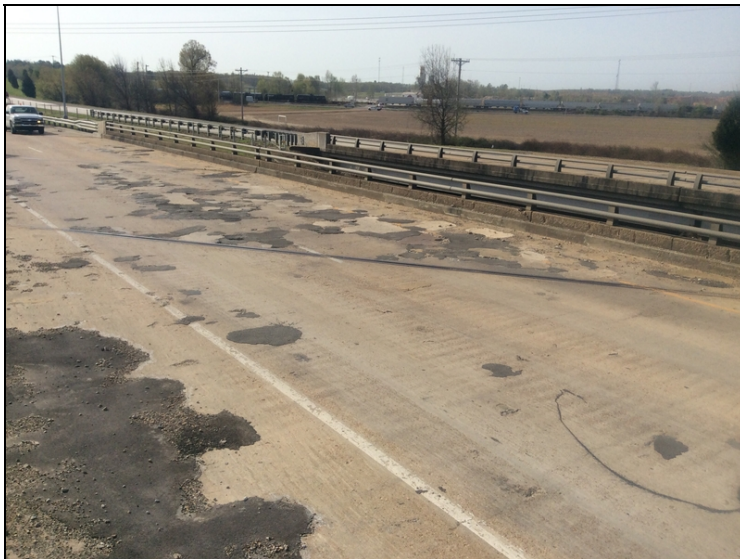
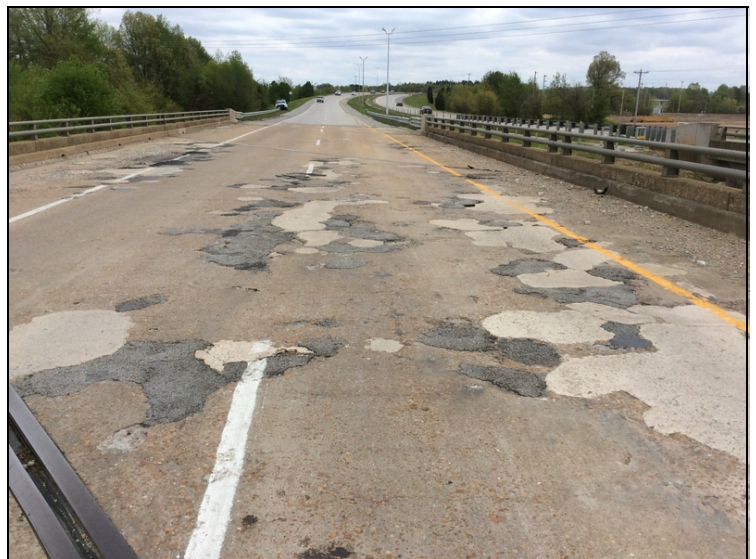
Span 2

Concrete deck has been noted in past inspections as having several cracks, delaminated and patched areas, and spalls with some rebar exposed.

Asphalt wearing surface has a few potholes in Rt lane at span 2. Exposed deck has some rebar exposed.

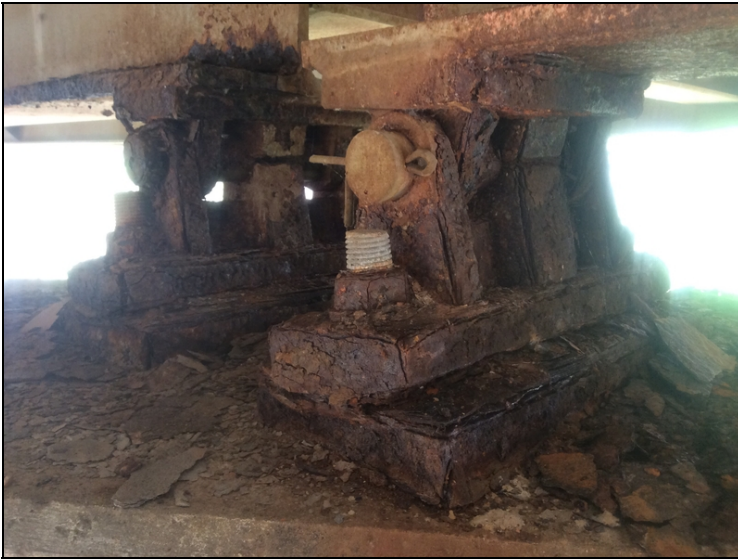
Bent 2 moveable bearings have heavy pack rust and section loss.
Bent 3 bearings are covered with asphalt debris.
