Bridge #06889(Routine)

SH 91 over LOST CREEK

Team Lead: Richard Jones Inspection Date: October 06, 2020

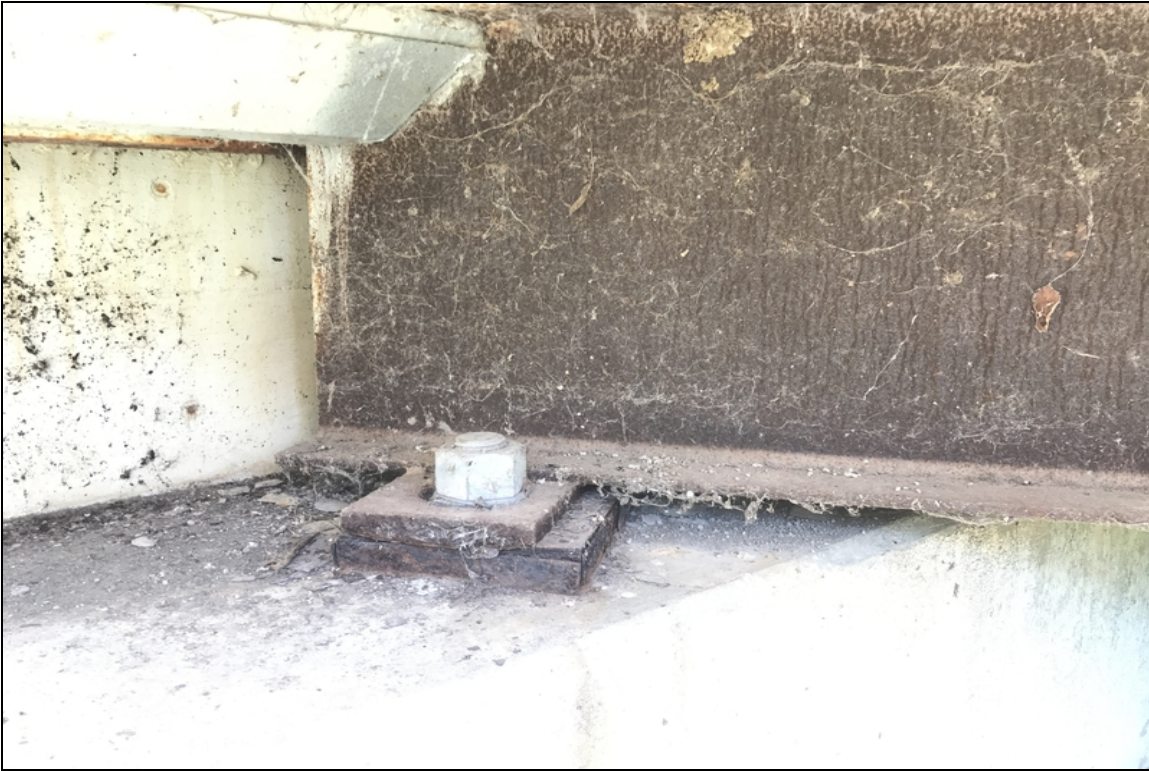
Bent 1 Rt

Expansion bearings at bents 1 and 4 have pack rust and some section loss.
Girders have areas of granular texture.

Concrete abutments and caps are in overall good condition.
Steel shell piling have areas of light freckled rust.
Pile encasement forms have rust and minor section loss near ground line.
Dirt is built up on bent 1 & 4 abutments.
Trees and brush under bridge and on channel banks.
