Bridge #03467(Routine)

SH 117-01- LM 1.40 over REEDS CREEK

Team Lead: James Adams Inspection Date: October 16, 2019

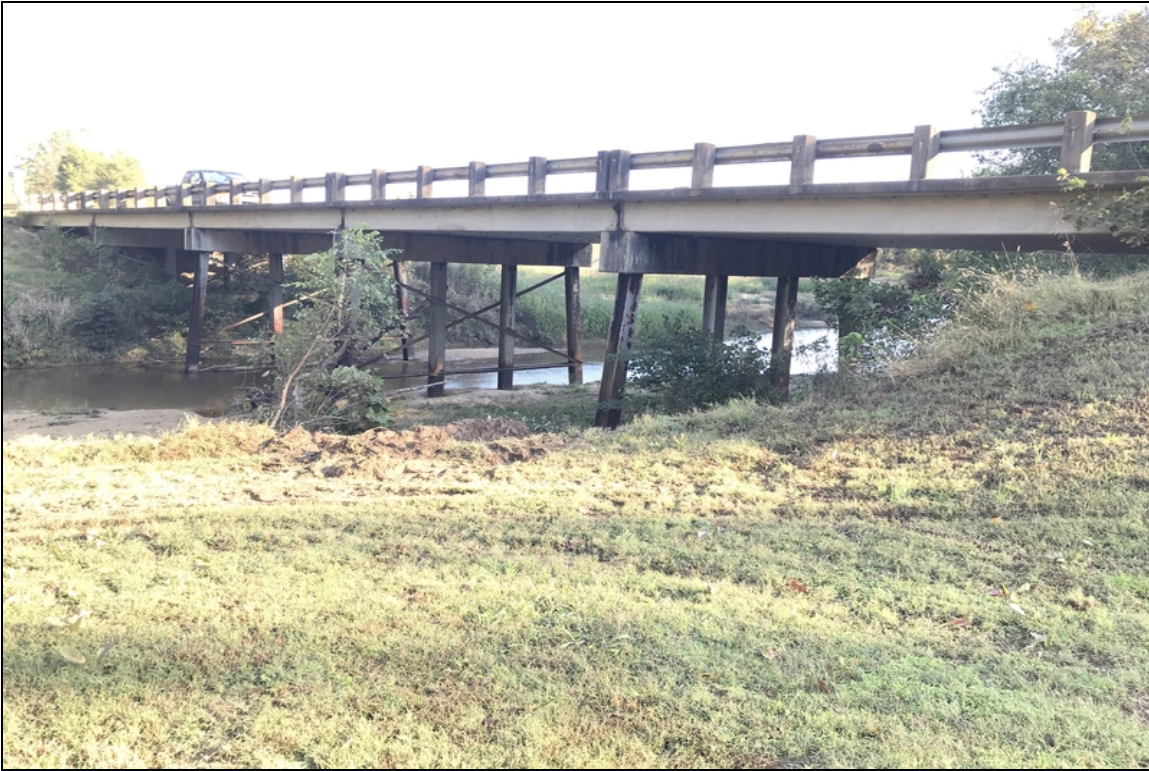
Bent 4 pile 4 2019

Steel piles have rust with areas of section loss at bottom of caps, at angle brace connections, and near ground line.

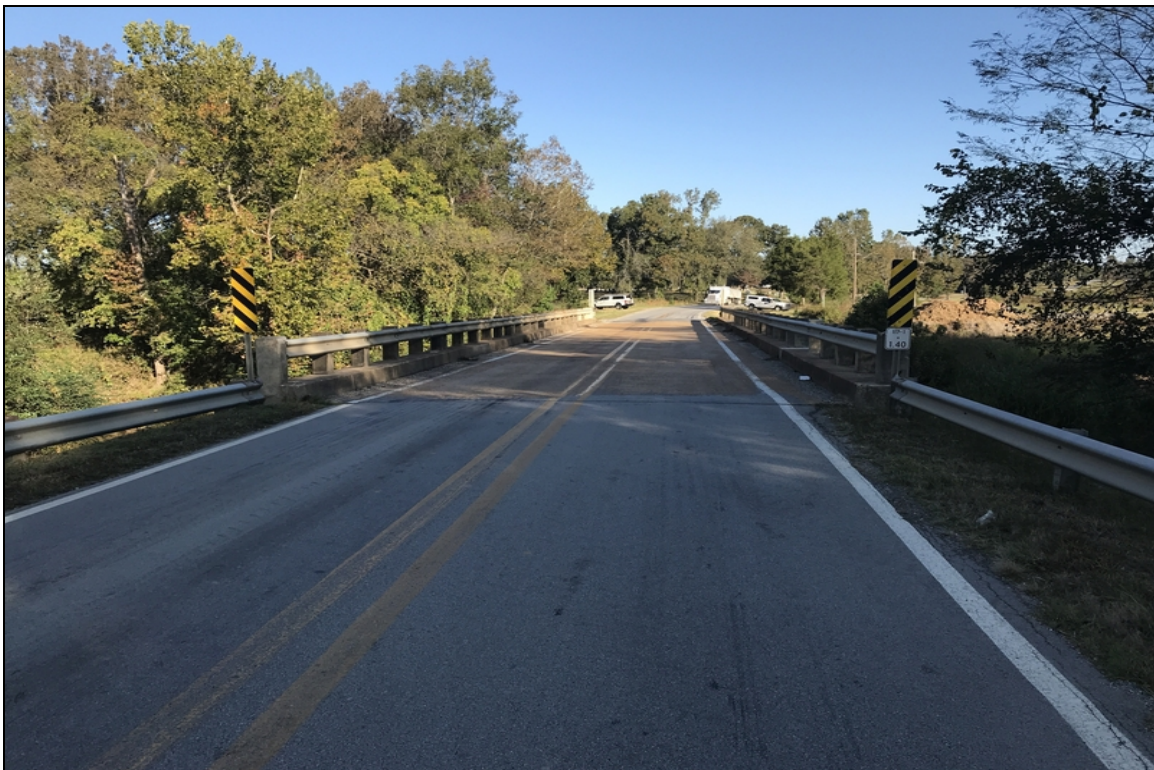
Span 5 LT SIDE over bent 5 2019

Span 5 left and right corners of slab are spalled over bent 5 cap. Left side is spalled with exposed rebar, see 2019 photo. Outside edge of slabs have horizontal cracking at all drain locations.
