Bridge #03468(Routine)

SH 117-01- LM 3.99 over BIG CREEK

Location: .22 MI S JCT SH 115 & 117

Team Lead: James Adams Inspection Date: October 16, 2019

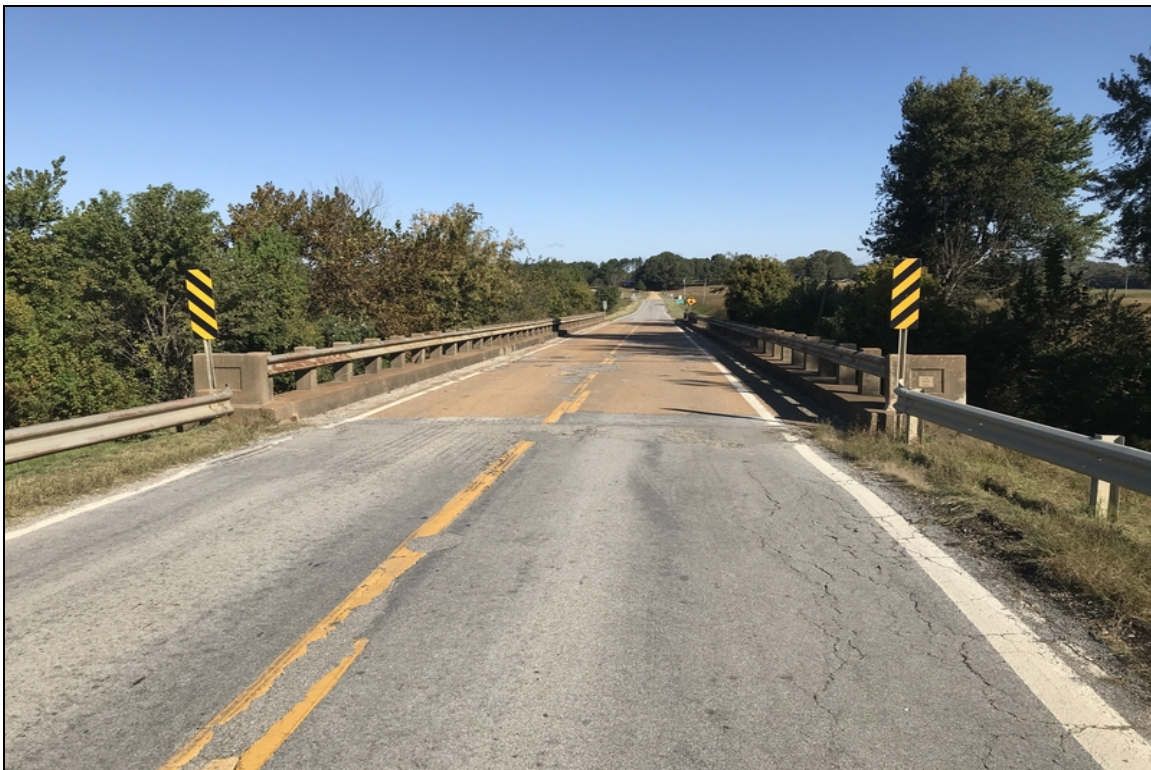
Roadway

Deck has several unsealed transverse cracks, delaminated areas, and spalls with some exposed rebar. Deck has several cracked and delaminated areas along edge of joint slide plates.
