Asset #B3162(Routine)

I 55-12NB-LM 63.28 over US 61-SEC 3

Location: JCT US 61 & I 55

Team Lead: Jacob Turner, Inspection Date: 06/15/2021

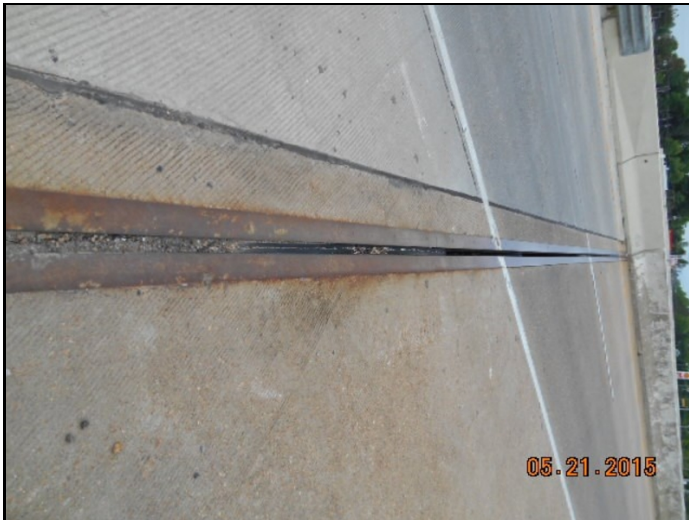
Bents 2 & 3 Compression Seal original seals have been replaced with a poured joint material in past.

Bents 2 & 3 Poured Joint Material seal is losing adhesion deteriorating and splitting allowing leakage thru joint.

B3162 05-21-2015 Bent 1 Compression seal
