Asset #A3166(Routine)

I-55-SB-12- 66.76 over SH 239 & RR

Location: 0.5 MI S SH 18

Team Lead: Richard Jones, Inspection Date: 11/03/2022

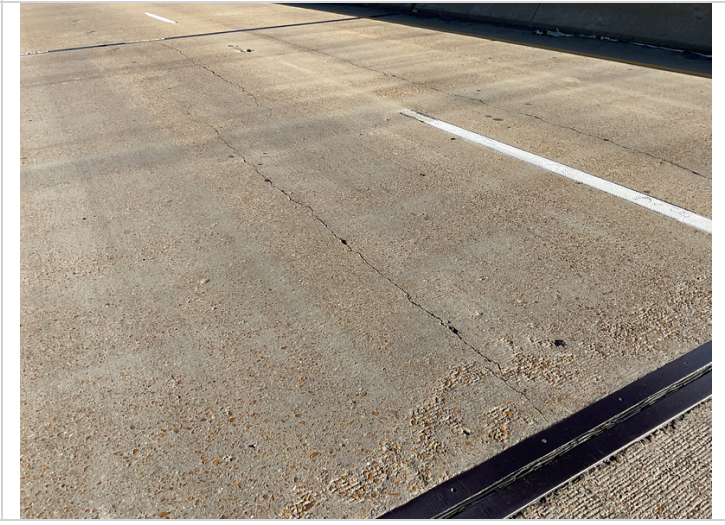
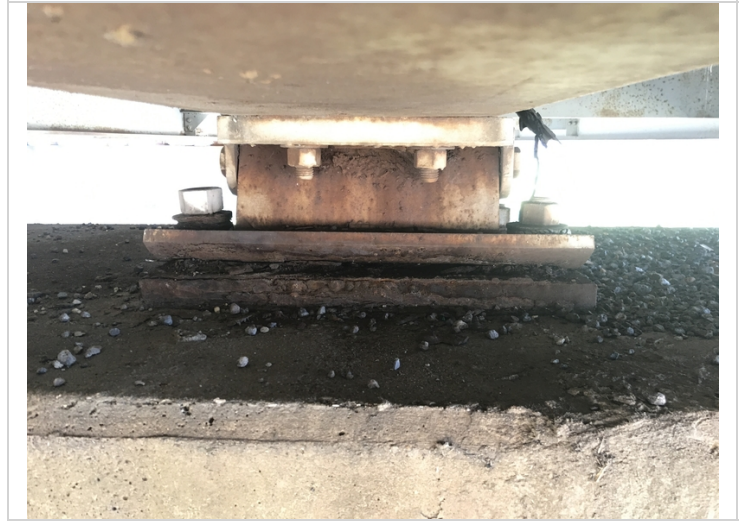
Main span 8

Main slab span at span 8 has several unsealed cracks.

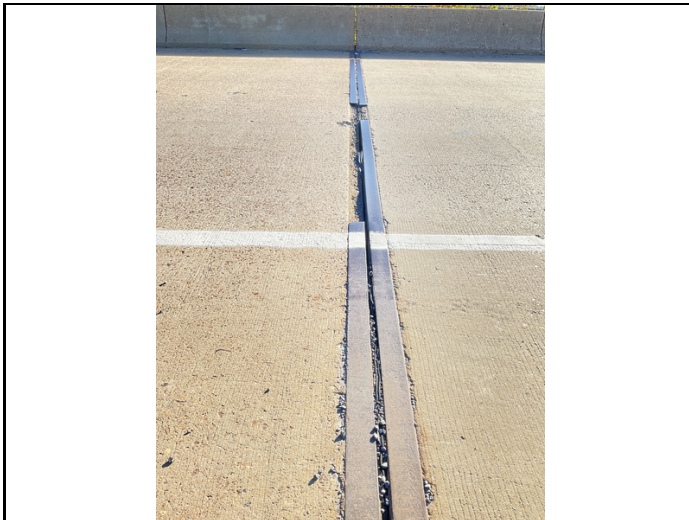
Bent 10

Compression seals have several areas that are ripped or torn and have several sections missing. Road irons have a few areas that are loose. Some have been partially removed at bents 2, 9, and 10.
