Asset #B3169(Routine)

I-55NB-12-LM 71.65 over PEMISCOT BAYOU

Team Lead: Richard Jones, Inspection Date: 04/04/2022

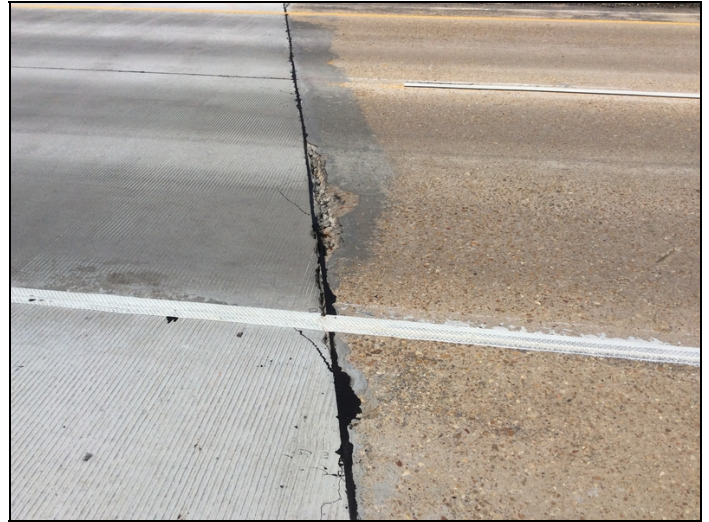
Bent 1 joint

Joint seals have loss of adhesion. Seals have a few torn areas. Deck adjacent to seals has a few spalls with rebar exposed.
