Bridge #03285(Routine)

CR 44/911=385 over I 55-SEC 12- Log 59.75

Location: 2.31 NO JCT SH 148

Team Lead: Tim Myrick Inspection Date: October 14, 2020

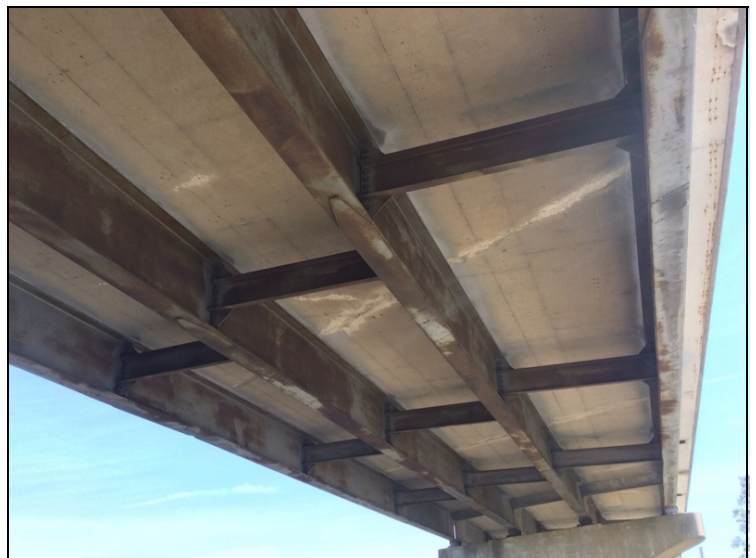
Steel Girders have been repainted by HBM. Span 2 girder 1 & span 3 girder 4 has a few minor areas of missing paint, see 2018 photo's. JFA/CWS

Span 2 Girder 1 is bowed in 3 to 4 inches due to collision damage, see 2014 & 2016 photos.
