Asset #02474(Routine)

SH 135-01-LM 15.09 over Right Chute Little River

Location: 2.12 Mi S Craighead CoLn

Team Lead: Tim Myrick, Inspection Date: 11/01/2022

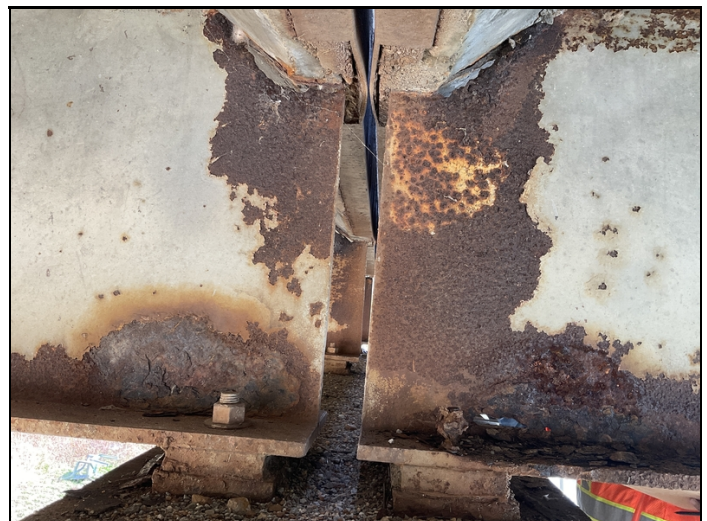
S14&13 b14 g3

Span 14 Bent 14 Girder 3 has an 8" x up to 2" hole in web below haunch.

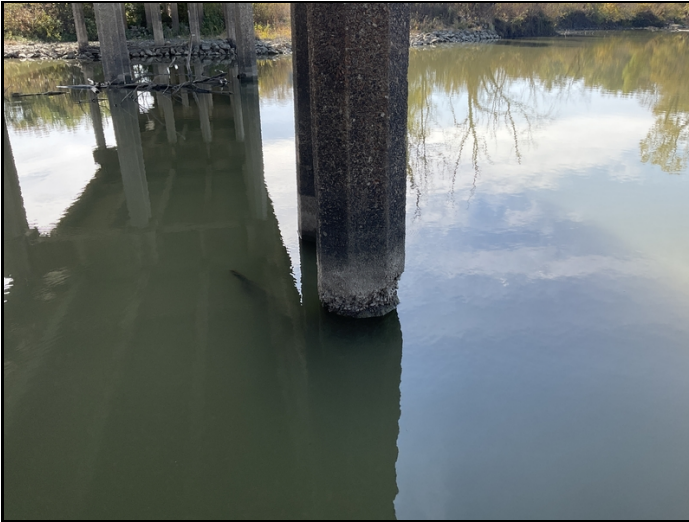
S10 b10 p1b

Bent 10 pile 1B span 10 side abrasion wear or delamination at WL, see photo.

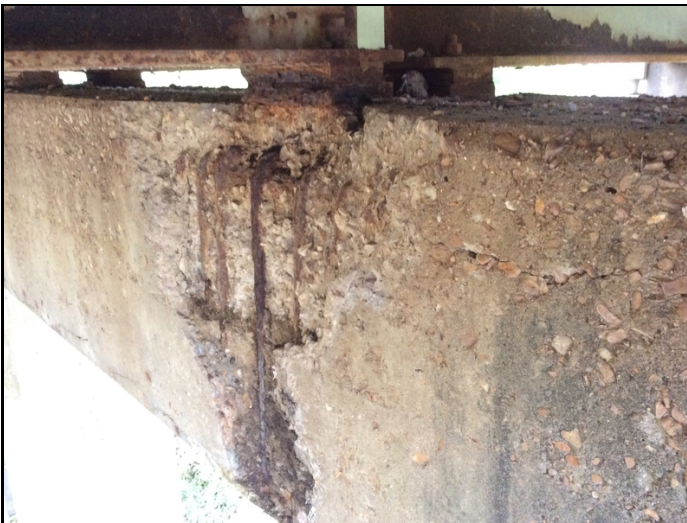
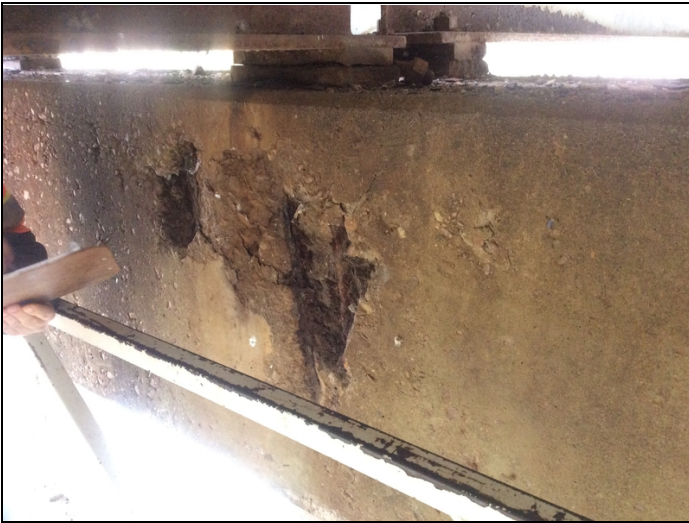
Most caps have cracked/delaminated areas and/or spalls with rebar exposed.

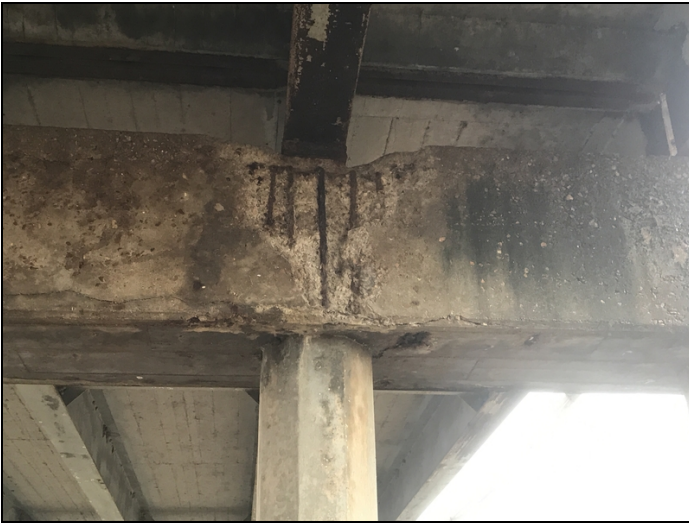
Bent 5 cap

Bent 5 Cap has a 3' x up to 8" deep spall under bearing 4 on span 4 side of cap. Cap has spalls on ahead side under bearings 3 and 4 on span 5 side with 10% loss of bearing area. Girder 3 is worse. Bearing pads have some loss of bearing area.

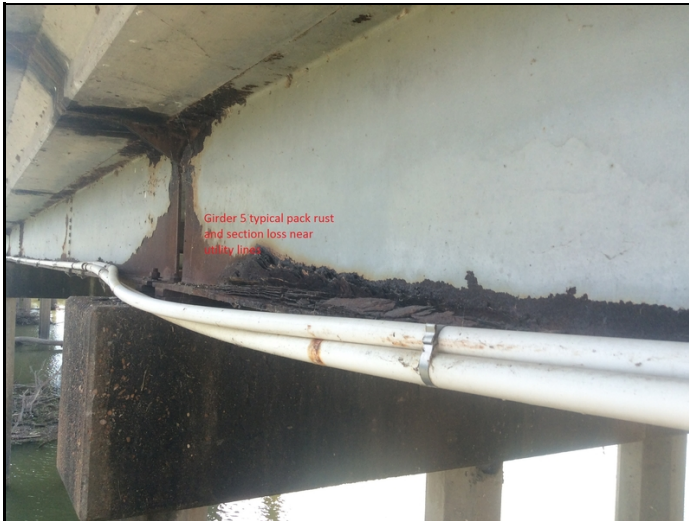
Span 11 girder 5

Several outside girders at haunch and web area has some out of plane bending due to pack rust, especially girder 5.

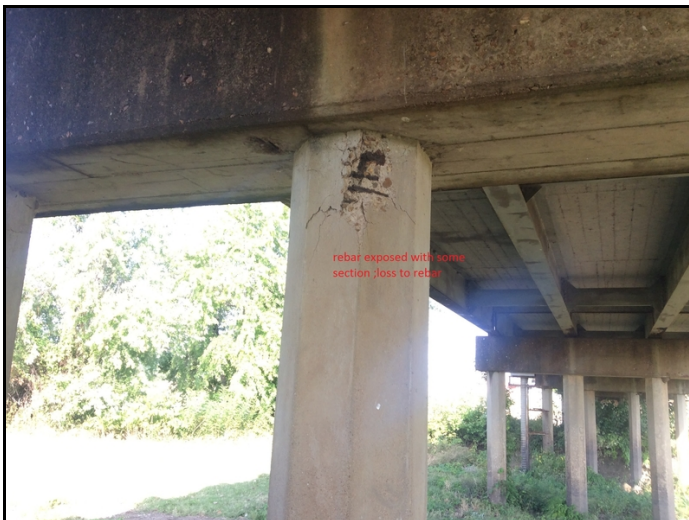
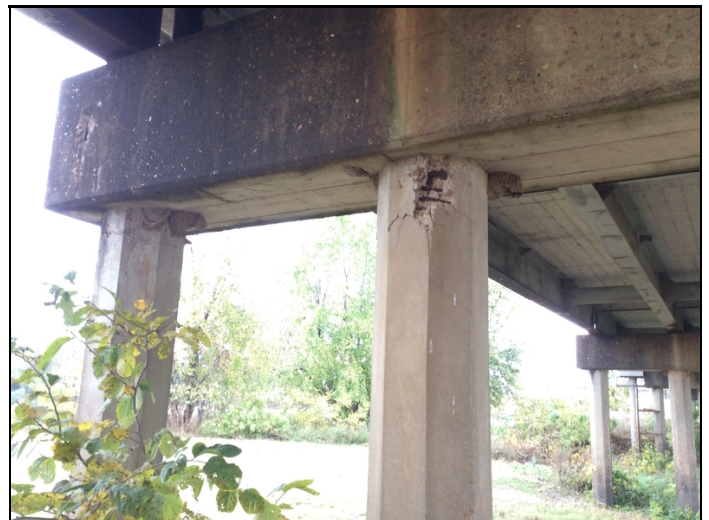
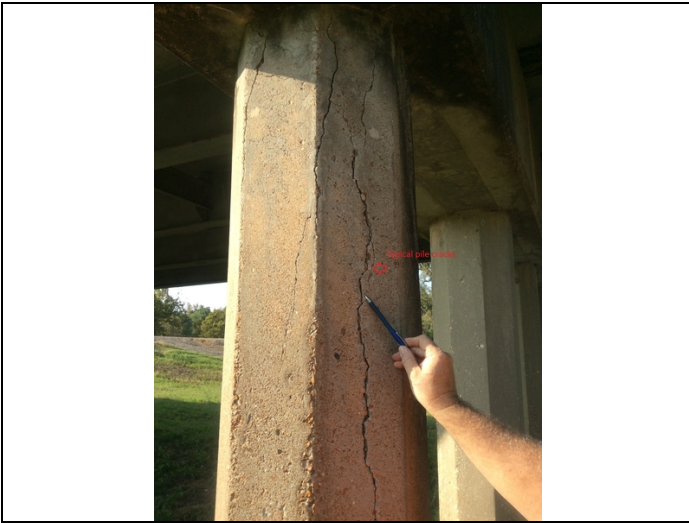
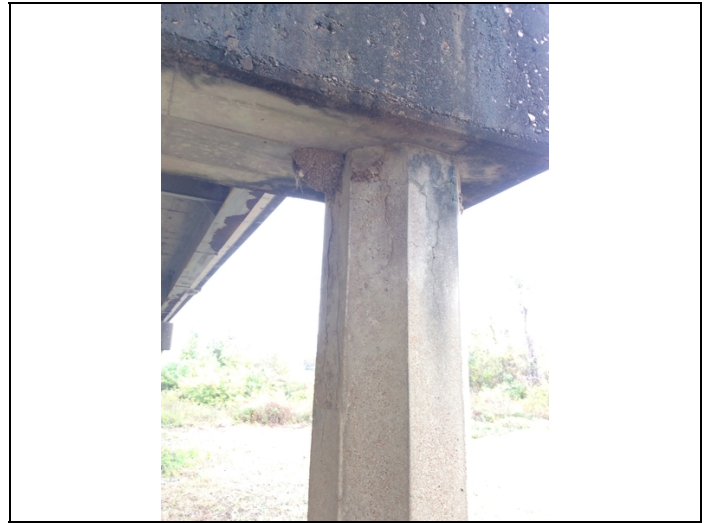
Several Piles have vertical cracks and delaminated areas near top of piles:

Bent 3 Pile 5 has 5 ft. cracked and delaminated area near top of pile, see 2017 photo.

Bent 4 Piles 1, 2, 3, and 5 have cracked and delaminated areas near tops of piles with rebar exposed to Piles 1&2, see 2017 photo.

Bent 14 Pile 5 has 3ft. cracks and delaminated area near top of pile.

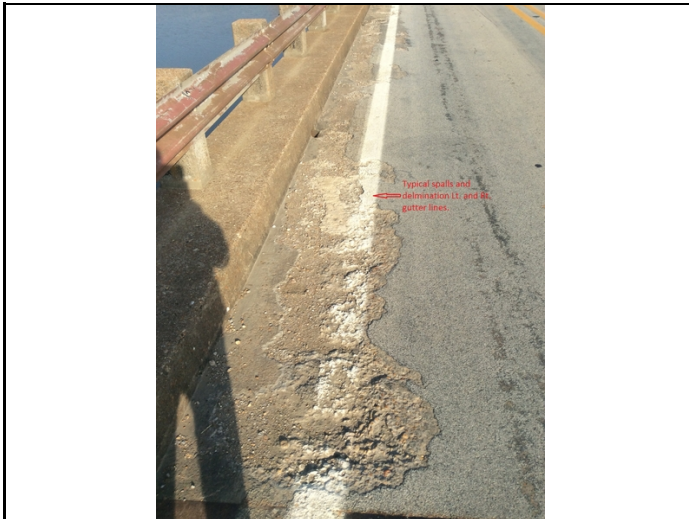
Lt and Rt gutters have areas of heavy scaling/spalls with some rebar exposed. Gutters have several patches in poor condition
