Asset #02884(Routine, Underwater type 2)
SH 135-01- LM 0.99 over DEAD TIMBER LAKE
Location: .99 MI N JCT OF US 63

Team Lead: Tim Myrick, Inspection Date: 04/07/2022

SH 135-01- LM 0.99 over DEAD TIMBER LAKE

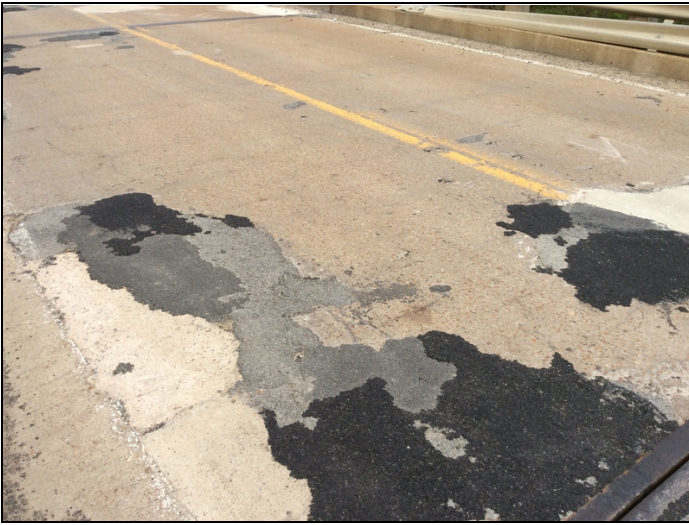
Span 4 & 5

Majority of deck is delaminated, spalled, patched, or cracked. Most patches are in fair to poor condition. Soffit has several areas of transverse and/or map cracking with efflorescence. Span 4 has 4' x 8' full depth patches in bays 3 and 4.
