Asset #02886(Routine)

SH 135-01-LM 6.03 over DITCH NO 47

Location: 3.0 MI N OF SH 118

Team Lead: Tim Myrick, Inspection Date: 09/19/2022

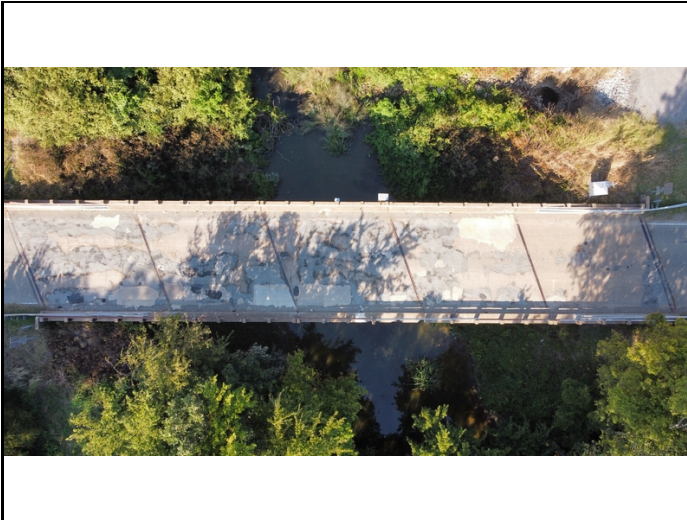
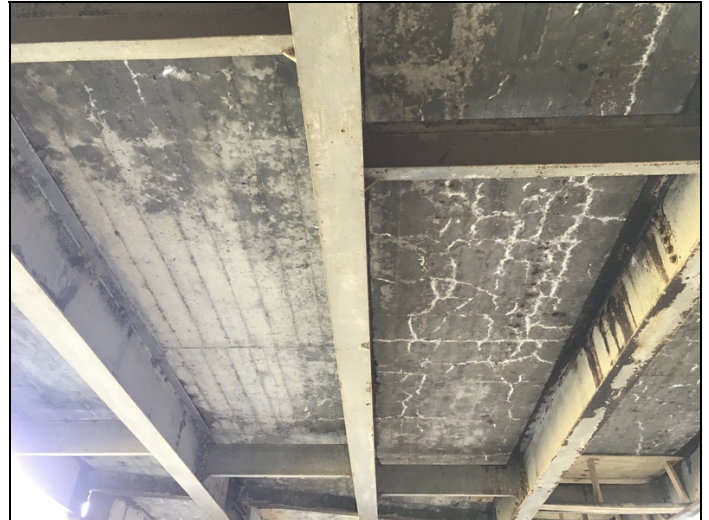
Span 2 Deck

Majority of deck has transverse cracks, large spalls, delaminated areas, and patched areas. Patches are in poor condition.
