Asset #02906(Routine)

SH 135-01-LM 15.60 over DITCH NO 4

Location: 1.65 MI S CRAIGHEAD CO

Team Lead: Tim Myrick, Inspection Date: 09/06/2022

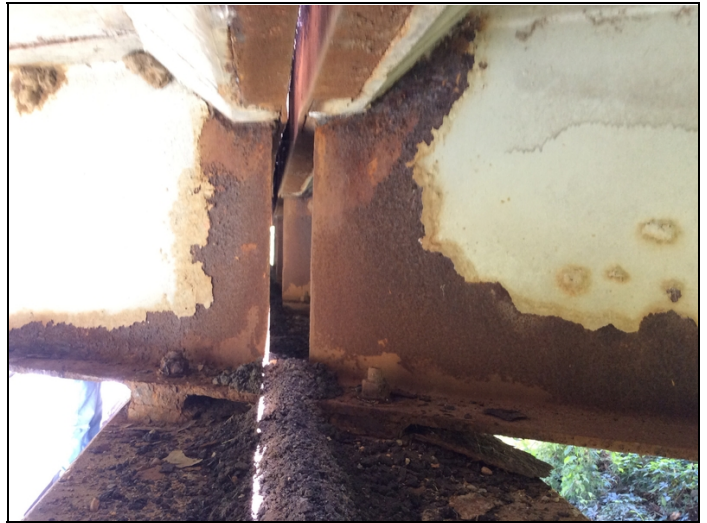
Span 5 bent 5 girder 3

***Span 5 bent 5 girder 3 has a 10" x 1" hole in web below haunch, and a 3.5" x 1" hole in bottom of web 7" from end of girder. Left bottom flange has heavy section loss with a 1" x 3" hole rusted through flange near bearing.

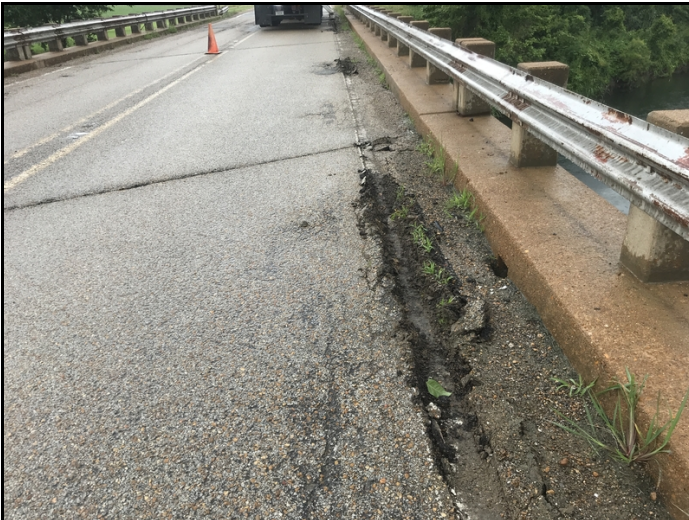
Wearing surface has several areas of map cracking and rutting along outside wheel path. Gutters have delaminated and spalled areas. Asphalt has a few patched areas. White line has path cut through it by snooper 2021.
