Asset #02907(Routine)

SH 135-02- LM 0.01 over DITCH NO 1

Location: POINSETT CO LINE

Team Lead: James Adams, Inspection Date: 11/14/2022

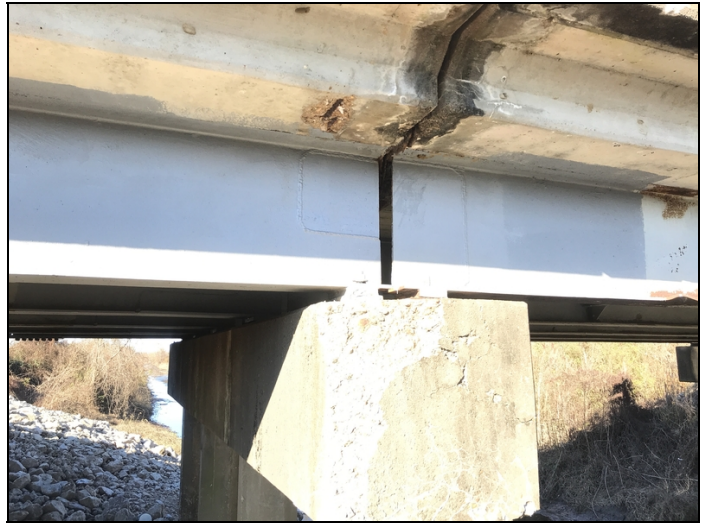
Girder 5 at bent 2

Girders have areas of section loss on ends over bents 3 and 4 and under drains. Several girders were repaired with T splices, and welded or bolted web plates in 2020. Bearings at T spliced locations are missing anchor bolts.
