Asset #02884(Routine, Underwater type 2)
SH 135-01- LM 0.99 over DEAD TIMBER LAKE

Location: .99 MI N JCT OF US 63

Team Lead: Tim Myrick, Inspection Date: 04/07/2022

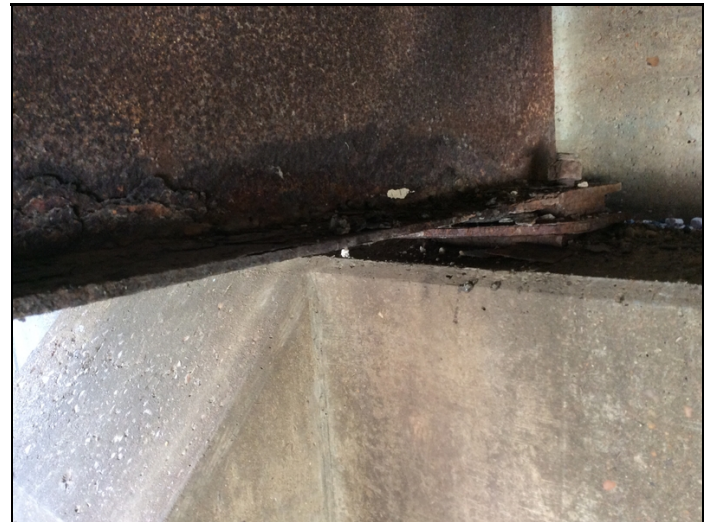
59 - Superstructure (5 - FAIR CONDITION - all primary structural elements are sound but may have minor section loss, cracking, spalling or scour.) Several girders have been repaired in the past with splices or plates welded over holes in web below haunch. Girders have areas of freckled rust on webs and along bottom flanges. Bearings have rust and section loss. Span 1 bent 1 girders 1 and 5 have splices at top of web 5' back from Bt.1 cap has rust with moderate section loss. Span 1 bent 1 girders 2 – 4 have been T-spliced. Span 1 bent 2 girders 1 and 5 have splices at top of web. Span 1 bent 2 girders 2 and 3 have plates welded over holes below haunch. Span 1 bent 2 girder 4 has been T-spliced. Span 2 bent 2 girders 1 and 5 have splices at top of web. Span 2 bent 2 girders 2 - 4 have been T-spliced. Span 2 bent 3 girders 1 and 5 have splices at top of web. Span 2 bent 3 girder 4 has plates welded over holes below haunch. Span 3 bent 3 girders 1 and 5 have splices at top of web. Span 3 bent 3 girder 2 has plates welded over hole below haunch. Span 3 bent 3 girders 3 and 4 have been T-spliced. Span 3 bent 4 girders 1 and 5 have splices at top of web. Span 3 bent 4 girders 3 and 4 have been T-spliced. Span 4 bent 4 girders 1 and 5 have splices at top of web. Span 4 bent 4 girder 3 has been T-spliced. Span 4 bent 5 girders 1 and 5 have splices at top of web. Span 4 bent 5 girder 3 has been T-spliced. Span 5 bent 5 girder 1 has 1' on end of web with section loss and some out of plane bending below haunch. Span 5 bent 5 girder 2 has a 4" x 1" hole in web below haunch. Span 5 bent 5 girder 3 has a 5" x 1" hole in web below haunch. Span 5 bent 5 girder 4 has a 4" x 1" hole in web below haunch. Span 5 bent 5 girder 5 has a 1' of heavy section loss on top half of web with a 8" x 2" hole in web below haunch. Span 5 bent 6 girder 1 has some section loss to web below haunch. Span 5 bent 6 girder 2 has a 12" x 1" hole in bottom of web 1' from end of girder. Right bottom flange has section loss near bearing (beginning to knife edge). 1' x 3" hole Left bottom flange has 3/16" remaining on edge of bottom flange. Hole in web below haunch has been filled with weld in the past. Span 5 bent 6 girders 3 and 4 have been T-spliced. Span 5 bent 6 girder 5 has 2' of 1/8" section loss along bottom of web 2.5' from end 1" x 4" hole in web at web near bottom flange 3' back from Bt.6.
