Asset #02886(Routine)

SH 135-01-LM 6.03 over DITCH NO 47

Location: 3.0 MI N OF SH 118

Team Lead: Tim Myrick, Inspection Date: 09/19/2022

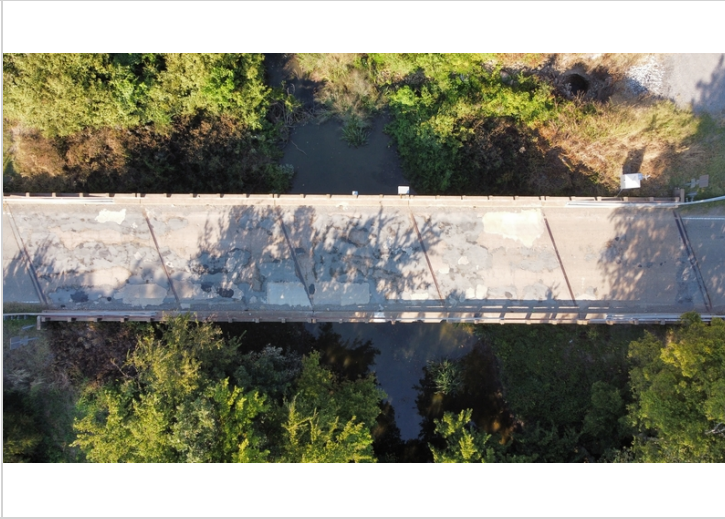
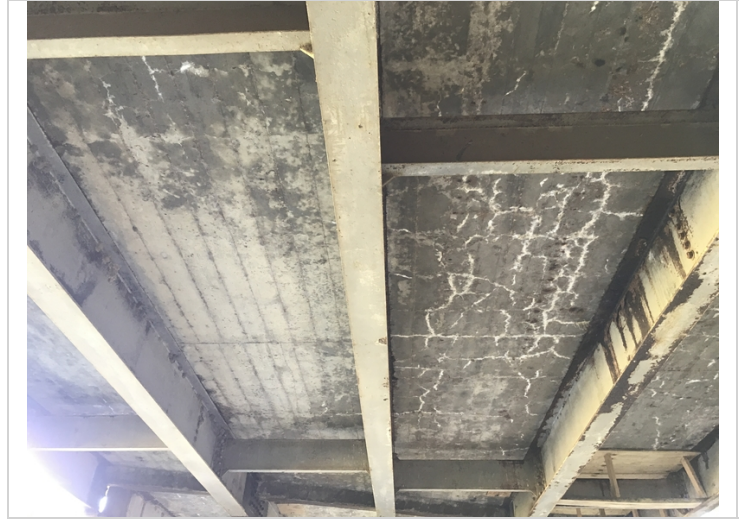
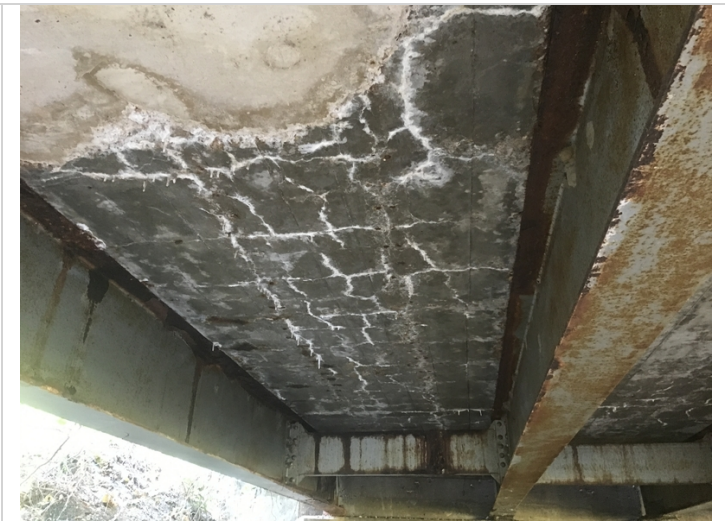
S1 b1 g5

Ends of girders that have been repaired at haunch or bottom web with T- splice/haunch plate.
1-2' typical ends of girders have been painted.
Span 1 bent 1 girder 2 Old t-splice has section loss.
Span 1 bent 1 girder 3 & 4 has old t-splice with section loss.
Span 5 bent 6 girders 2, 3, & 4 has been t-spliced in the past, t-splice has section loss.
Several bearings have pack rust and section loss.
Majority of anchor bolts are rusted with section loss, several are rusted off:
Span 3 bent 4 girders 1, 3, and 4 - (floating with 1/4 in. gap at bearing)
Span 4 bent 5 girders 1, 3, and 4 - (floating with 1/16in. gap at bearing).

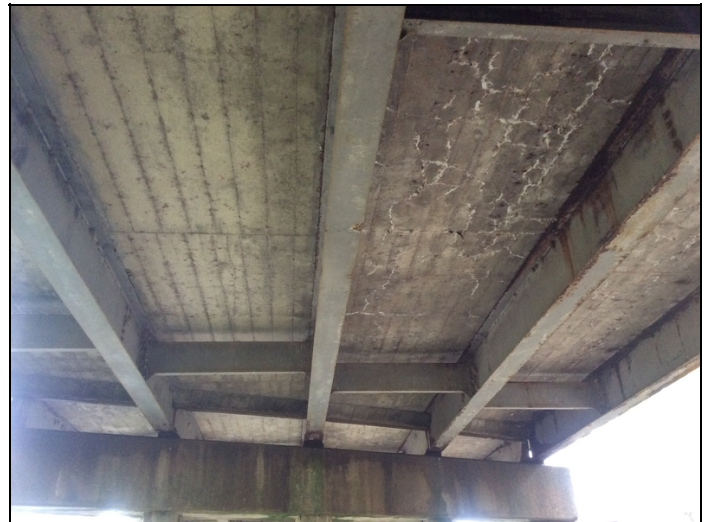
EFFLORESCENCE

Caps have moderate cracking with some efflorescence.
Bents 1 & 6 caps have dirt buildup on top of caps.
Bent 2 cap has some cracks with efflorescence.
Bent 4 pile 1 has some cracks near the bottom of cap.
Left and right Ends of bent 4 cap is spalled with heavy cracking, efflorescence and exposed rebar.
Left end of bent 5 cap is spalled with heavy cracking, efflorescence and exposed rebar.
Bent 5 cap span 4 side has two 1' areas with exposed rebar over piles 3 & 4.
