Bridge #01111(Routine, Underwater type 2)

Us-70/Sec-17/L5.25 over Bayou Devieu River

Team Lead: Myron Futrell Inspection Date: April 14, 2020

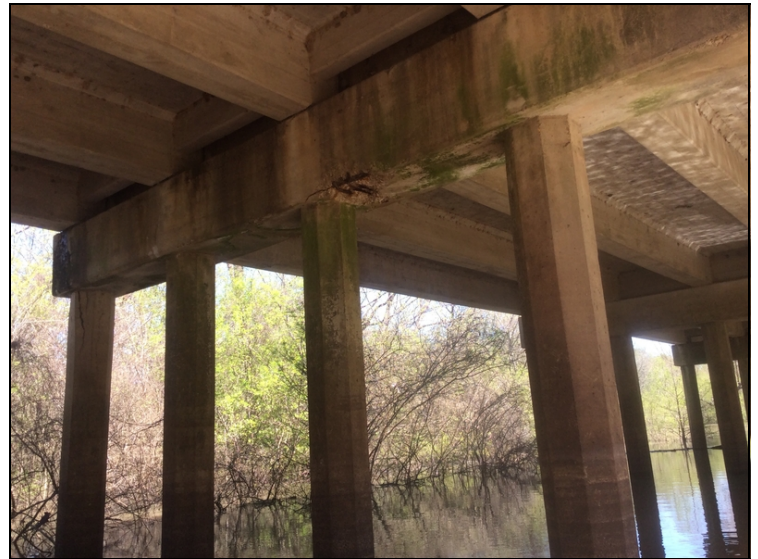
Bent 3 cap back face.

Bent #3 cap back face left end corner spalled off no rebar exposed.

Bent #3 cap back face 6" from top has longitudinal crack between girders #1 through #4.

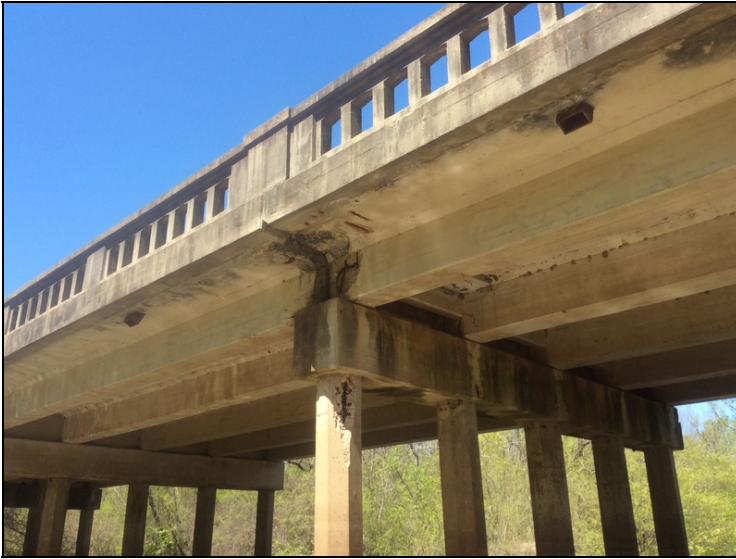
Span #4 girder #5 at bent #5.

(110)							
<p>All girders have hairline vertical cracks spaced two feet apart.</p> <p>Span #1 girder #5 has 2' delamination at abutment #1.</p> <p>Span #4 girders #4,5 at bent #5 both have a 2' spall at bearing with exposed rebar with no section loss.</p> <p>Span #5 girder #5 at bent #5 has a 1' spall on left side with exposed rebar no section loss.</p> <p>Span #6 girder #5 at bent #7 last one foot bottom of girder is spalled with exposed rebar with 20% section loss.</p> <p>Span #7 girder #5 at bent #7 has a 2' spall on right side at bearing with rebar exposed with 20% section loss.</p> <p>Span #7 girder #2 at bent #7 has a 3' spall with 1' exposed rebar with 20% section loss on left side.</p> <p>Span #7 girder #4 at bent #7 has a two foot spall with 1' exposed rebar with 20% section loss on right side.</p> <p>Span #7 girder #1 at bent #8 has vertical 1/32" wide crack on left side.</p> <p>Span #8 girders #1,4 at bent #9 each are cracked at bearing with a one foot delamination.</p> <p>Span #9 girder #5 at bent #9 is cracked and delaminated at bearing for one foot.</p> <p>Span #10 all girders at bent #11 each have a one foot spall on end with exposed rebar with 10% section loss.</p> <p>Span #11 girders #1,2,3,4 at bent #11 each have a two foot spall on end with exposed rebar with 10% section loss.</p> <p>Span #12 girder #1 first ten feet from bent #12 has delamination.</p> <p>Span #12 girder #2 has 1/32" crack across bottom and up sides two feet from bent #12.</p> <p>Span #12 girders #3,4 at bent #12 each have a one foot spall.</p> <p>Span #13 girder #1 at bent #13 is cracked and delaminated on left side for one foot.</p> <p>Span #13 girder #4 at bent #13 has a 2' spall on right side bottom corner with exposed rebar with 5% section loss.</p> <p>Span #13 girders #1 and 5 at bent #14 has a 1' spall on left side with exposed rebar with no section loss.</p> <p>Span #14 girder #1 has a two foot delamination three feet ahead of bent# 14 on right side.</p> <p>Span #14 girders #4,5 at bent #15 each have a one foot spall with exposed rebar with 20% section loss.</p> <p>Span #15 girders #1,3,4,5 at bent #15 first foot is cracked, delaminated, and spalled with exposed rebar with 10% section loss.</p>
