Asset #M3876(Routine)

Sh-50/Sec-4/L-8.42 over Ditch Number 9

Location: 8.42 Mi Ne Of Jct Us 64

Team Lead: Drew Melton, Inspection Date: 04/11/2023

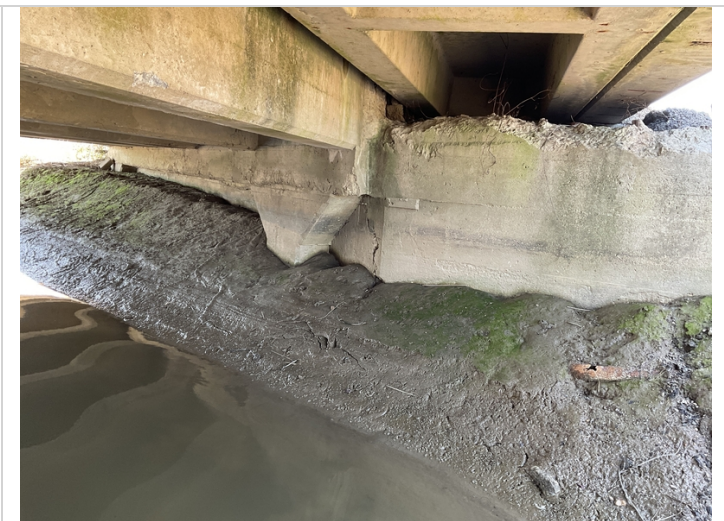
ELEMENTS	DESCRIPTION	UNITS	TOTAL	CS1	CS2	CS3	CS4
(216) Timber is cracked and weathered Abutment #1 right and left timber caps are decayed on top with 30% section loss. Abutment #2 left timber cap is decayed on top with 15% section loss.							
228	Timber Pile	EA	8	0	8	0	0
1160	Crack (Timber)	EA	8	0	8	0	0
(228) All timber piles are cracked vertical and weathered. Timber piles have unknown depth or length.							
234	Reinforced Concrete Pier Cap	LF	51	51	0	0	0
(234) Bent #2 cap back face has 2' of delaminated areas between girders #3,4.							
235	Timber Pier Cap	LF	17	0	8	9	0
1140	Decay/Section Loss	LF	9	0	0	9	0
1160	Crack (Timber)	LF	8	0	8	0	0
(235) All timber caps have cracks, splits, and weathering. Abutment #1 right and left timber caps are decayed on top with 30% section loss. Abutment #2 left timber cap is decayed on top with 15% section loss.
