Asset #03832(Routine)
Sh-357/Sec-1/L5.38 over Drainage Ditch #20

Location: 5.38 Miles North Sh 50

Team Lead: Myron Futrell Inspection Date: 01/11/2024

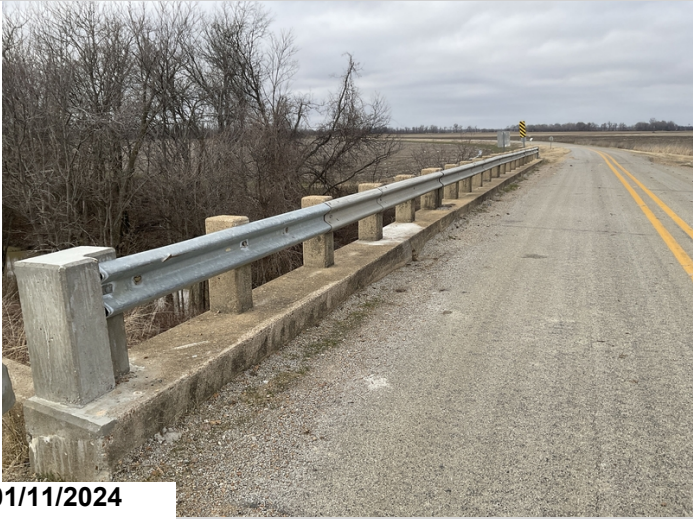
Left bridge rail

ELEMENTS	DESCRIPTION	UNITS	TOTAL	CS1	CS2	CS3	CS4
(301) Joints are overlaid with asphalt.							
330	Metal Bridge Railing	LF	224	218	0	6	0
7000	Damage	LF	6	0	0	6	0
515	Steel Protective Coating	SF	672	672	0	0	0
(330) Abutment #2 right end post has collision damage and is broken at base with exposed rebar with no section loss. Attached #2 left end post broken loose at bottom with exposed rebar. Span #4 left side 2nd post from bent #4 is broken at base.

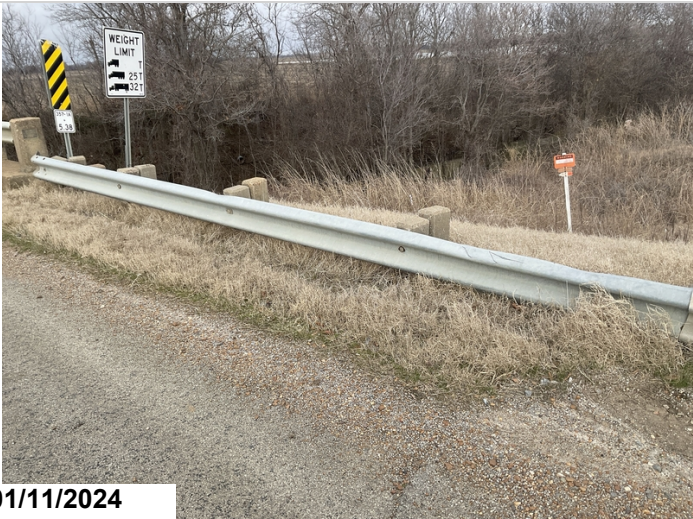
Abutment #1 right approach rail

Last approach rail post misaligned and loose alignment abutment #1 right side

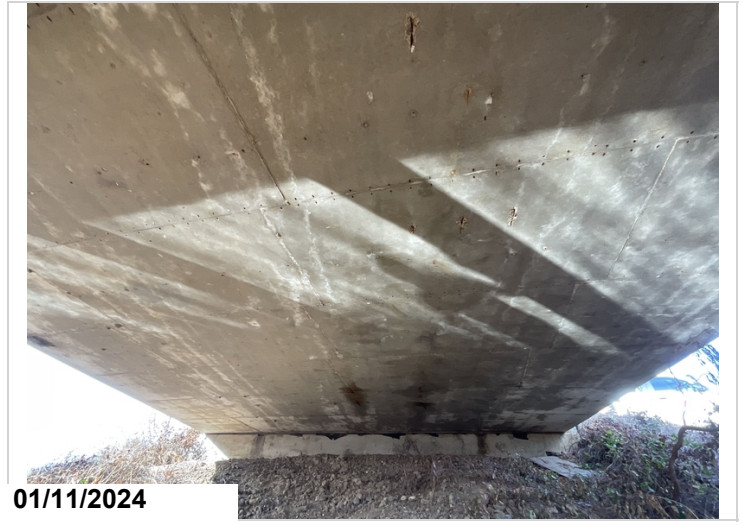
Span #4 soffit / underside of deck

Superstructure is a voided slab with an ACHM overlay and is in overall good condition. Sides of slab have vertical hairline cracks spaced at roughly 8" to 12". Soffit / underside of slab has multiple CS2 longitudinal and transverse cracks each span, some with efflorescence and rust staining.

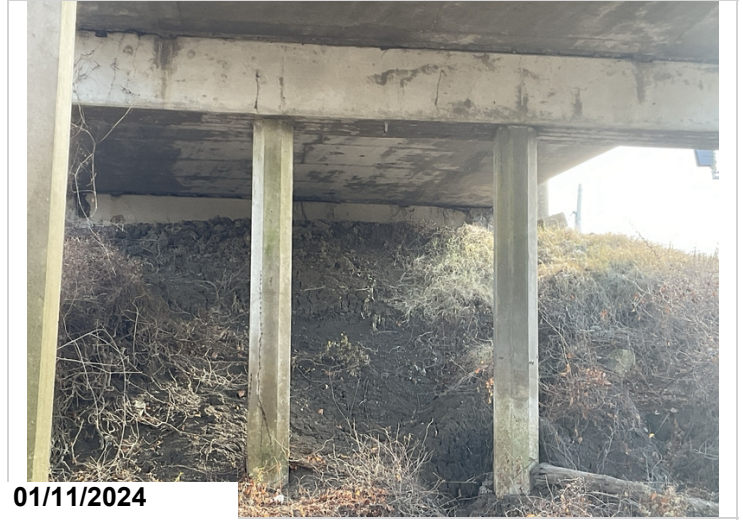
Bent #2 ahead face

(234) Bent #2 cap ahead face right side above pile #4 at top has a 1' delamination. Bent #2 cap bottom face has 1' of exposed rebar moderate section loss between piles #2,3 and by pile #4 due to poor concrete coverage each. Bent #3 cap back face has a 1' crack with delamination above pile #3 at top. Bent #3 cap ahead face has a 1' spall on left above pile #1 and 3' of cracks with delamination. Bent #3 cap both sides on bottom have several 1' spalls with rebar exposed moderate section loss. Bent #4 cap back face has a 1' spall with exposed rebar 1' from right side at top no section loss. Bent #4 cap bottom face has 1' spall with exposed rebar moderate section loss between piles #1,2 and four small delaminated areas above pile #2.							
301	Pourable Joint Seal	LF	144	22	0	122	0
2350	Debris Impaction	LF	122	0	0	122	0

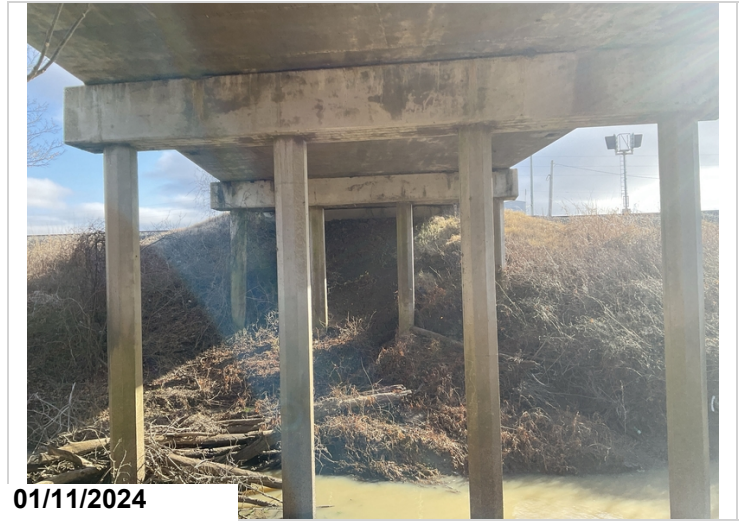
Bent #3 ahead face

(227) Bent #3 piles have light scaling with no loose aggregate on bottom 3'.							
234	Reinforced Concrete Pier Cap	LF	84	67	0	17	0
1080	Delamination/Spall/Patched Area	LF	5	0	0	5	0
1090	Exposed Rebar	LF	8	0	0	8	0
1130	Cracking (RC and Other)	LF	4	0	0	4	0

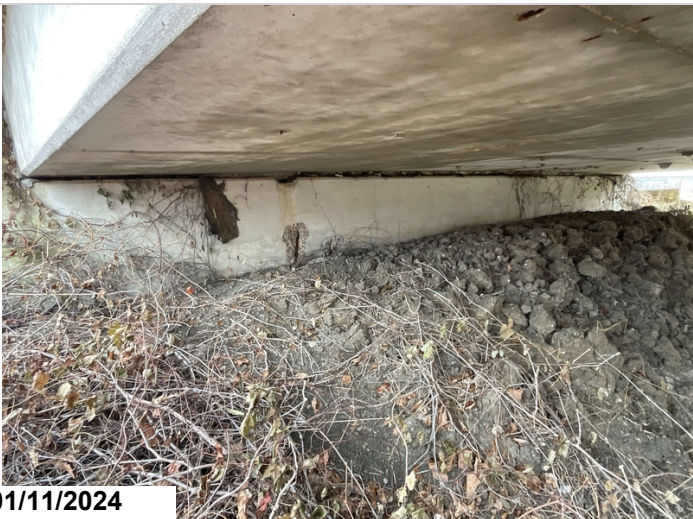
(215) Abutment #1 cap right side has 1' spall with exposed rebar with moderate section loss. Abutment #1 right wing has spall with one foot of exposed rebar.							
227	Reinforced Concrete Pile	EA	12	8	4	0	0
1190	Abrasion/Wear (PSC/RC)	EA	4	0	4	0	0

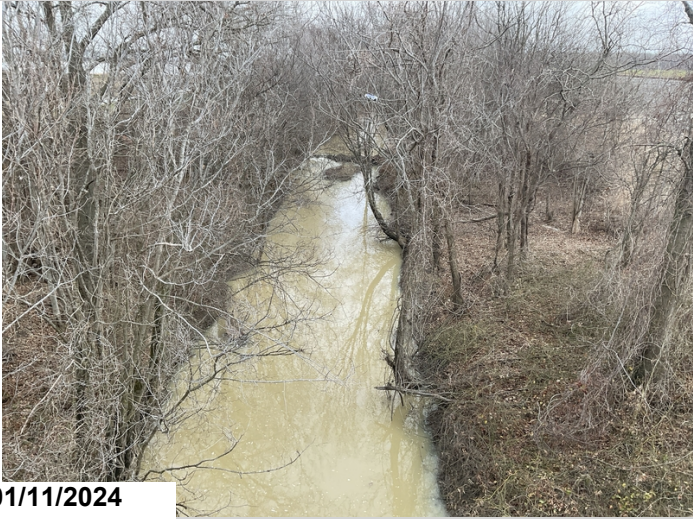
Channel right side

61 - Channel/Channel Protection (6 - Bank is beginning to slump. River control devices and embankment protection have widespread minor damage. There is minor stream bed movement evident. Debris is restricting the channel slightly.) Channel is in overall satisfactory condition. Channel alignment is good, trees and brush restrict channel slightly. There is a moderate drift in channel at bent #3. Banks are slumping and not well vegetated.
