Asset #m3912(Routine)

Sh-75/Sec-00/L4.66 over Creek

Location: 4.0 Mi No Of Jct Sh 50

Team Lead: Myron Futrell Inspection Date: 08/22/2024

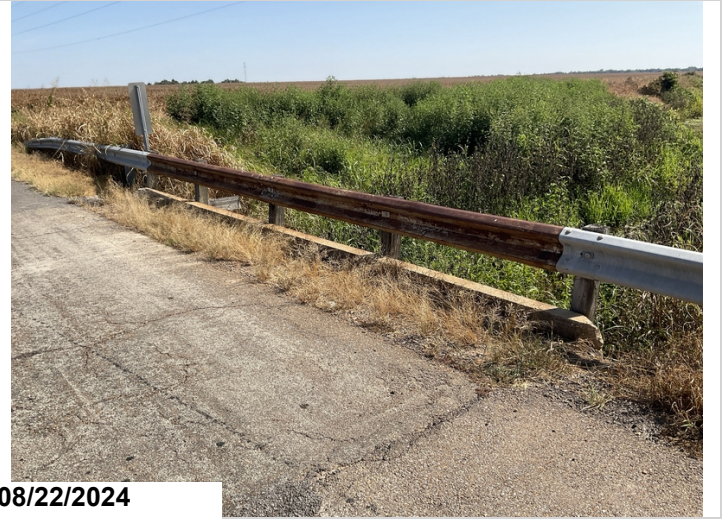
Bridge rail, right side

(330)	Bridge rails, full length: surface rust very limited paint left with little to no section loss.	Corrosion 46LF	CS3				
Bridge rail, left side:	not connected to last rail post.	Connection 1LF	CS4				
Left rail rocked back and rail post spacers and split and decayed.	Connection 5LF	CS3					
Steel protective coating, full length:	paint system failing.	Effectiveness 165SF	CS4

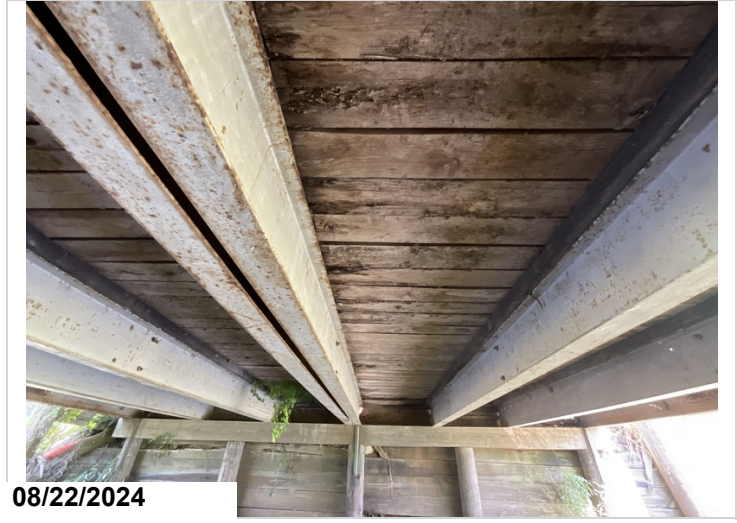
Undersurface of deck

Deck appears to be in overall satisfactory condition, top of deck has achm overlay, underside of deck is mostly covered with timber and is only visible in areas where timber has completely decayed. Overlay has transverse and longitudinal cracking and curbs are heavily scaled and spalled on ends with some exposed rebar. Gutters have dirt, debris and vegetation in them. Timber sub deck / stay in place forms have areas over exterior girders and at bridge ends with 100% section loss due to decay.
