**Bridge #01374(Routine, Underwater type 2)**

**Us-70/Sec-19/L18.9 over Drainage Canal**

**Location: 1.00 Mi Sw Jct Of Sh 149**

**Team Lead: Myron Futrell Inspection Date: January 13, 2020**

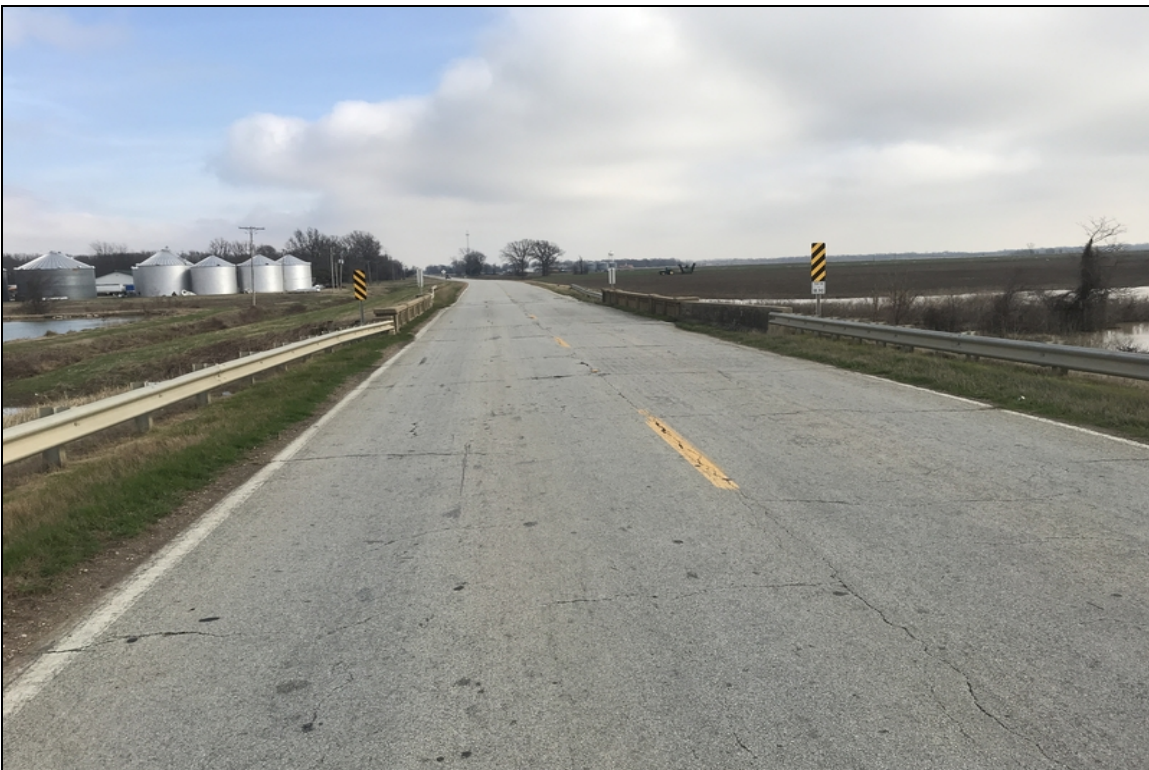
Top view.

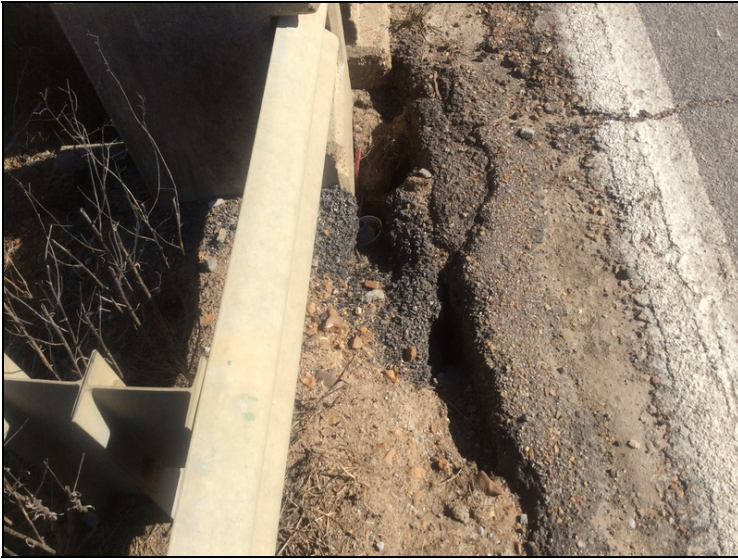
Approach rails abutment #1 right side and abutment #2 both sides have minor collision damage.

Abutment #2 right approach rail minor damage
