Bridge A3732 Inspection Report

Asset #A3732(Routine, Underwater type 2)

I-40WB/Se43/217.76 over Piney Ditch

Team Lead: Myron Futrell Inspection Date: 12/19/2024

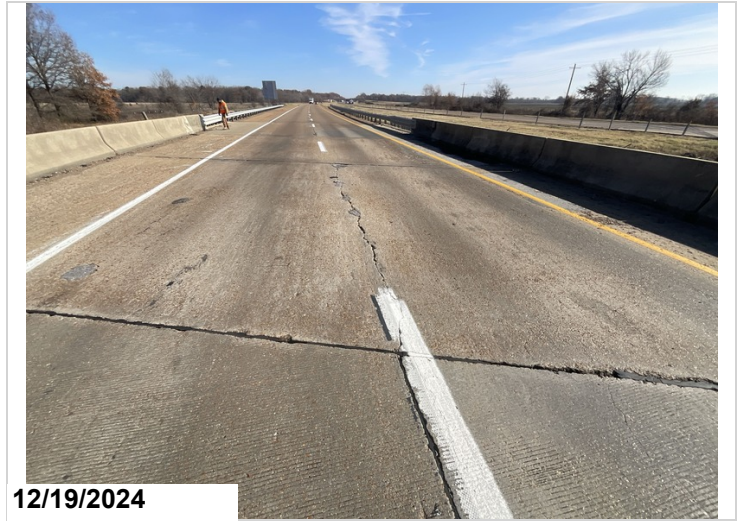
Span 1, deck

Reinforced concrete voided slab deck is in overall fair condition. Top of deck has unsealed longitudinal cracking, and abrasion full length. Undersurface of deck has a large, delaminated area span 1 with cracking, some having rust staining or efflorescence each span.

Deck has multiple sealable cracks.

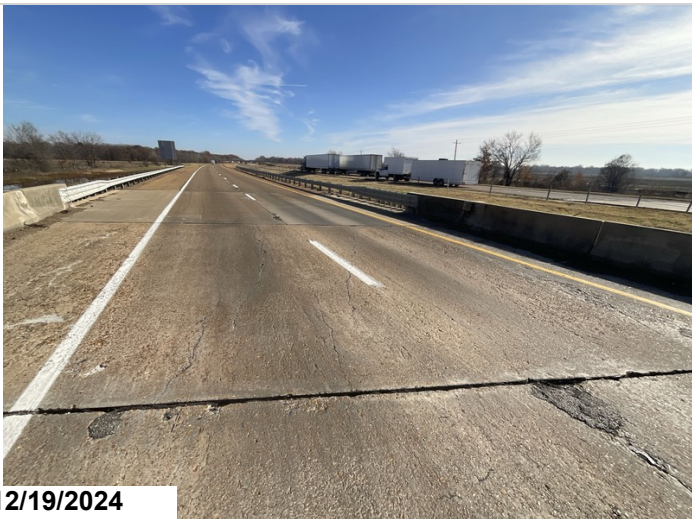
Span 2, deck

Deck has numerous longitudinal cracks, and areas of heavy scaling.

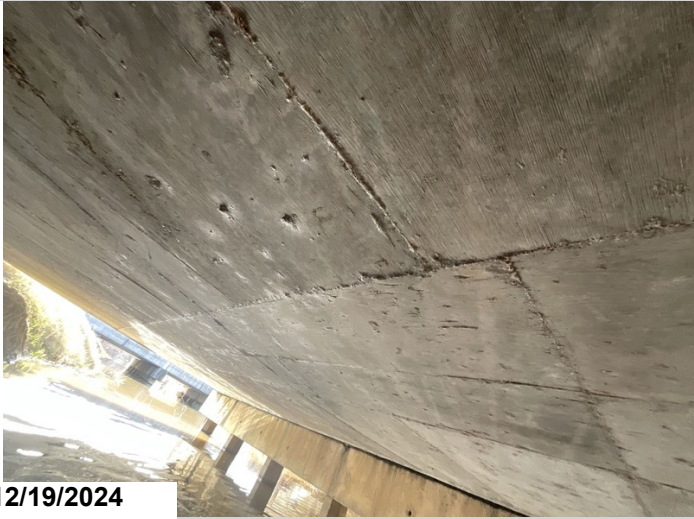
Span 2, undersurface of deck

Reinforced concrete voided slab superstructure is in overall fair condition. Top of deck has unsealed longitudinal cracking, and abrasion full length. Undersurface of deck has a large, delaminated area span in span 1 with cracking, some having rust staining or efflorescence, both spans.

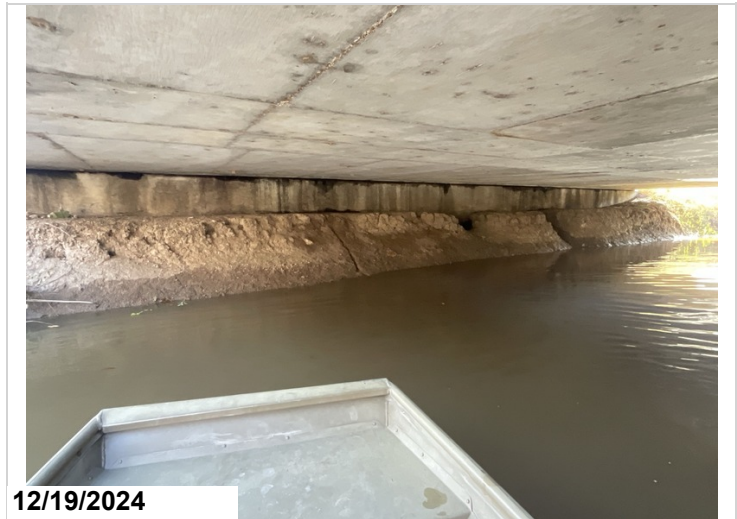
Abutment 2

Abutment 2, by pile 3: large animal hole under cap exposing pile 3 up to 1'.

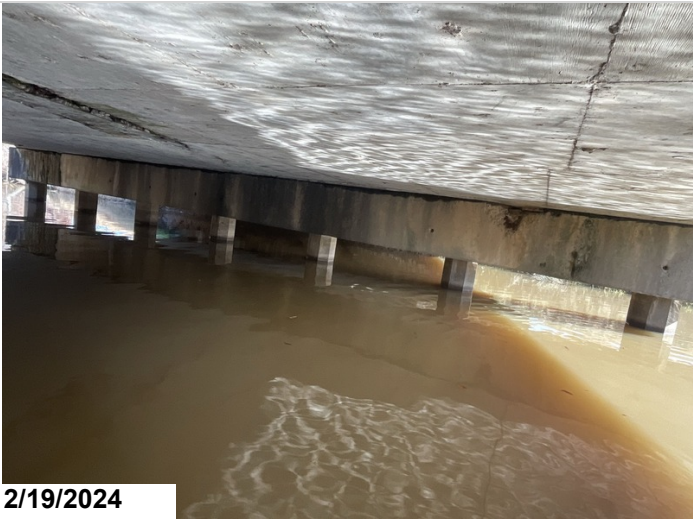
Bent 2, back

Reinforced concrete substructure is in overall fair condition. Abutment 1 cap has minor erosion. Bent 2 cap has a moderate spall with no exposed reinforcing steel and bent 2 piles have minor abrasion.

Bent 2, pier cap, back, between piles 6 and 7, at top: spalled with no exposed reinforcing steel.

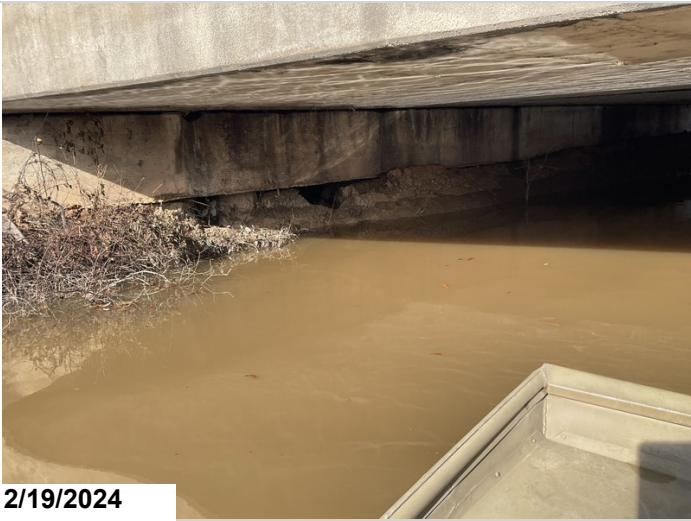
Abutment 1

Abutment 1, right side: cap undermined 6' up to 2' deep exposing pile 6.

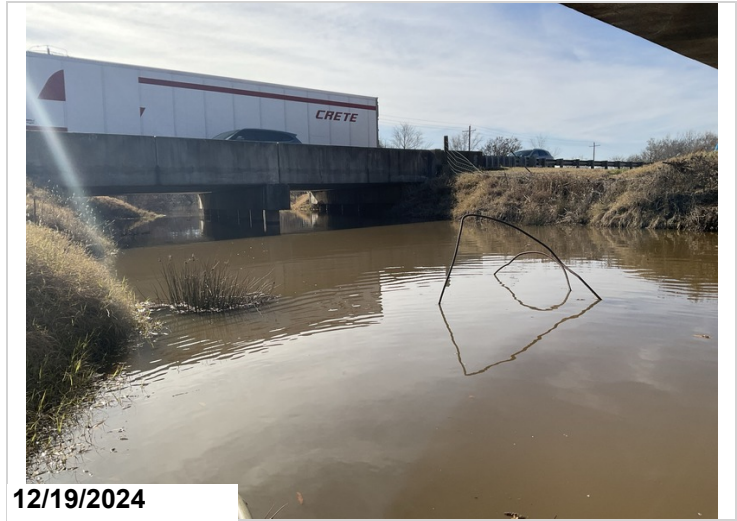
Channel, right side

61 - Channel/Channel Protection (5 - Bank protection is being eroded. River control devices and/or embankment have major damage. Trees and brush restrict the channel.)

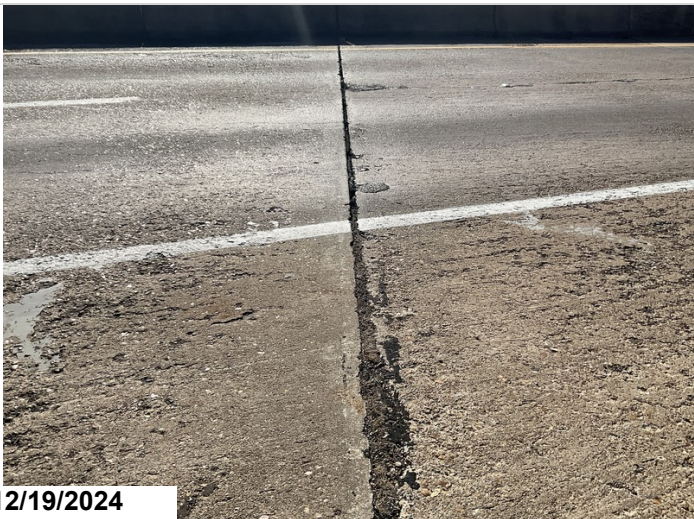
Bent 2, joint

Joints have areas of missing or damaged material.

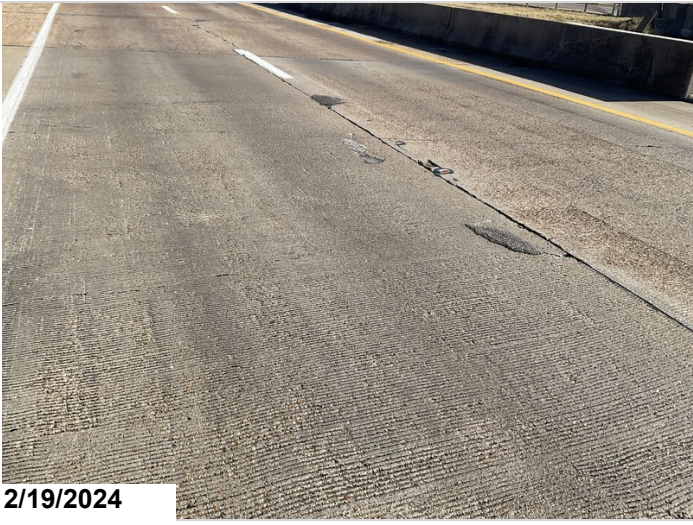
Abutment 1, approach slab

Approach slabs: moderate sized open cracks.

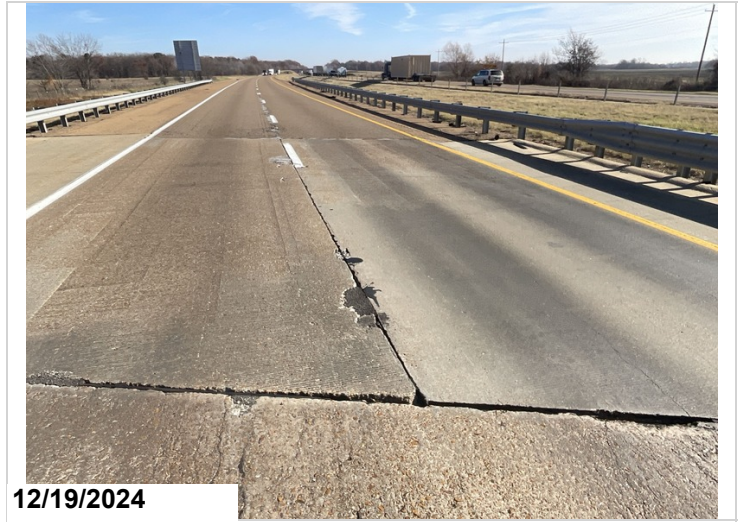
Abutment 2, approach slab

ELEMENTS	DESCRIPTION	UNITS	TOTAL	CS1	CS2	CS3	CS4
Abutment 2, approach slab: 5 SF achm patches. Patches 5SF CS3							
331	Reinforced Concrete Bridge Railing	LF	100	99	1	0	0
1080	Delamination/Spall/Patched Area	LF	1	0	1	0	0
(331) Span 2, bridge rail, at bent 2: 6" spall on outside at the cap. Spall 1LF CS2
