Bridge A3766 Inspection Report

Asset #A3766(Routine, Underwater type 2)

I-40WB/Se51/219.89 over Flat Fork Creek

Team Lead: Myron Futrell Inspection Date: 02/06/2024

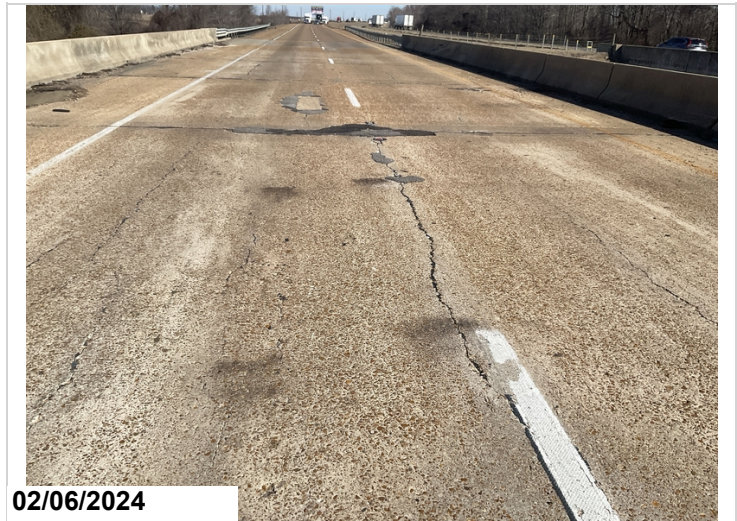
Typical deck

Concrete slab deck is in overall fair condition. Gutters have several areas of heavy scaling with loose aggregate. Deck has several areas that have been patched, some with ACHM and some that the patches are failing. Joints have several areas of missing joint sealer allowing leakage and debris impaction. Deck has CS2 and CS3 cracking on surface, as well as cracking in soffit, some with rust staining and moderate to heavy efflorescence. Soffit / underside of deck has several one-to-two-foot spalls with exposed rebar under sona-tube voids.

Deck has cracking, spalled and patched areas.

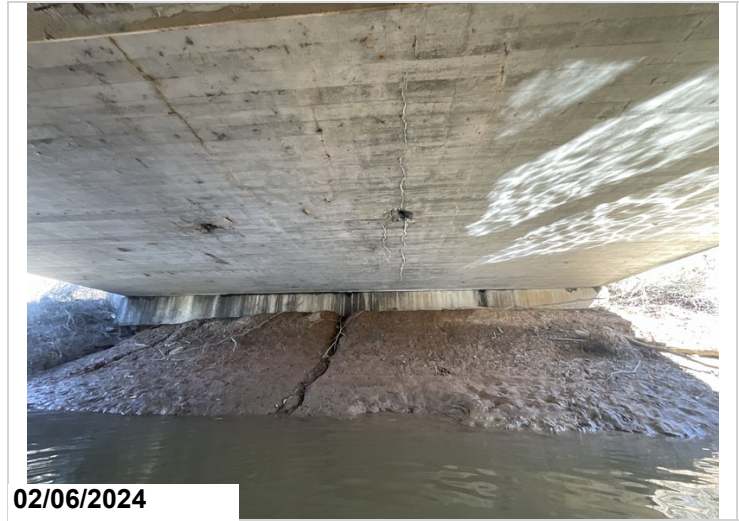
Span #5 soffit / underside of deck

Soffit-under surface all spans have one foot spalls at sona-void drains with exposed rebar with minor section loss.

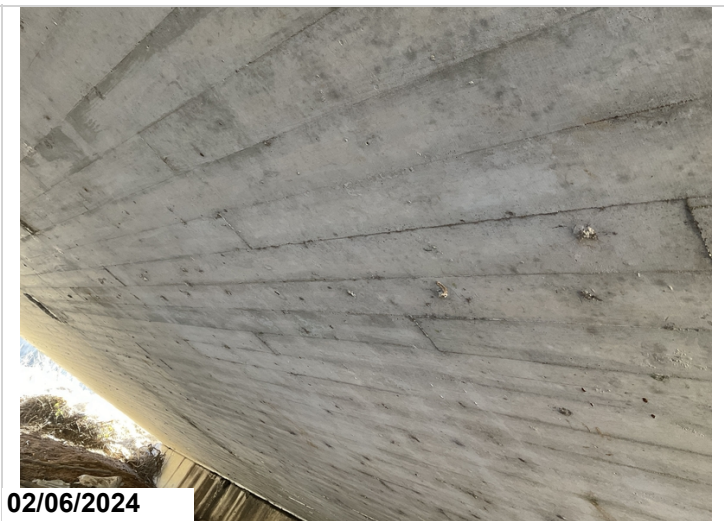
Span #1 soffit / underside of deck

Span #1 left shoulder has two-foot spall no rebar exposed.

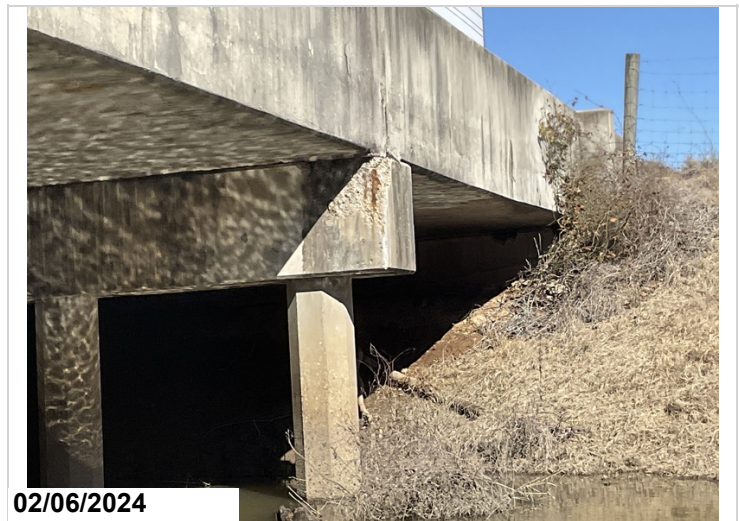
Bent #5 cap right end

Concrete substructure is in overall satisfactory condition. Caps have moderate amounts of exposed rebar due to spalling and poor concrete coverage. Piles have minor abrasion with no loose aggregate. Abutment #2 cap left side is undermined up to one foot for six feet with one exposed pile.

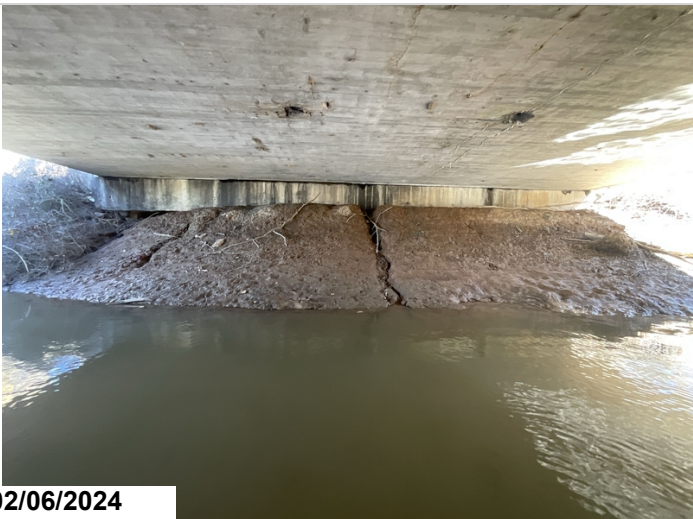
Abutment #2

Channel is in overall satisfactory condition. Banks are slumping somewhat and there is moderate erosion at abutment #2 exposing one pile. Channel alignment is good and there is some vegetation growing into channel.

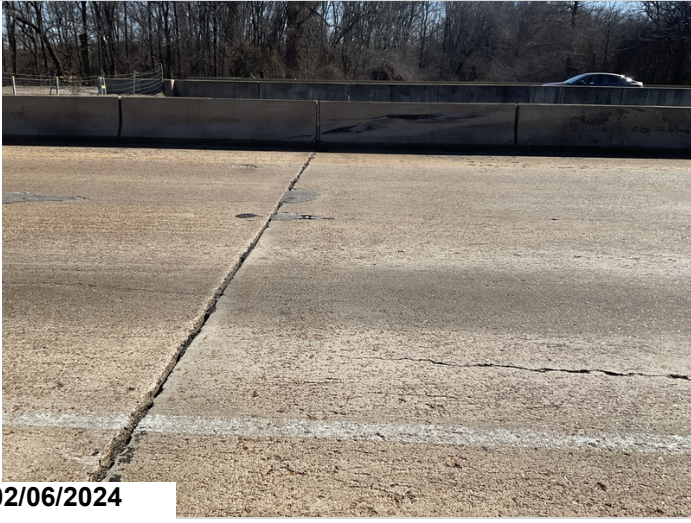
Bent #5 joint

Deck joints have areas of missing and damaged joint sealer.

All joint seals are cracked leaking and allowing debris to enter.
